Five-O Building Inspections
2450 SE Springtree Pl
Stuart FL 34997
tomglyn@adelphia.net

02/06/07

Inspection Report of 1005 Ruby Ave Vero Beach FL 32968
Prepared for Bob & Tracey Schafer

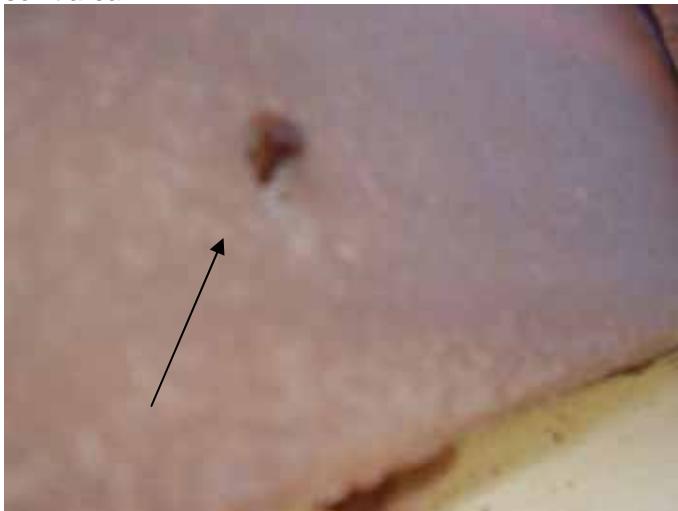
There was rust &/or corrosion at some of the rake tile anchor nails. §1506.5 Fasteners

All of the rake tile anchor nails should be made of corrosion resistant material as per FBC §1506.5 Fasteners & R118-2.01A.

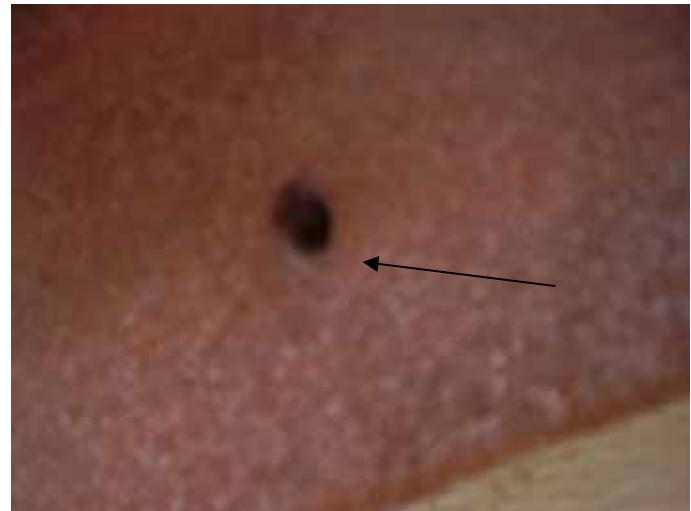
Some of the rake tile anchor nails were loose or not correctly secured. – Hazard.

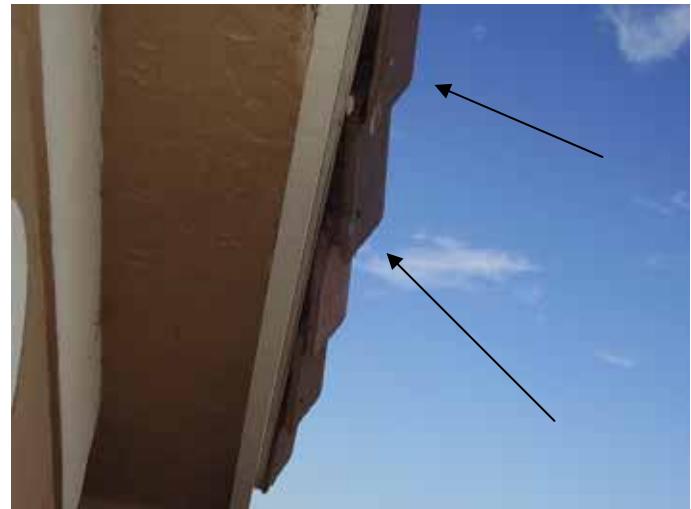
Some of the rake tile anchor nails were loose or not correctly secured. – Hazard.

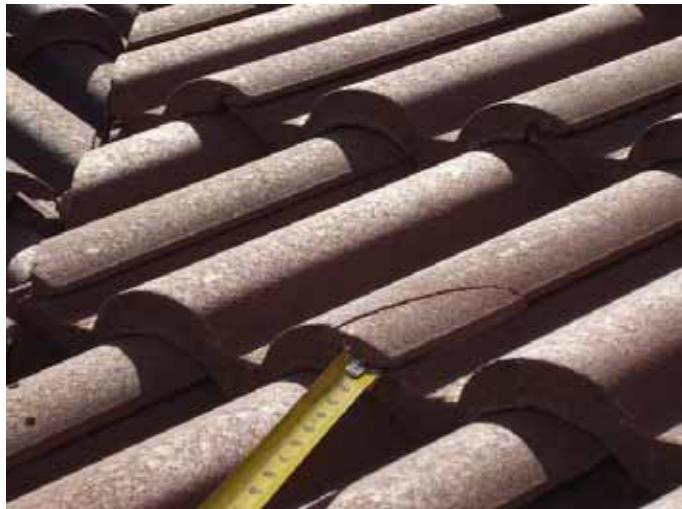
There were broken tiles that were incorrectly "glued" back together on the roof.

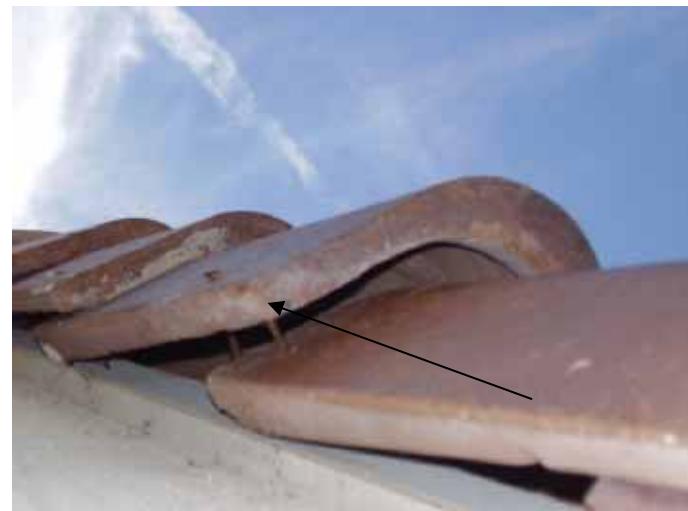
Some of the rake tile anchor nails were loose or not correctly secured. – Hazard.

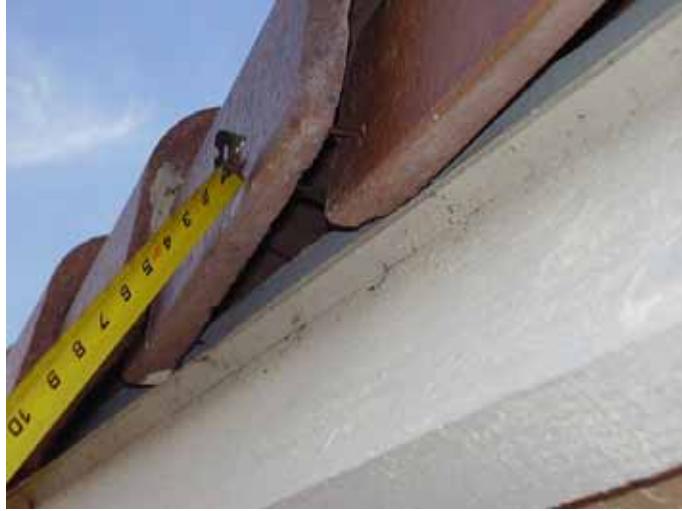
Some of the rake tile anchor nails were loose or not correctly secured. – Hazard.

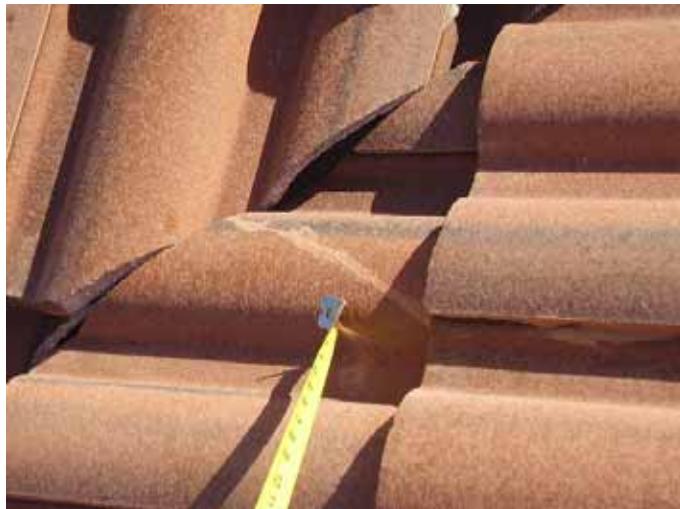
Broken tiles have been incorrectly repaired or "glued" back together at multiple locations.

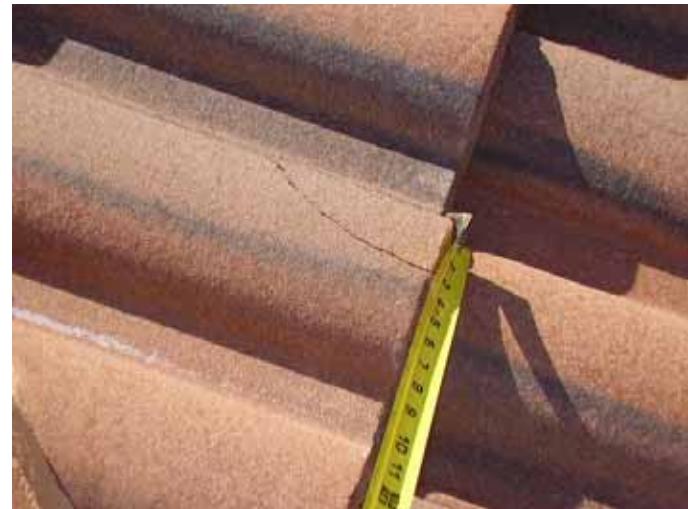
There were broken & incorrectly repaired roof tiles at multiple locations.

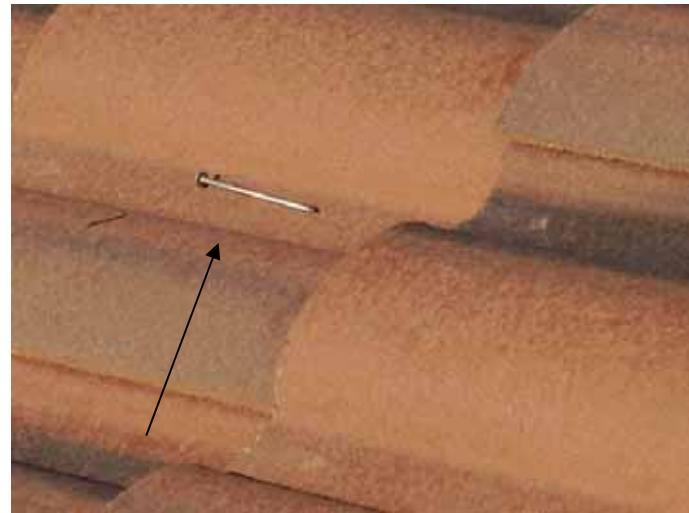
All nails & construction debris should be removed from the roof. – Hazard.

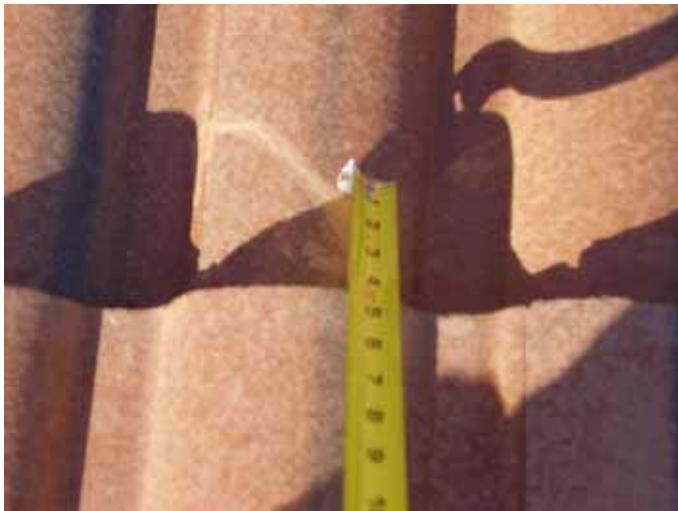
There were broken & incorrectly repaired roof tiles at multiple locations. The broken roof tiles should be removed & replaced, not "glued" back together.

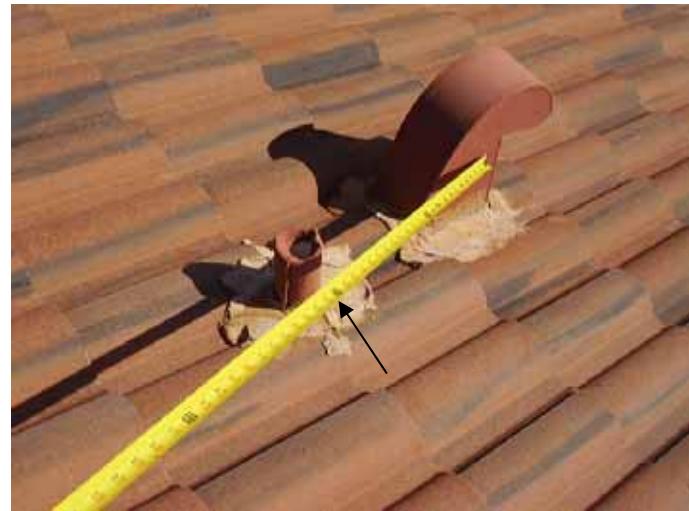
Some of the waste drain plumbing vent stacks are very close to the exhaust hood openings.

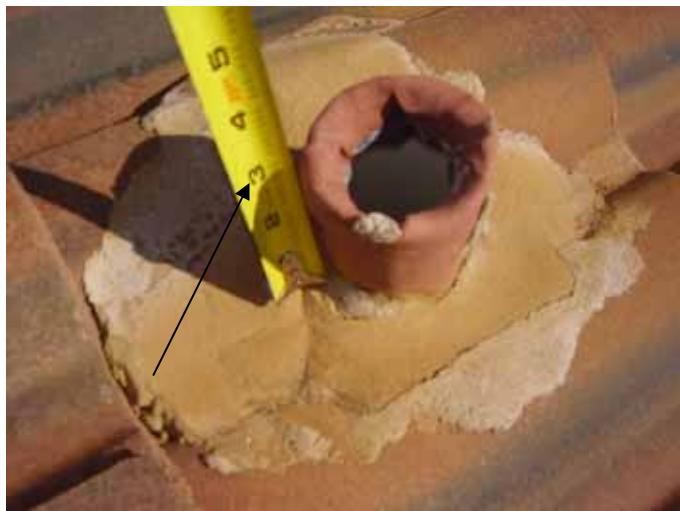
The plumbing vent stack was not the correct height. The vent stack should terminate at 6 inches minimum above the roof. §P904.1

The opening can act as a make up air intake when the AC or Heat is running. Sewer gasses can be drawn back into the attic & house. §M401.5.1, §P904.5. We recommend installing dampers at the exhaust hoods to prevent any possibility of waste gasses re-entering the building.

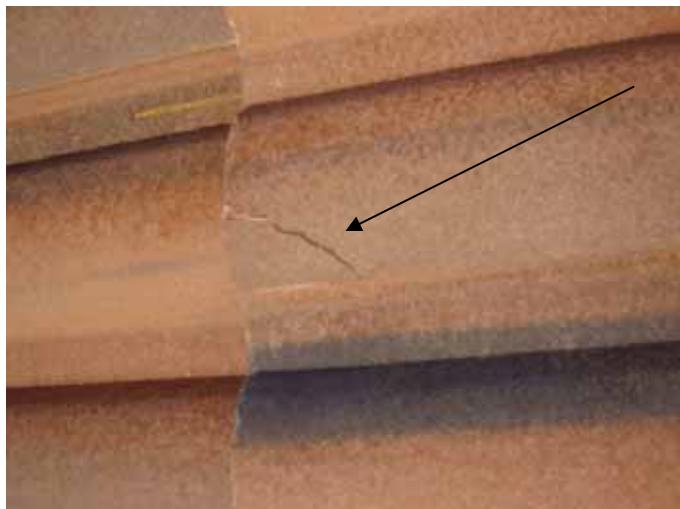
There were broken & incorrectly repaired roof tiles at multiple locations.

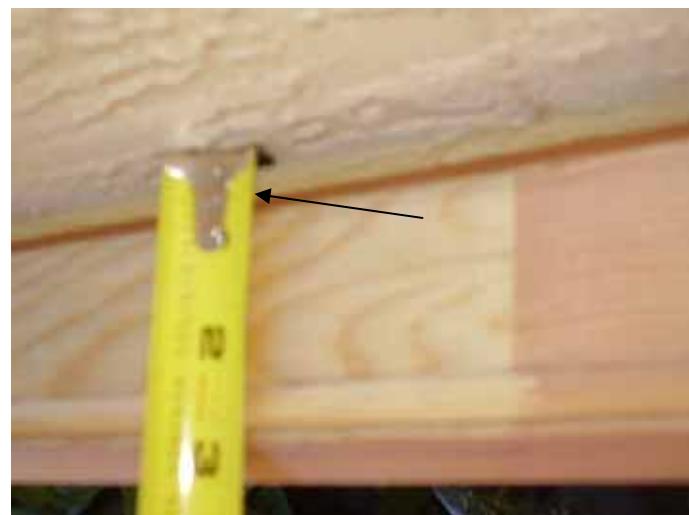
The stucco at the some of the exterior walls is concave or curved in & does not appear to be the correct thickness.
§2504.2

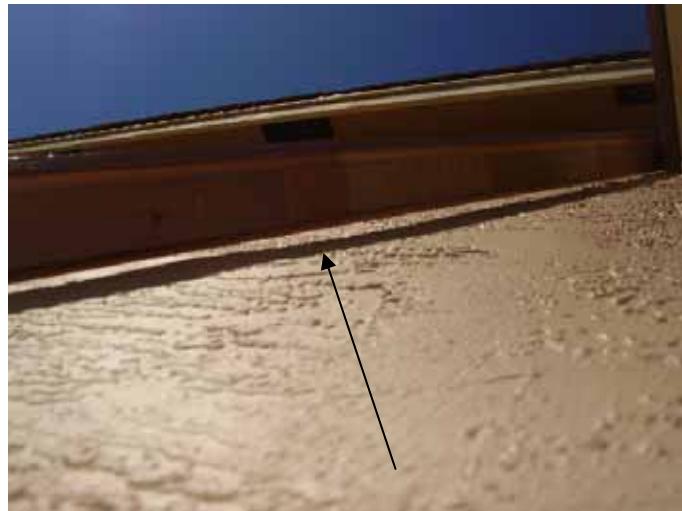
The stucco at some of the exterior walls is concave or curved in & does not appear to be the correct thickness.
§2504.2

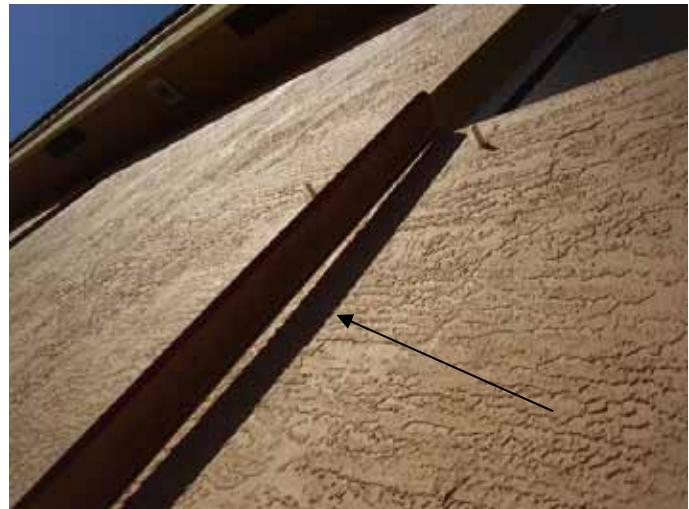
The stucco at the some of the exterior walls is concave or curved in & does not appear to be the correct thickness. \$2504.2

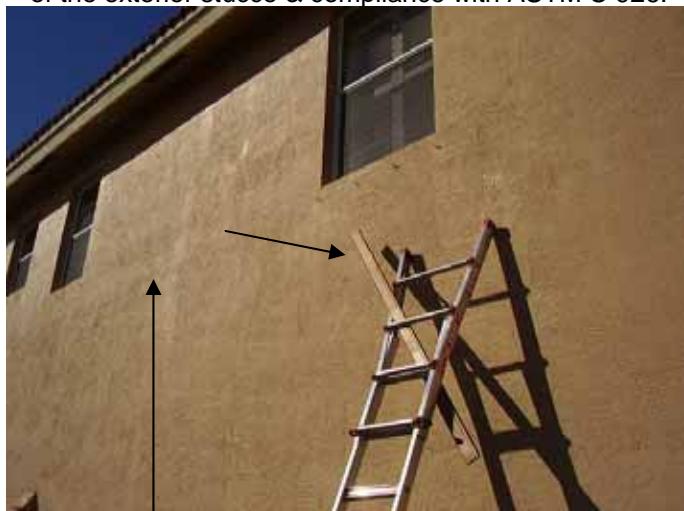
Location of the previous photo/s. The make-up air intake exhaust covers were loose &/or not correctly secured or sealed at the soffits.

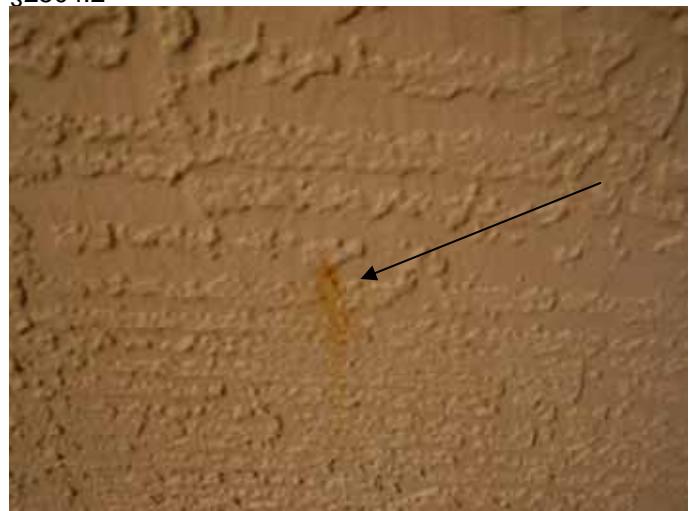
There was rust bleeding through the stucco at several locations. We recommend core sampling at the areas identified to verify the thickness of the exterior stucco.

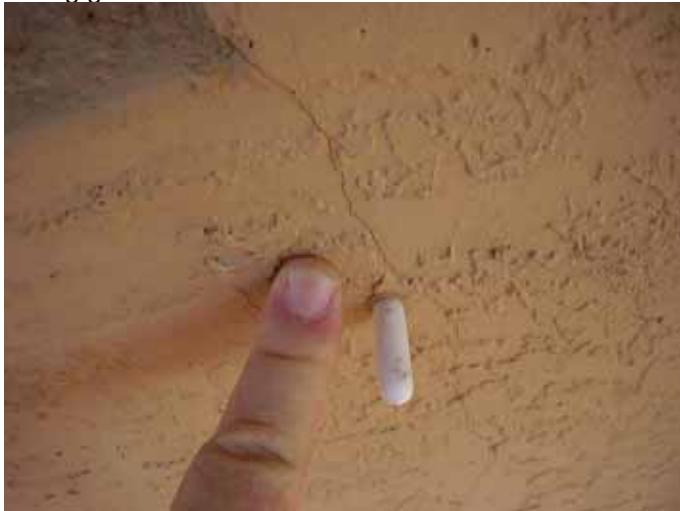
There were unsealed cracks in the stucco in the exterior wall under the NE side guest bedroom area window.

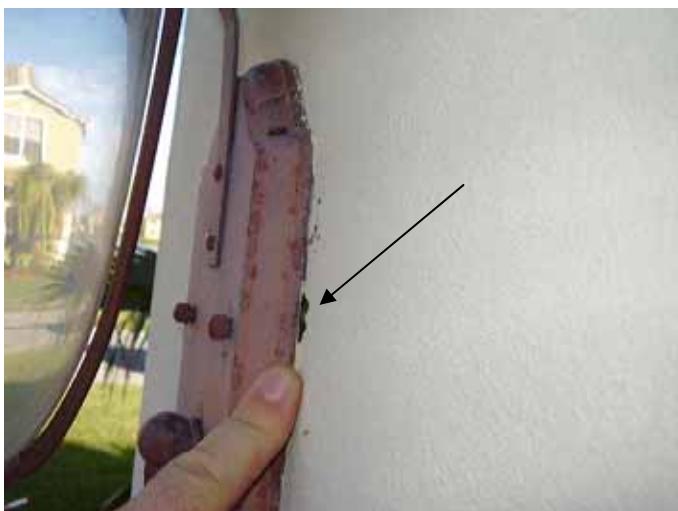
Some of the lighting fixtures were not completely sealed to prevent water & pest intrusion at the wall or base.
2002 NEC 410.4, §13-606.1.ABC.1.2

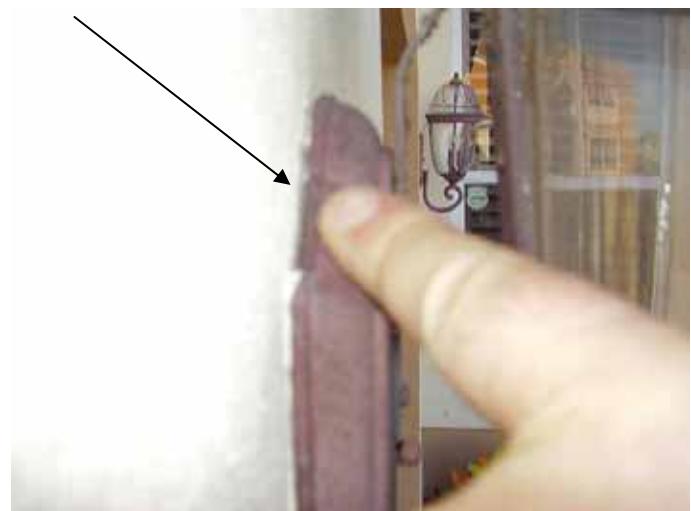
The exterior lighting fixtures were not completely sealed to prevent water & pest intrusion at the wall or base.
2002 NEC 410.4, §13-606.1.ABC.1.2

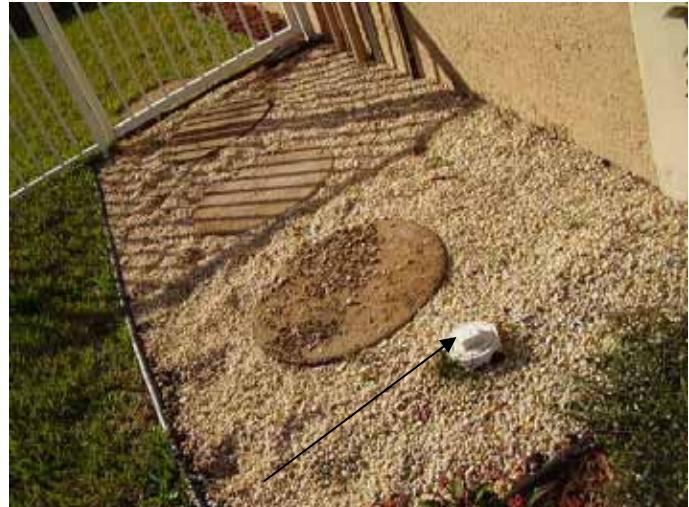
The plumbing wasteline cleanout access was located in an area where pedestrian traffic may occur. The cover should be countersunk or turned upside down. Trip hazard. §P708.2

§P708.2 Cleanout plugs. Cleanout plugs shall be of brass, plastic or other approved materials. Brass cleanout plugs shall be utilized with metallic drain, waste and vent piping only, and shall conform to ASTM A 74. Plastic cleanout plugs shall conform to the requirements of §P702.4. Plugs shall have raised square or countersunk square heads. Countersunk heads shall be installed where raised heads are a trip hazard. Cleanout plugs with borosilicate glass systems shall be of borosilicate glass.

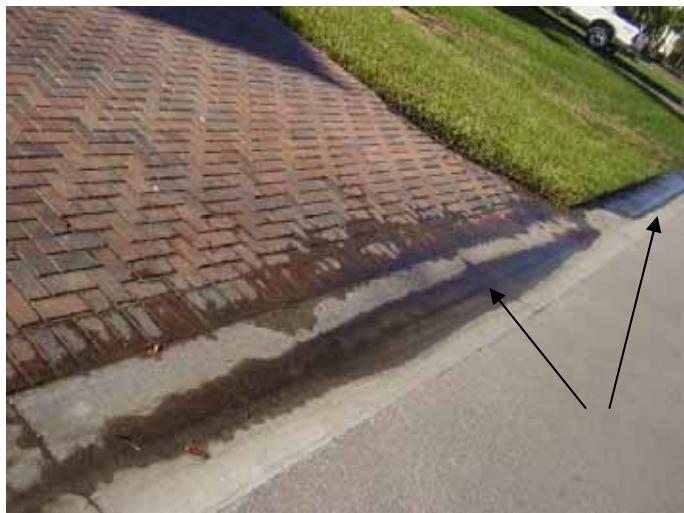
The front of the house & yard were very wet. The area was not draining correctly.

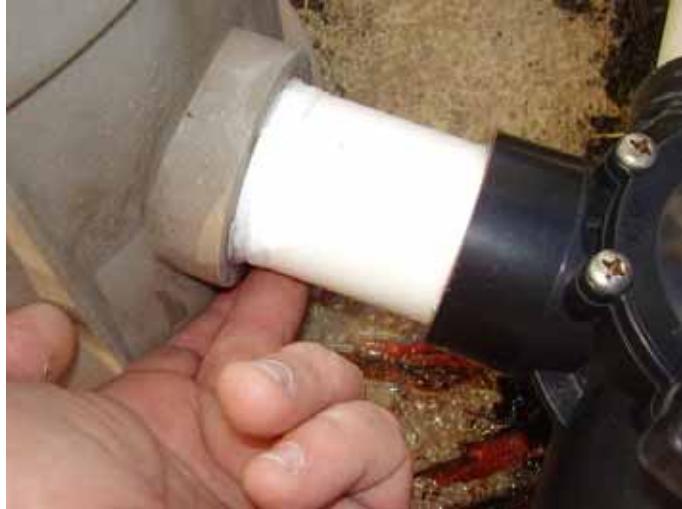
There were leaks at the pool plumbing pipe at the connection to the filter housing.

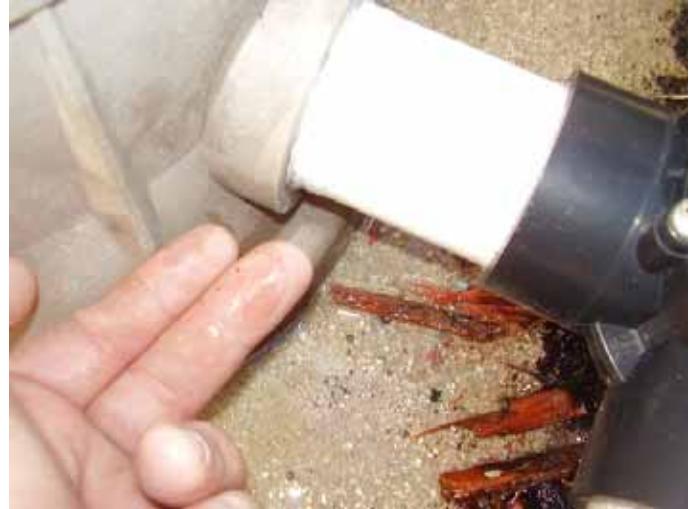
The bottom of the pipe was wet.

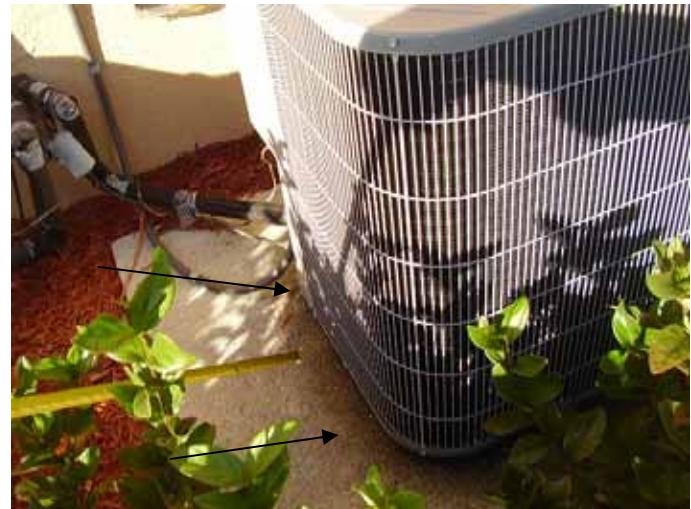
There should be 3 anchors per side as per FBC M301.13.1 unless otherwise prescribed by the design professional.

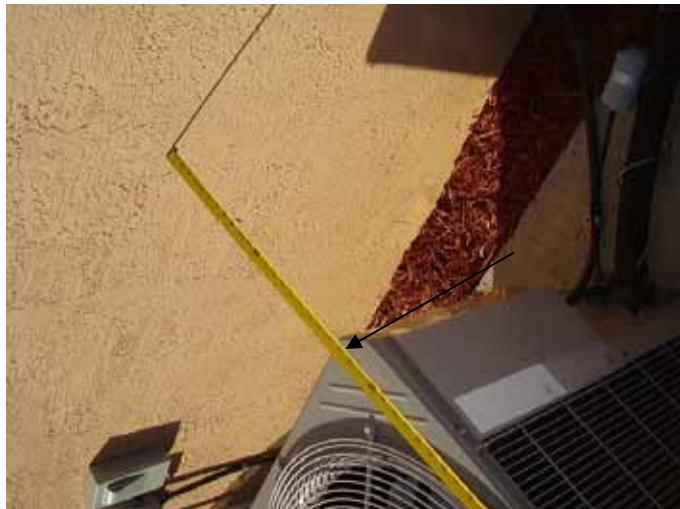
The AC condensing units were turned the wrong way. 36 inch working space clearance is required at the electrical component access panel.

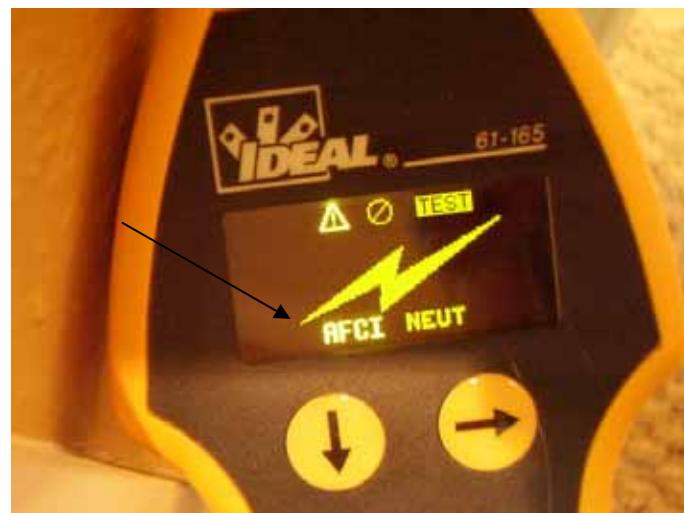
The receptacle & fixture outlets test non-AFCI protected behind by the closet in the 2nd floor master bedroom.
2002 NEC 210.12 Arc-Fault Circuit-Interrupter Protection.

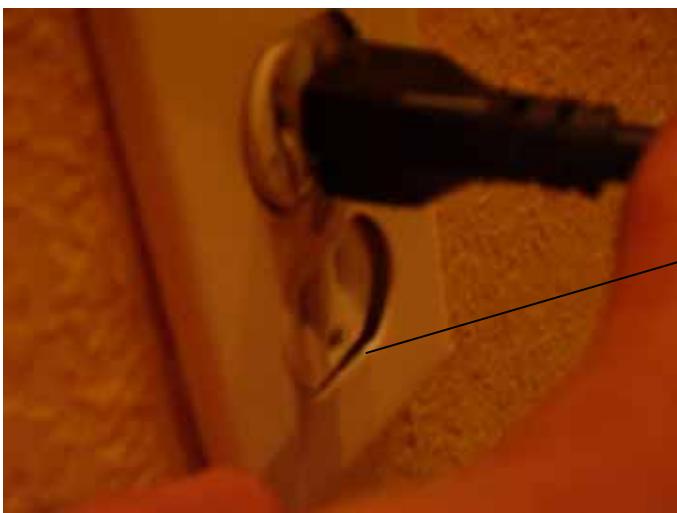
There were several receptacles that were loose & not correctly secured in the walls.

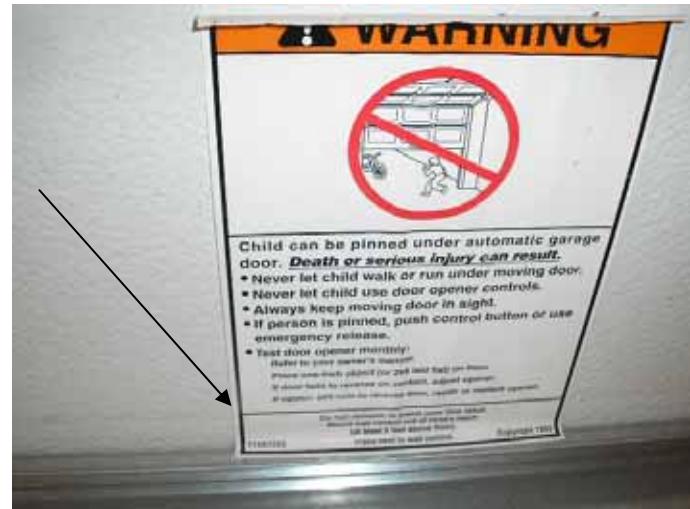
A warning label like this one needs to go on the wall by the auto door opener switches §M304.1

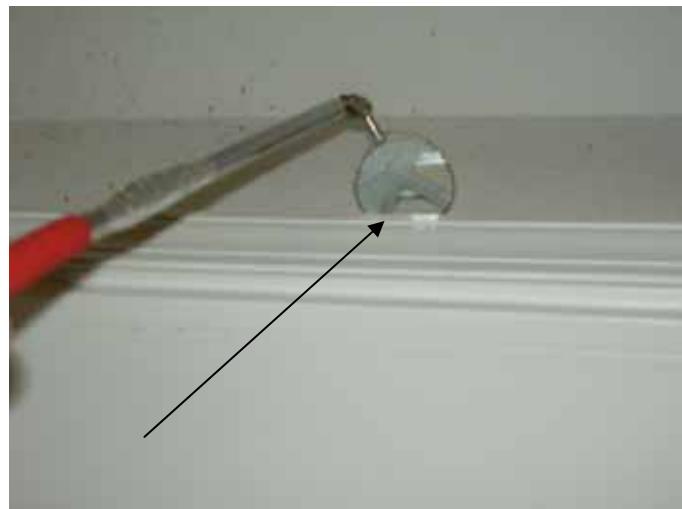
The top of the garage/laundry room access door frame was not correctly sealed. §13-606.1.ABC.1.2

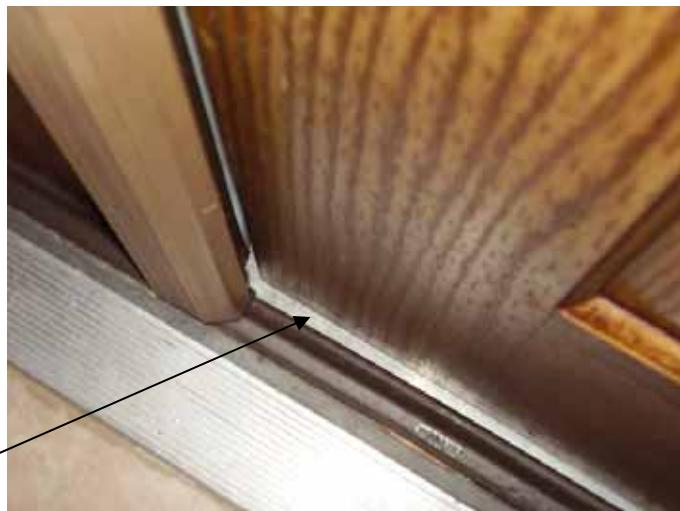
There were gaps with daylight at the front door & frame.

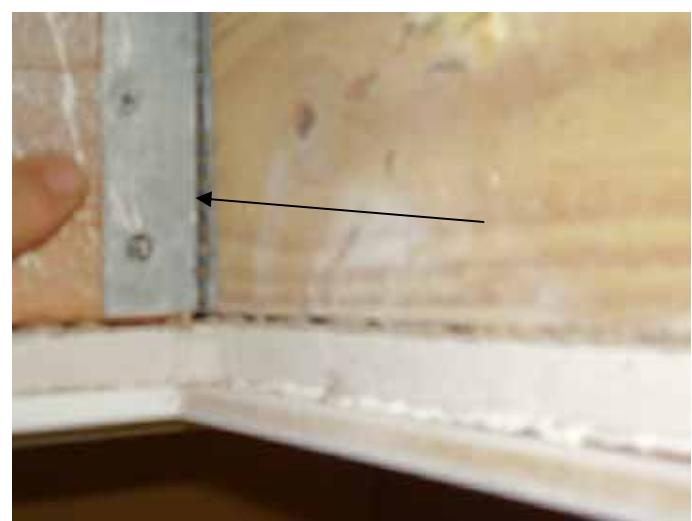
Drywall screws & light gauge framing metal is not designed to support the weight of persons entering the attic. – Hazard. §2504.5.1

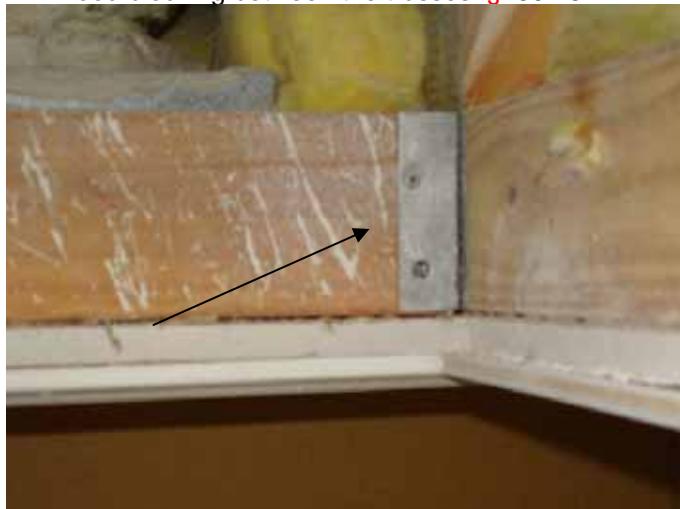
Drywall screws & light gauge framing metal is not designed to support the weight of persons entering the attic. – Hazard. §2504.5.1

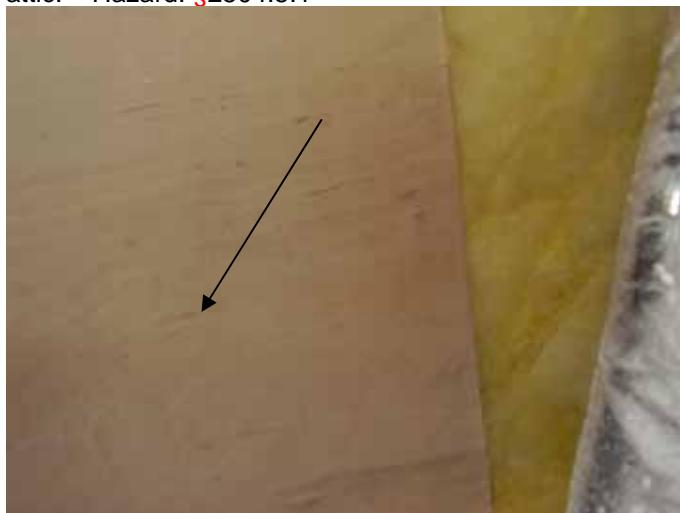
There was no insulation for the attic hatch cover. Insulation should be attached to the back of the attic access hatch cover.

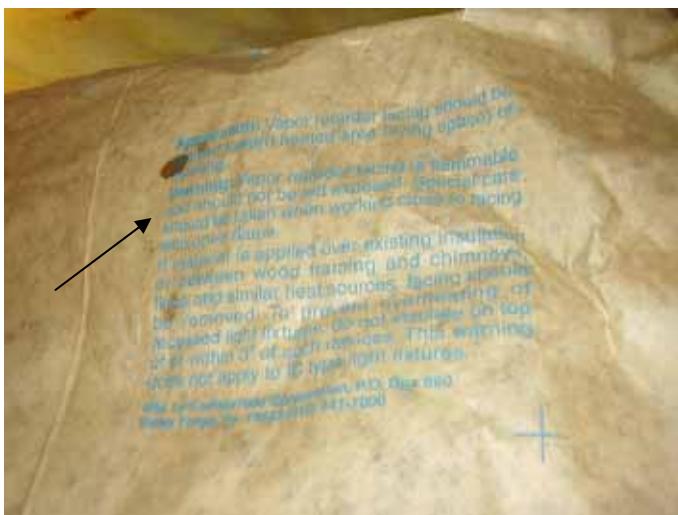
There is exposed kraft paper insulation backing in the attic. The manufacturer states the facing will burn & should not be exposed. §708.2

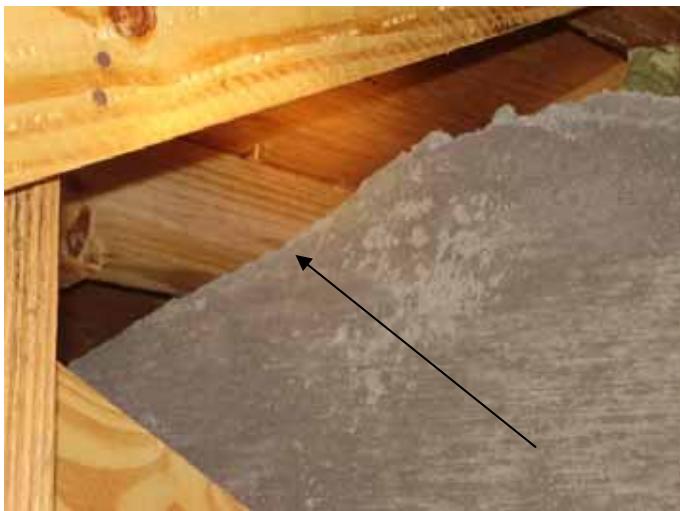
There were one or missing straps at the roof framing above the front gable end wall at the 2nd floor.

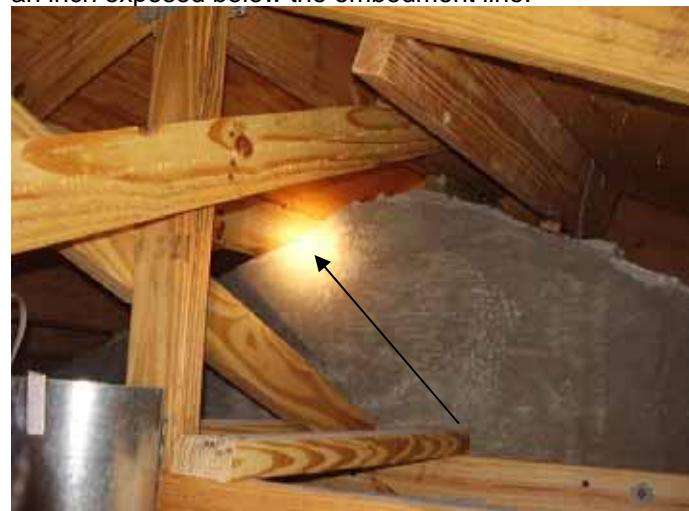
Location of the previous photo. There was no strap at this 2x6 roof framing component above the front gable end wall at the 2nd floor.

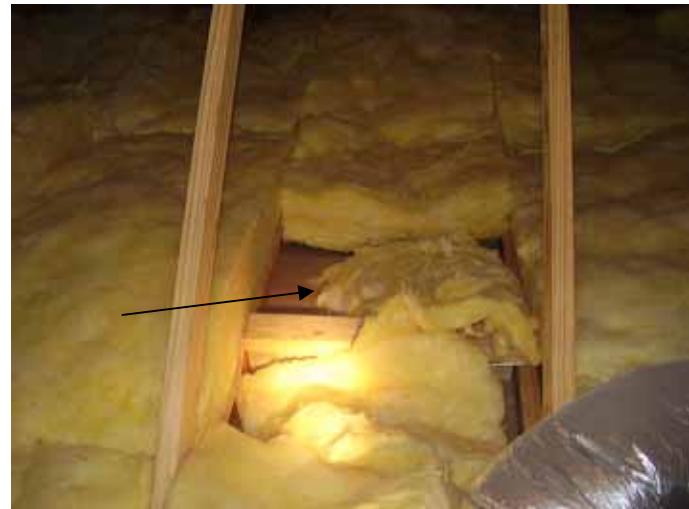
Some of the attic insulation was out of place or missing.

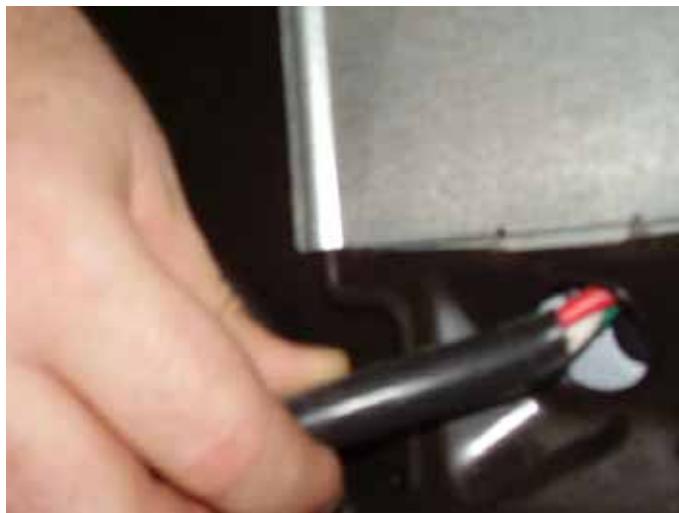
The grommet was not installed to secure the electrical wiring at the back of the dryer. – Shock Hazard.

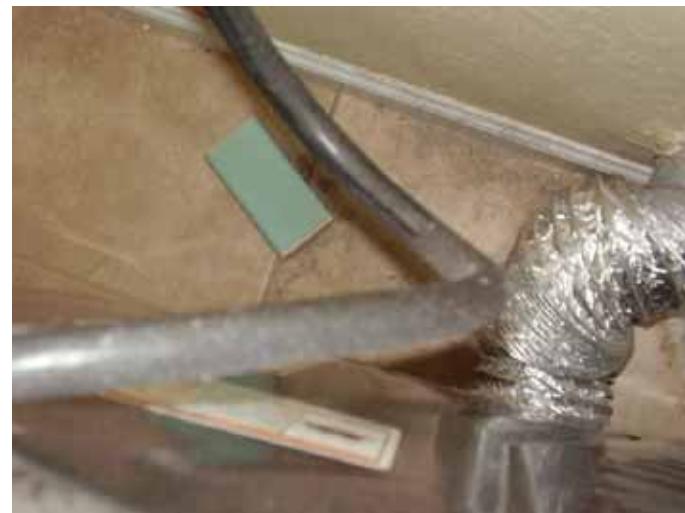
The foil vent is not permitted for use with this dryer.

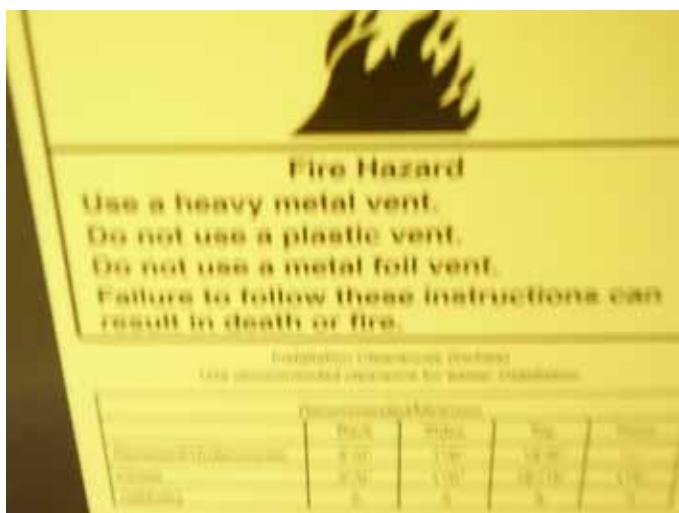
The manufacturer states the use of this duct is a fire hazard.

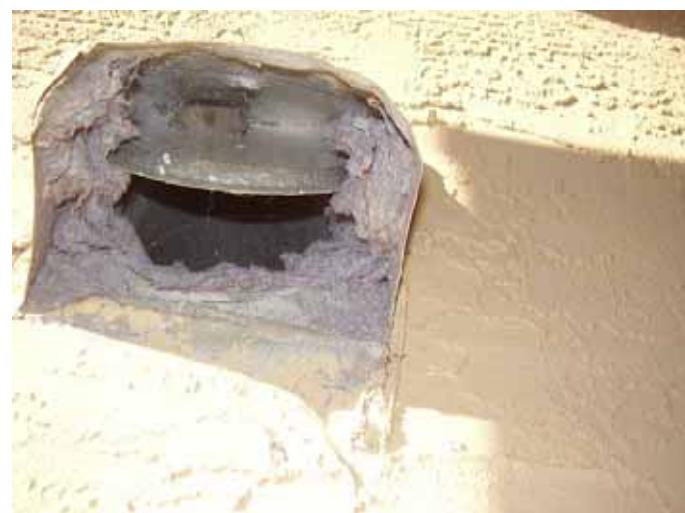
The dryer exhaust housing was obstructed with lint & did not allow the damper door to close correctly.
