## Inspection Report of 5419 Fleming Way Stuart FL 34997 Prepared for Stella Luongo

### **The State of Florida requires the builder to build in compliance with the Florida Building Code.**

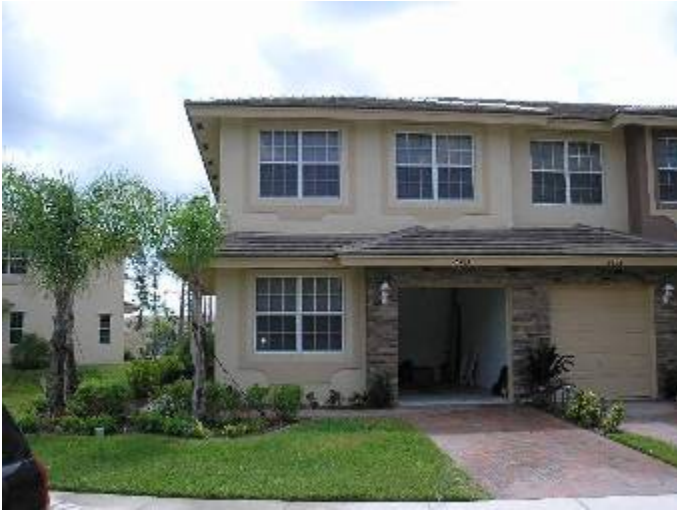
Site photo. The front of the house faces towards the west.

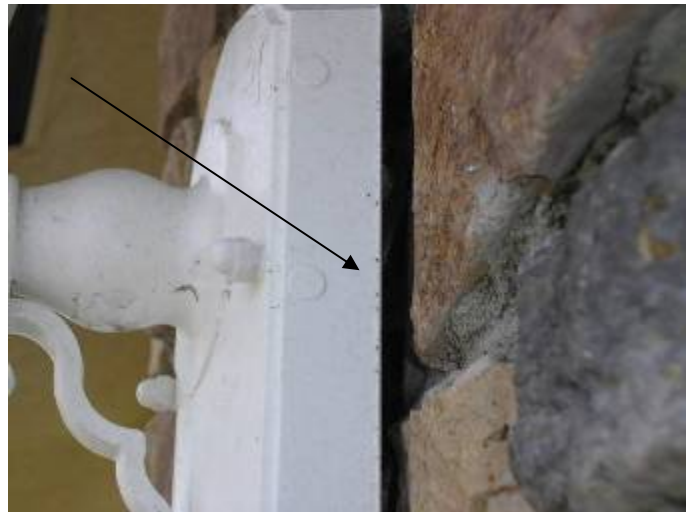
There are visible/exposed wires & the exterior light fixtures are not completely sealed or gasketed at the base as required. §13-606.1.ABC.1.2

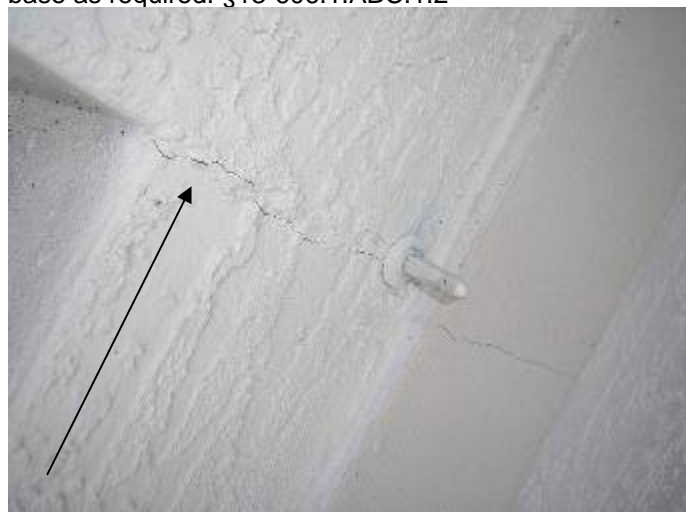
There are unsealed cracks in the stucco banding. §1403.1.3

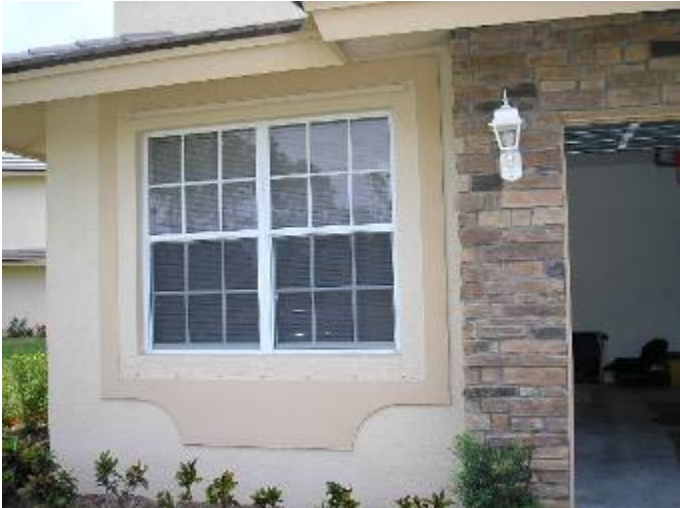
Location of the previous photo/s.

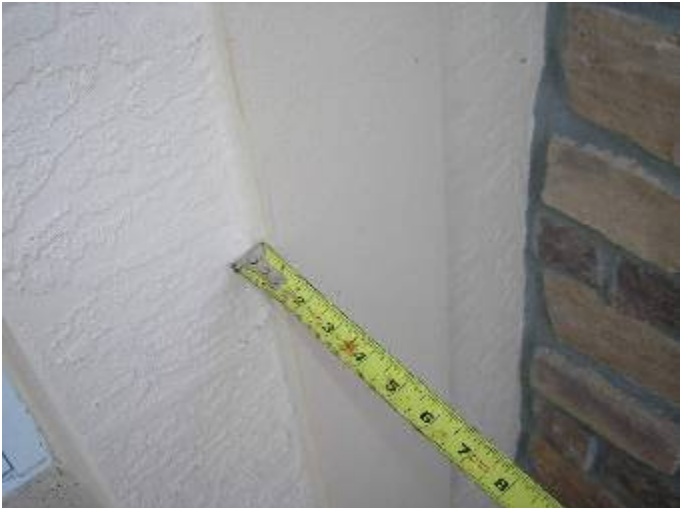
We recommend core sampling to verify the thickness of the exterior stucco & compliance with ASTM C 926.

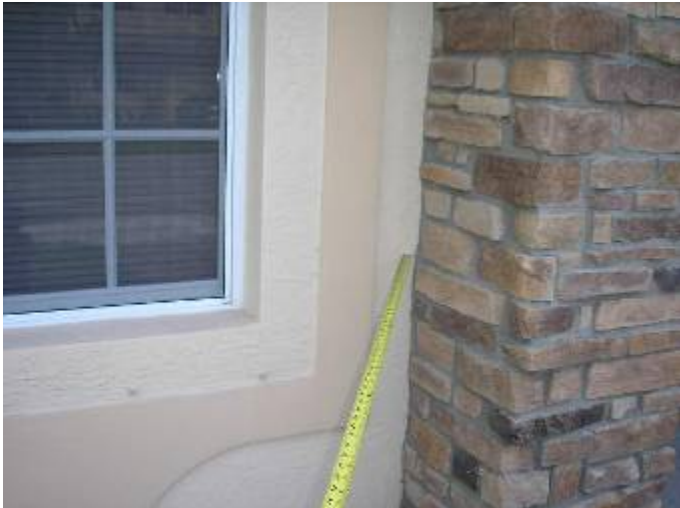
Location of the previous photo/s.

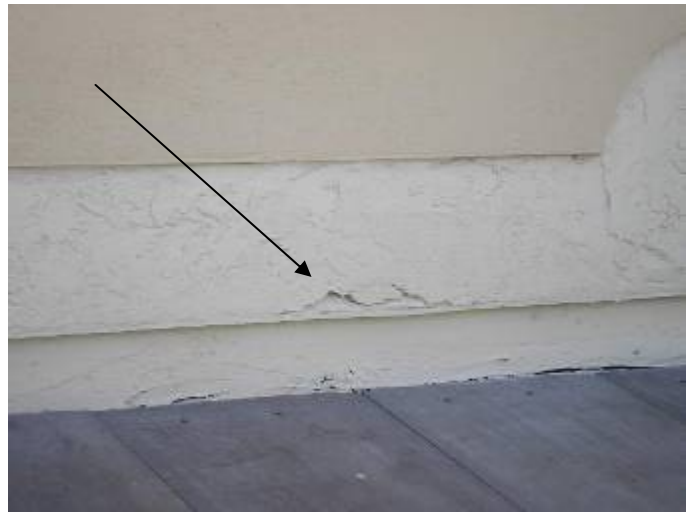
There is missing stucco above the garage roof tile at the 2<sup>nd</sup> floor exterior wall. §13-606.1.ABC.1.2, §1403.1.3.

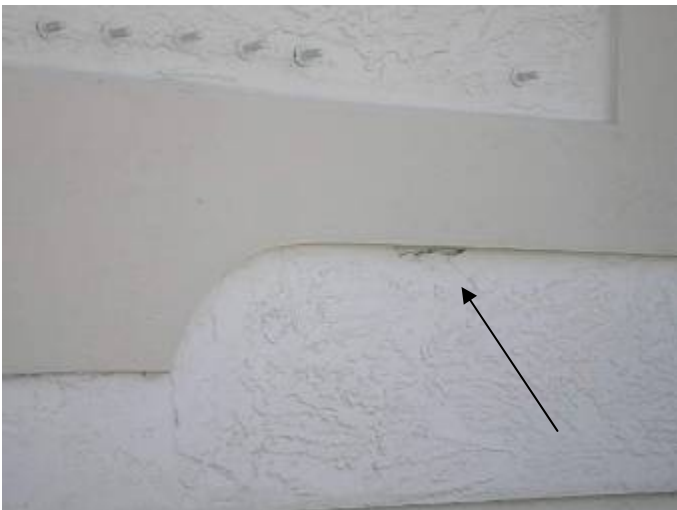
There is missing stucco above the garage roof tile at the 2<sup>nd</sup> floor exterior wall. §13-606.1.ABC.1.2, §1403.1.3.

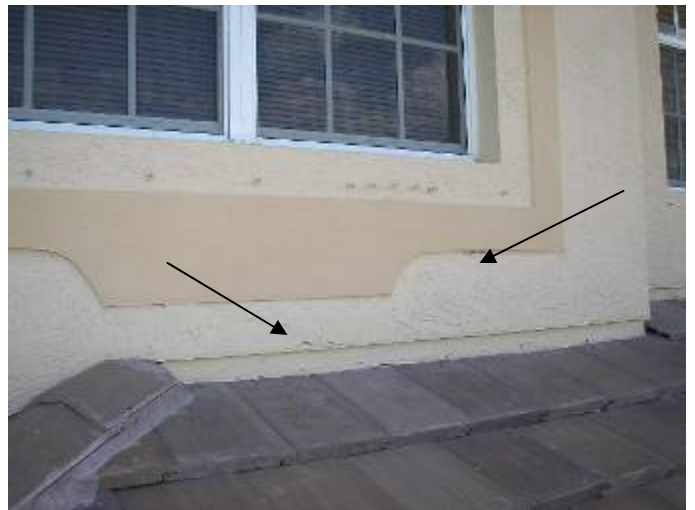
Location of the previous photo/s.

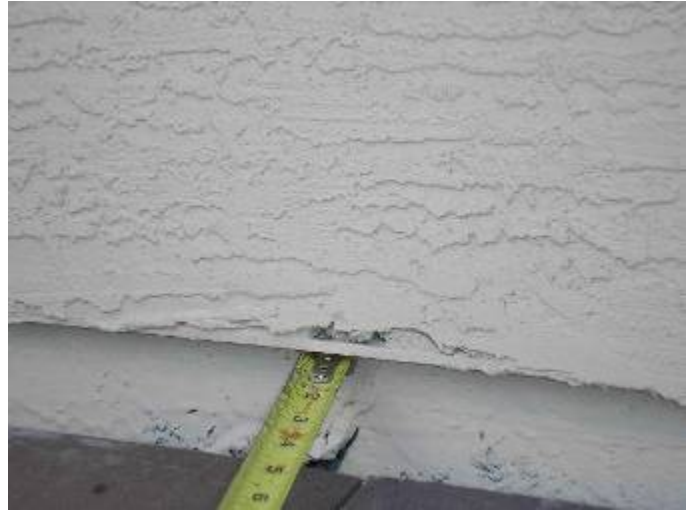
There is missing stucco outside the 2<sup>nd</sup> floor north side exterior wall. §13-606.1.ABC.1.2, §1403.1.3.

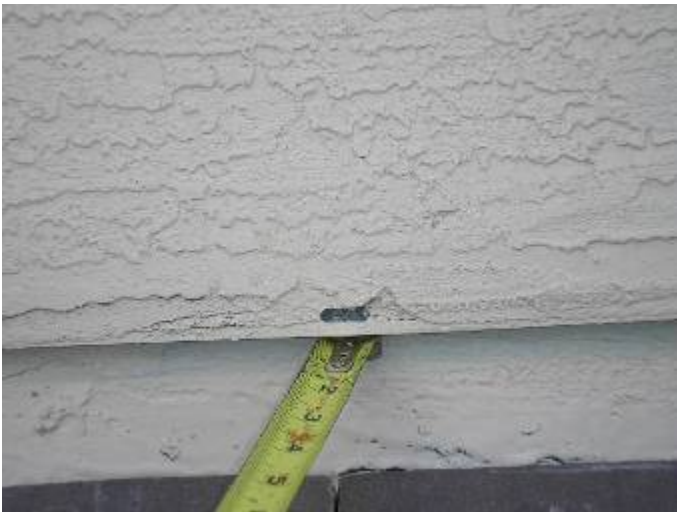
There is missing stucco outside the 2<sup>nd</sup> floor north side exterior wall. §13-606.1.ABC.1.2, §1403.1.3.

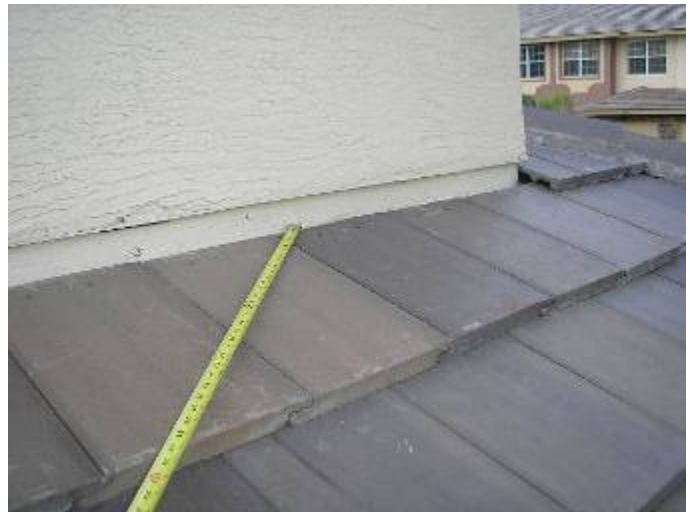
The roof wall abutments have not been correctly pointed up with mortar at the back patio. R118-3.13

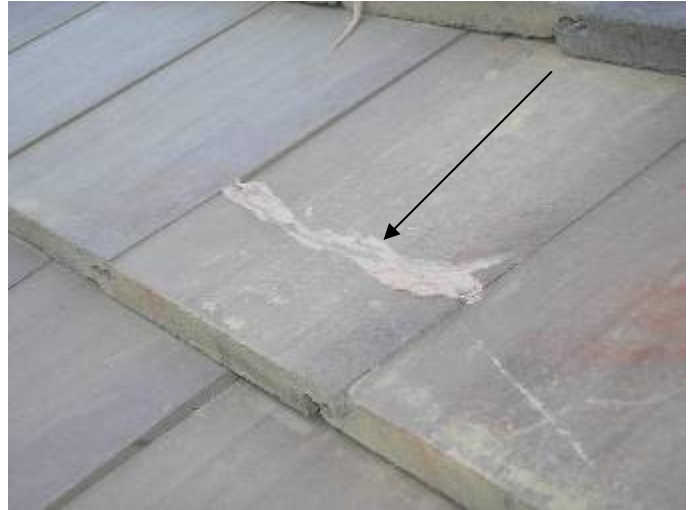
There were broken & incorrectly repaired roof tiles at several locations. The broken roof tiles should be removed & replaced, not "glued" back together.

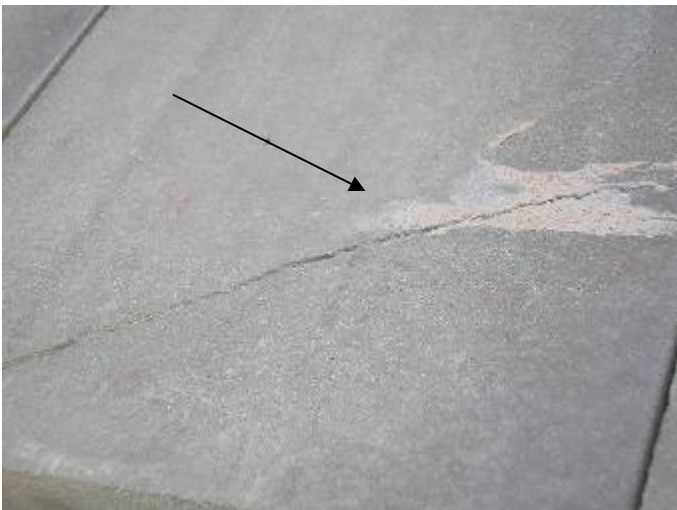
There were broken & incorrectly repaired roof tiles at several locations. The broken roof tiles should be removed & replaced, not "glued" back together.

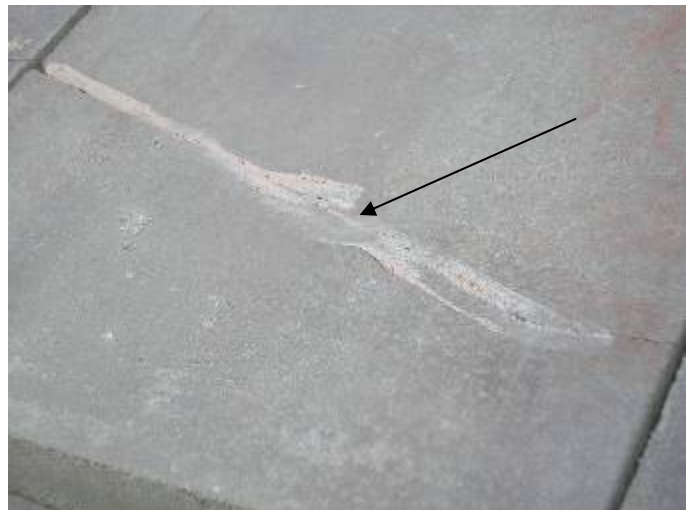
There should not be any broken tiles on the new roof. The tiles need to be removed & replaced; not "glued" back together.

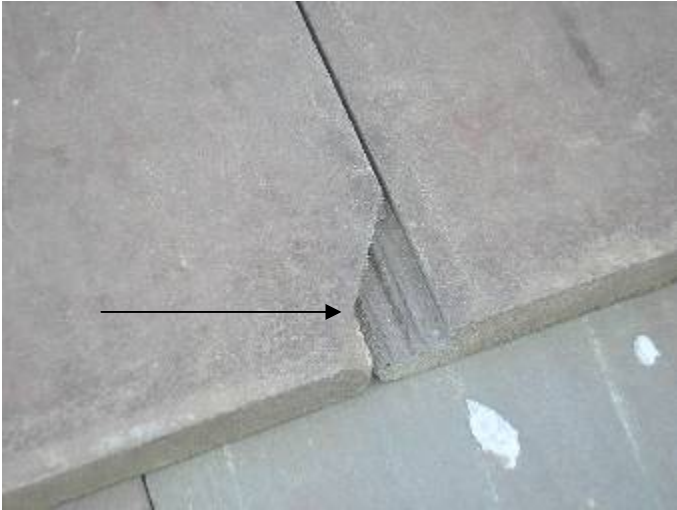
There were broken & incorrectly repaired roof tiles at several locations. The broken roof tiles should be removed & replaced, not "glued" back together.

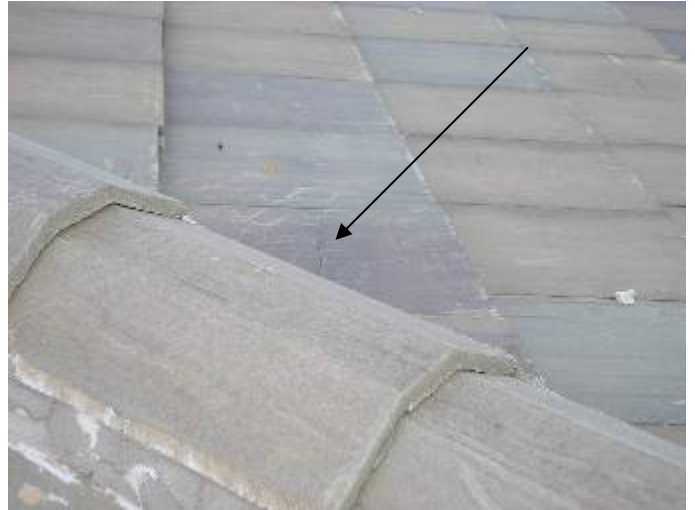
There should not be any broken tiles on the new roof. The tiles need to be removed & replaced; not "glued" back together.

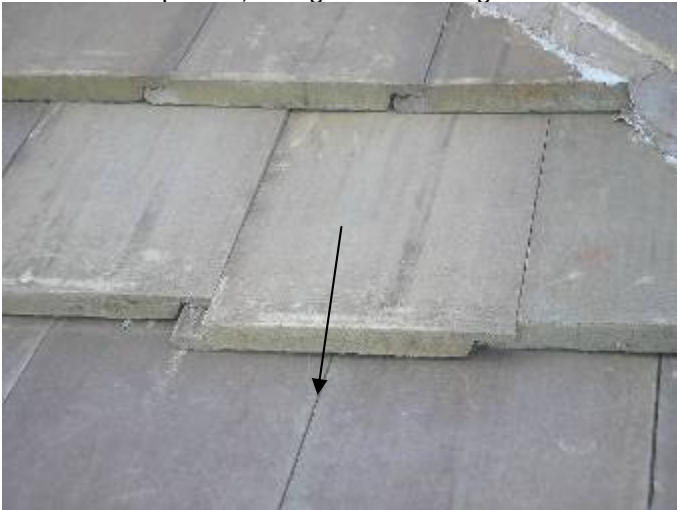
Some of the tiles are loose &/or have slipped out of place. All loose tiles need to be correctly secured.

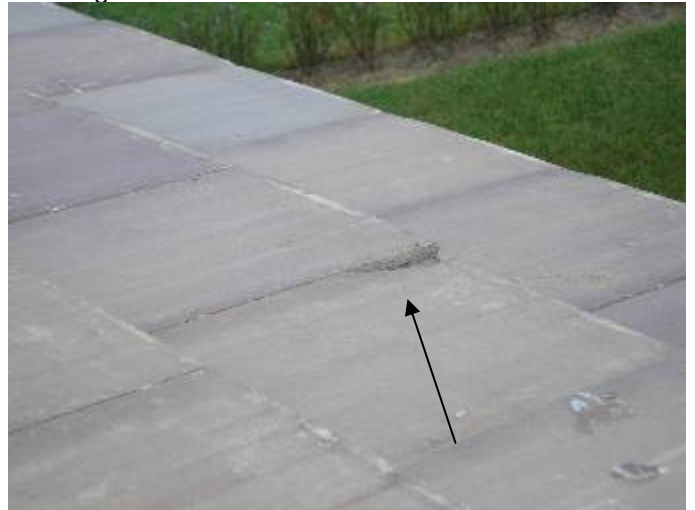
There were broken & incorrectly repaired roof tiles at several locations. The broken roof tiles should be removed & replaced, not "glued" back together.

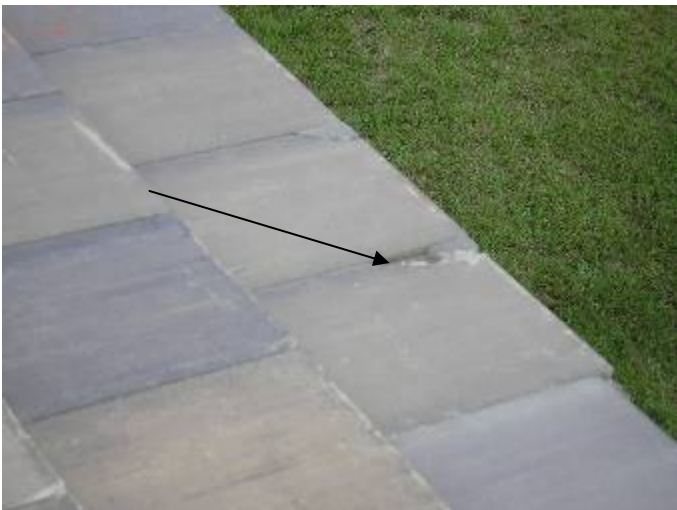
There should not be any broken tiles on the new roof. The tiles need to be removed & replaced; not "glued" back together.

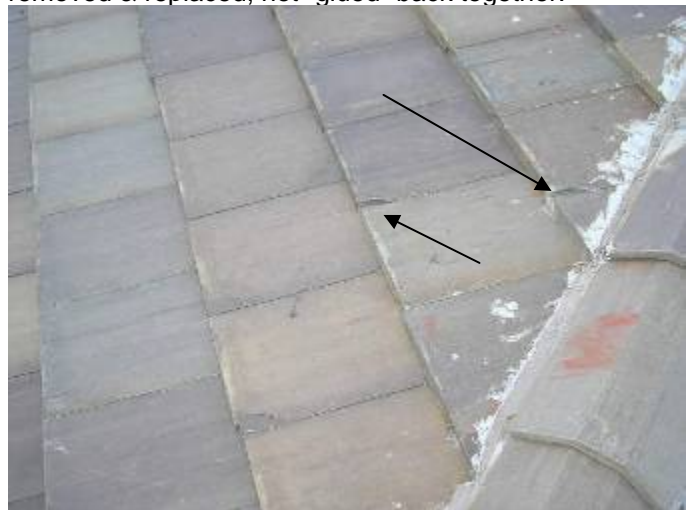
All loose & damaged tiles need to be correctly secured &/or replaced.

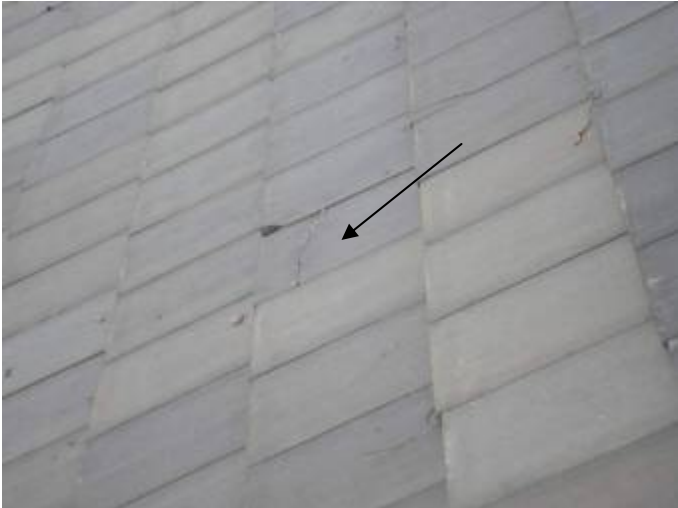
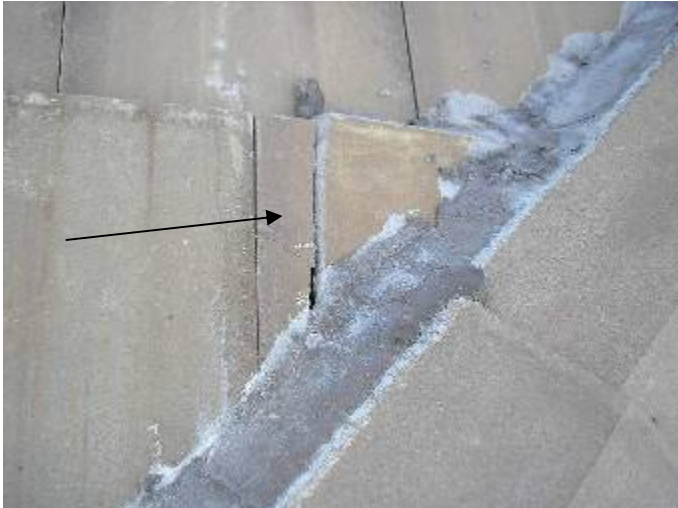
There should not be any broken tiles on the new roof. The tiles need to be removed & replaced; not "glued" back together.

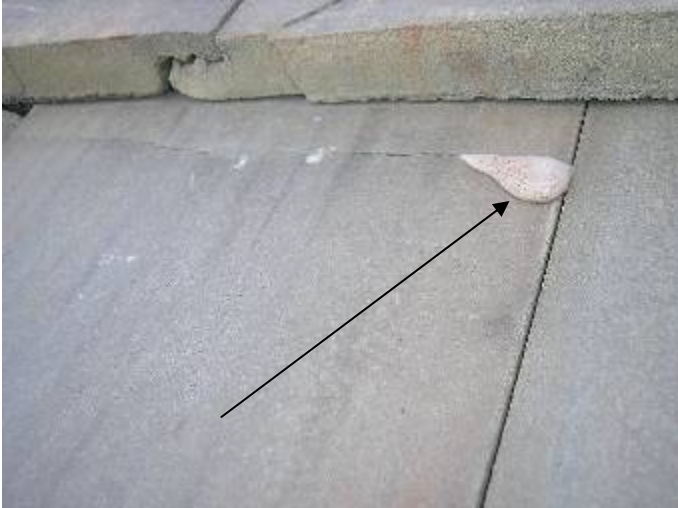
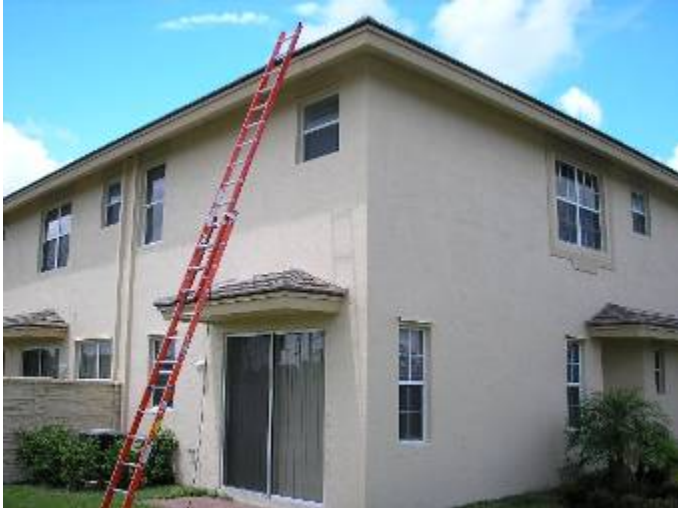
All loose & damaged tiles need to be correctly secured or replaced.

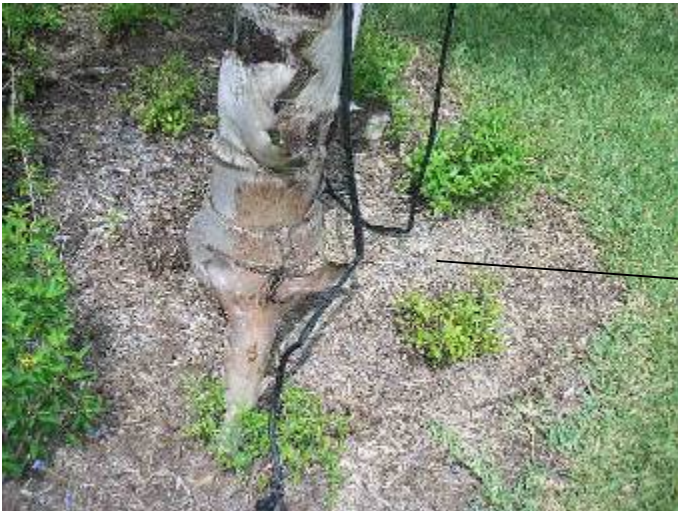
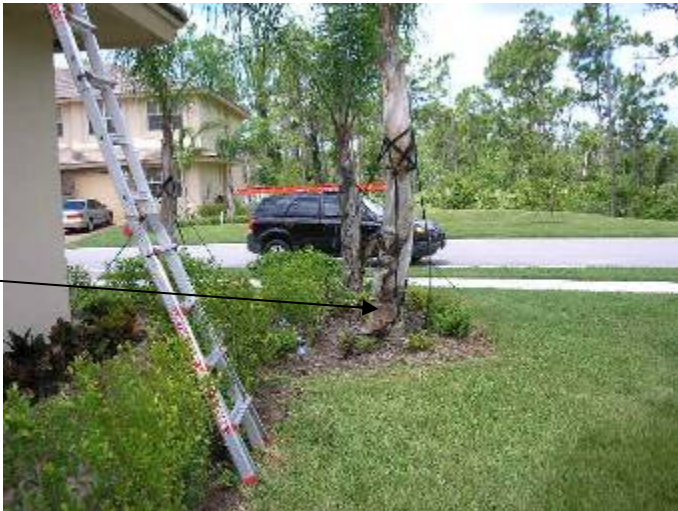
The strapping is loose & not correctly secured at some of the landscape trees.

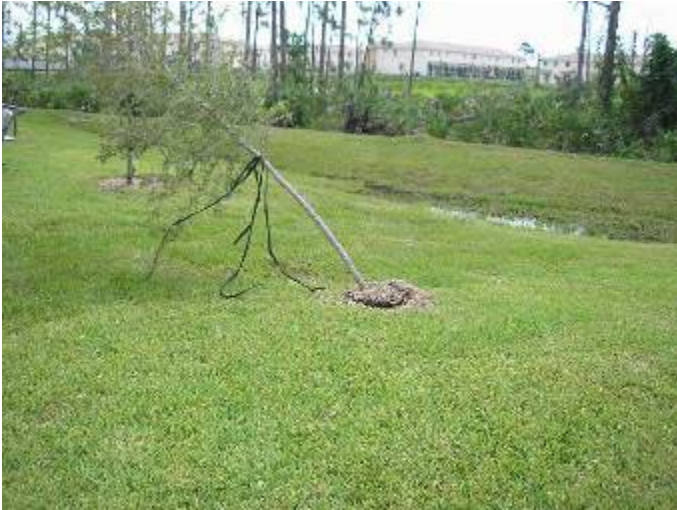
The strapping is loose & not correctly secured at some of the landscape trees. This tree is falling over in the back yard.

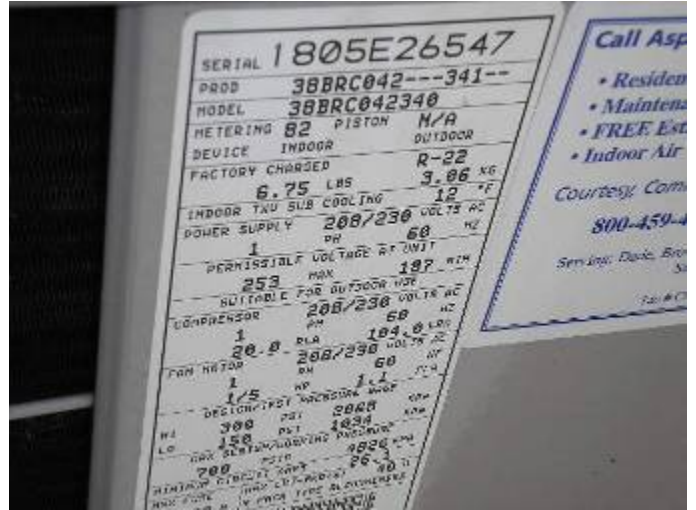
Info plate for the AC condensing unit. – See below & attachment.

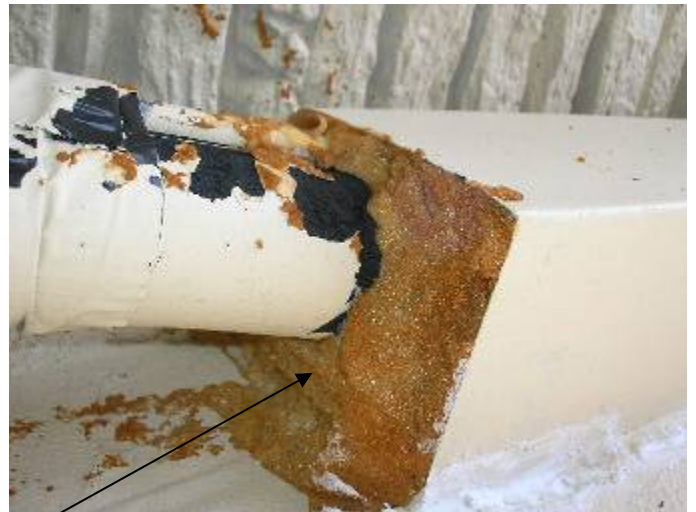
The expandable foam is not designed to be exposed to U.V. damage from sunlight. The bottom of the refrigerant line cover is not correctly sealed. §1205.1.2.2

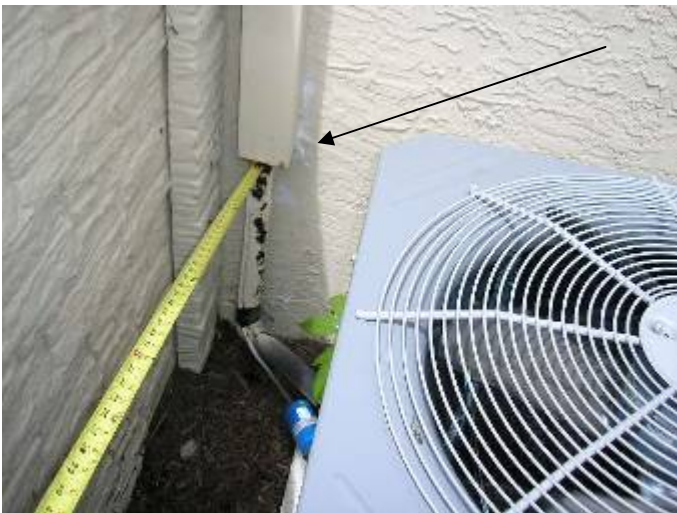
Location of the previous photo/s.

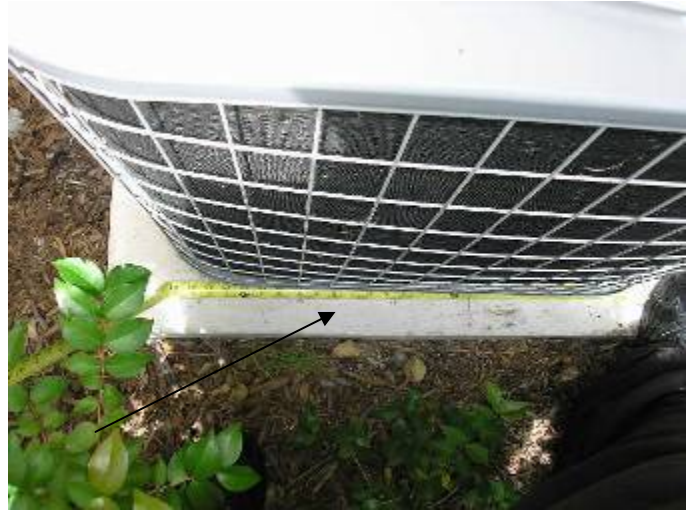
The A/C condenser is not secured properly. There are not enough straps at the base of the unit. There are only 4 anchor pins inside the unit. M301.13.1  
**Florida Building Code**

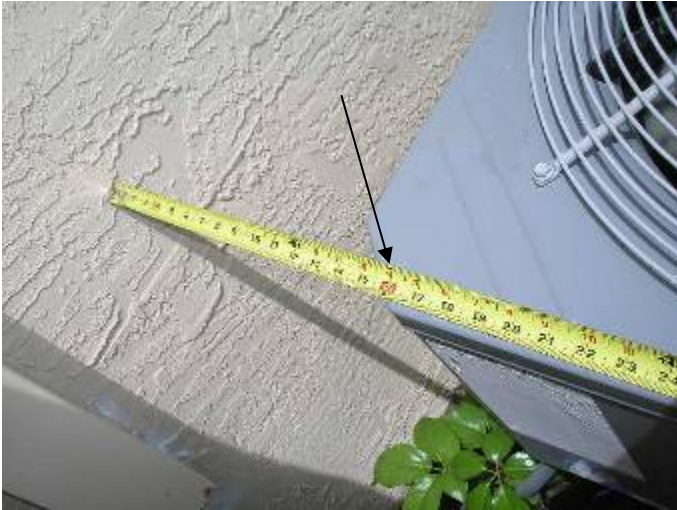
The AC condensing unit is turned the wrong way. 36 " working space clearance is required at the electrical access panel covers. 2002 NEC §110.26

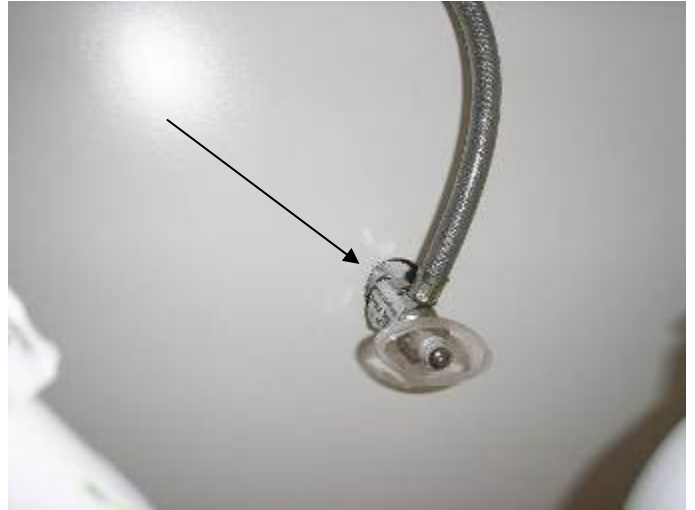
Some of the plumbing pipes have loose, unsealed or missing escutcheons (covers) inside the sink cabinets.

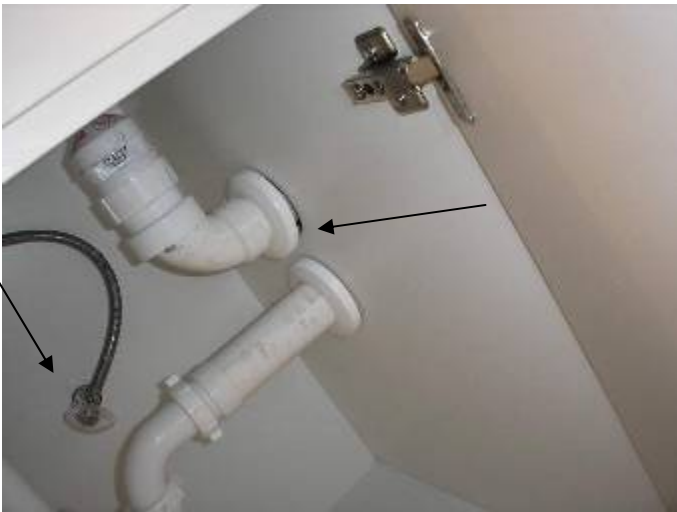
Some of the plumbing pipes have loose, unsealed or missing escutcheons (covers) inside the sink cabinets.

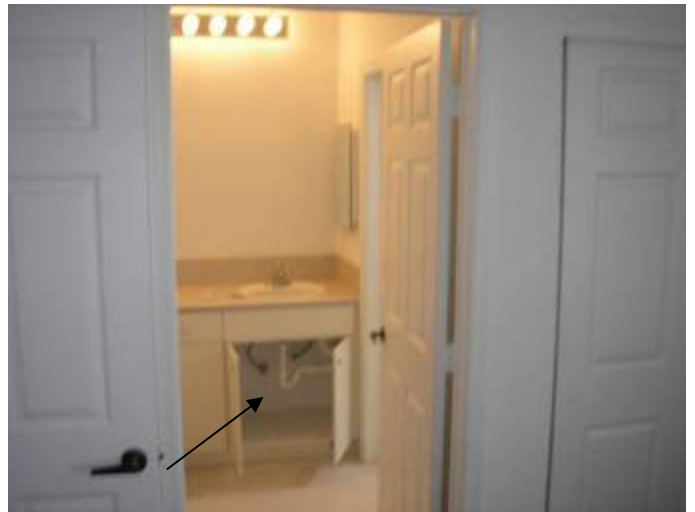
Location of the previous photo/s.

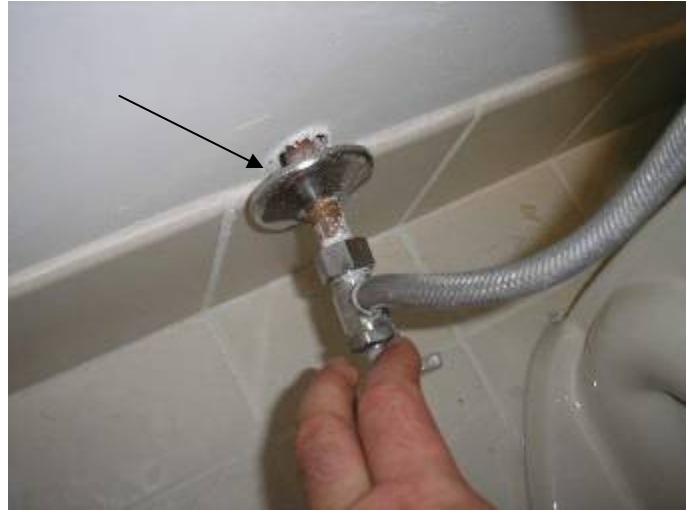
Some of the plumbing supply piping is loose & not correctly secured at the sink cabinets & behind the walls at the water closets (toilets).

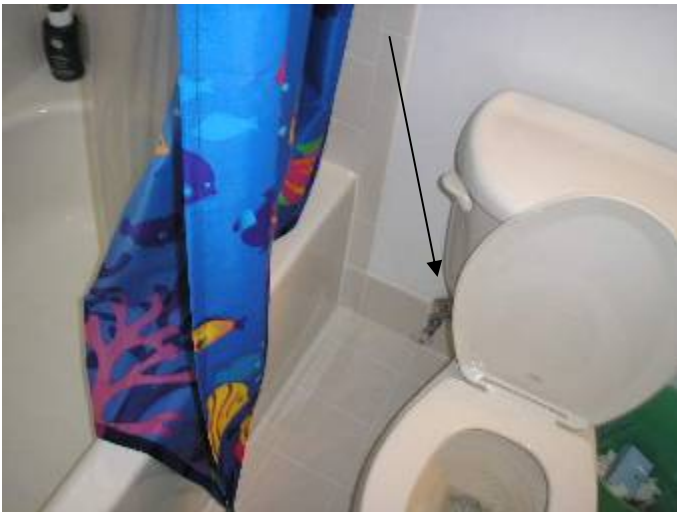
Location of the previous photo/s.

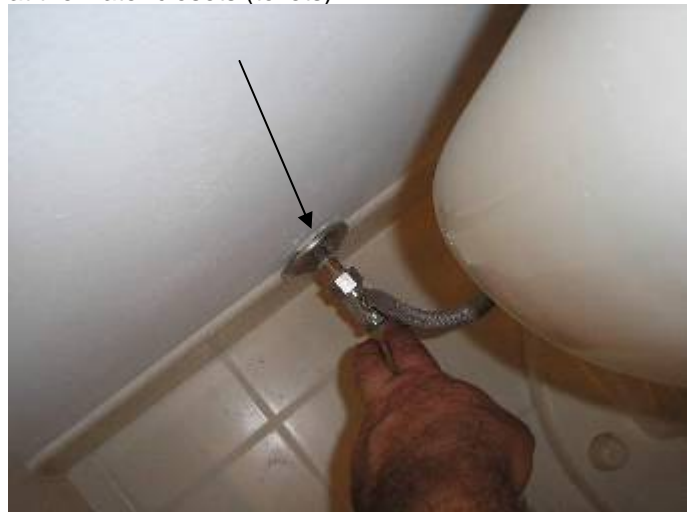
Some of the plumbing supply piping is loose & not correctly secured at the sink cabinets & behind the walls at the water closets (toilets).

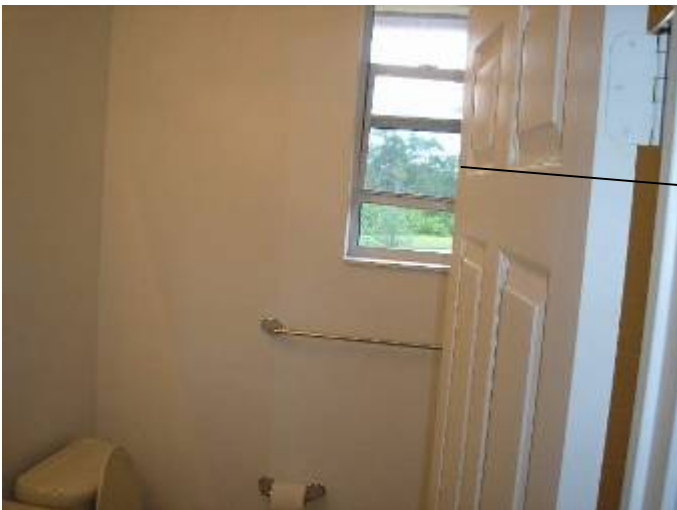
Location of the previous photo/s.

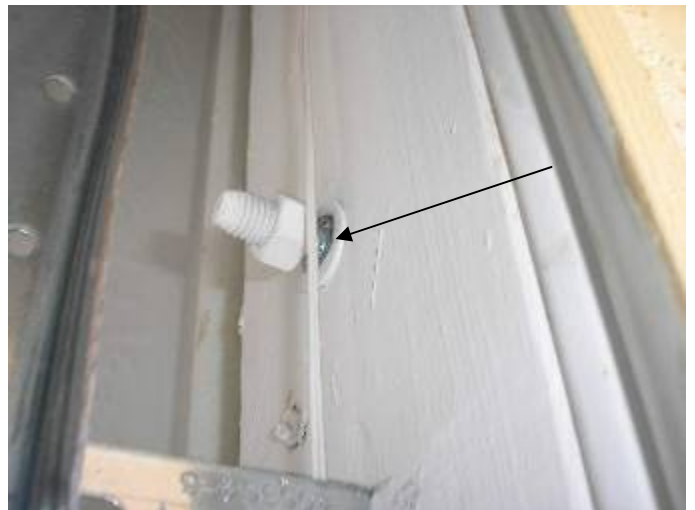
Some of the garage door buck anchor nuts are loose & not correctly secured. §1606.1.3, §2306.2

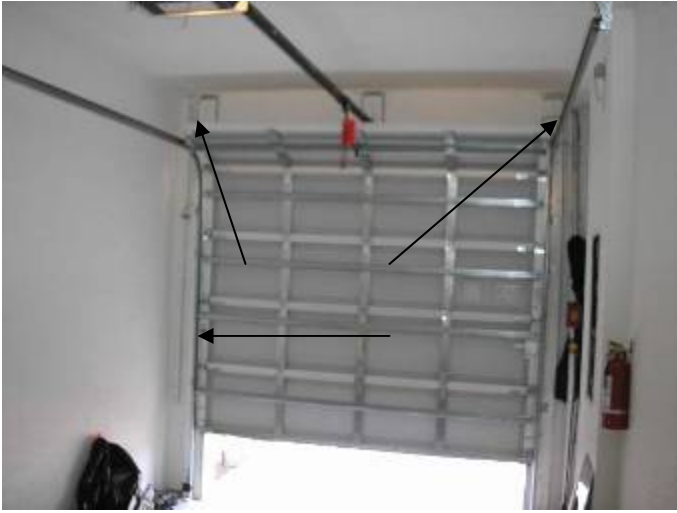
Location of the previous photo/s.

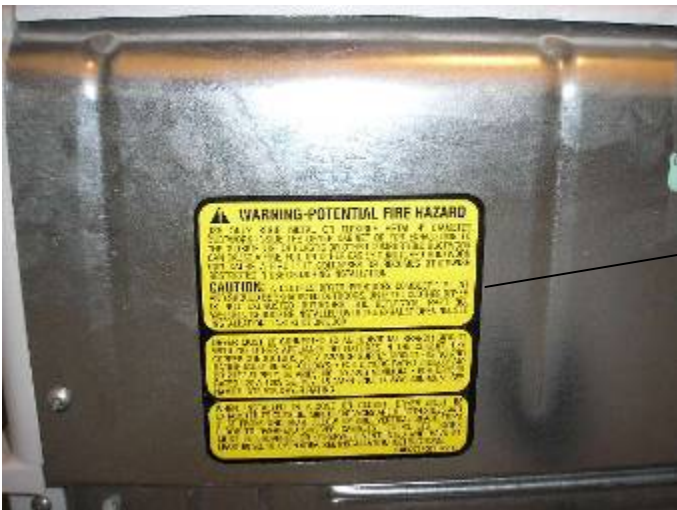
The thin aluminum foil dryer vent duct material is a fire hazard per CSPC & the manufacturer. See warning label on back of the dryer. §M304.1

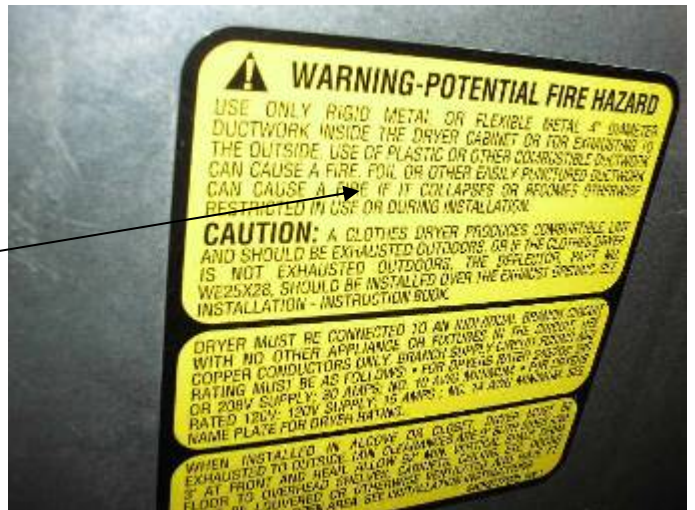
The thin aluminum foil dryer vent duct material is a fire hazard per CSPC & the manufacturer. See warning label on back of the dryer. §M304.1

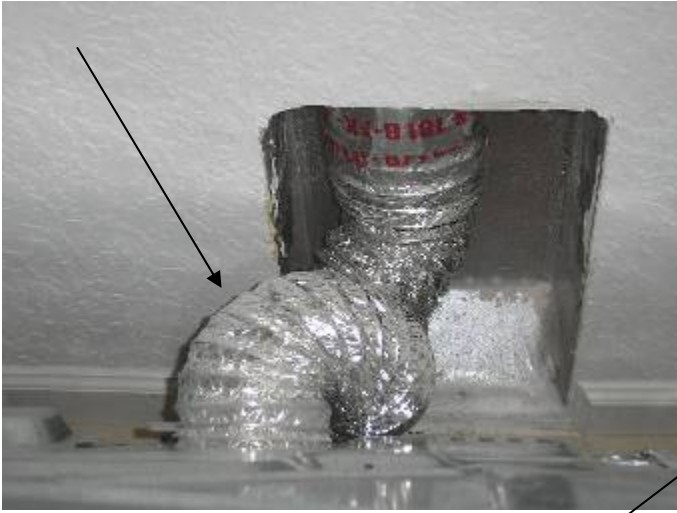
The thin aluminum foil dryer vent duct material is a fire hazard per CSPC & the manufacturer. See warning label on back of the dryer. §M304.1

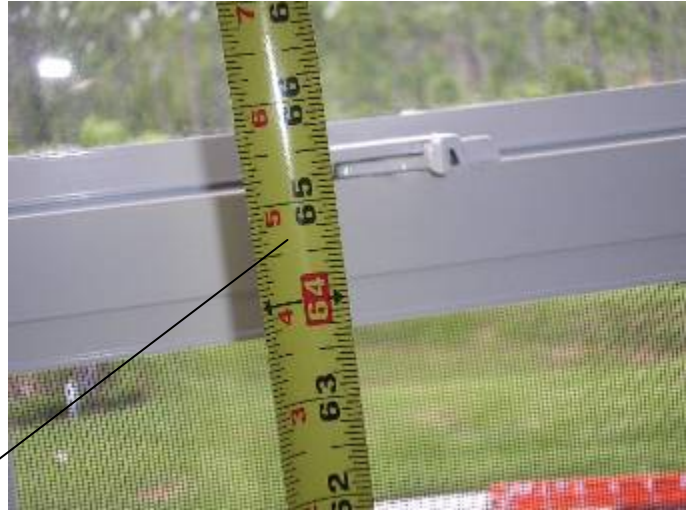
The window locks should not be higher than 54" above the floor in the bedrooms.

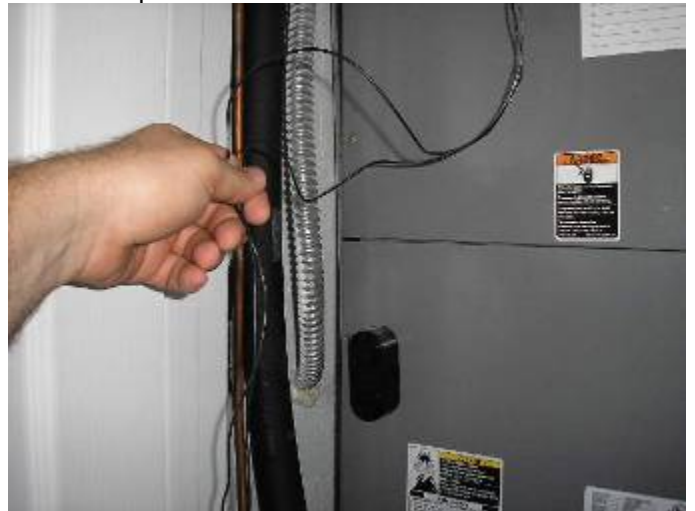
The overflow sensor low voltage wiring is not correctly secured or protected from damage at the AC air handler.

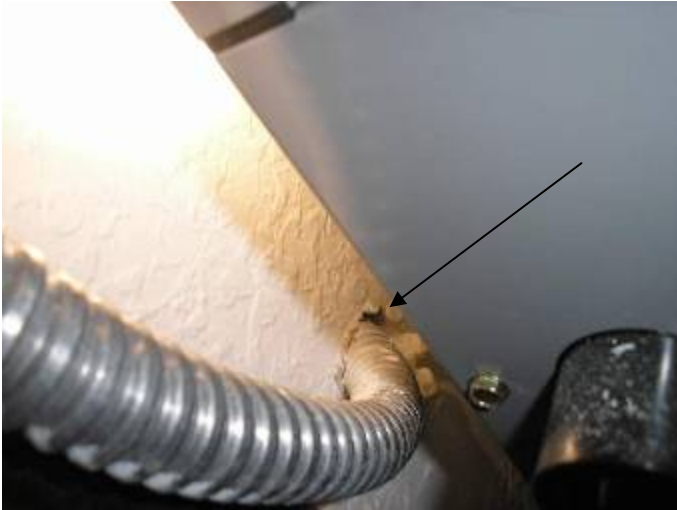
The AC mechanical closet is not completely sealed around penetrations through the walls & ceiling.

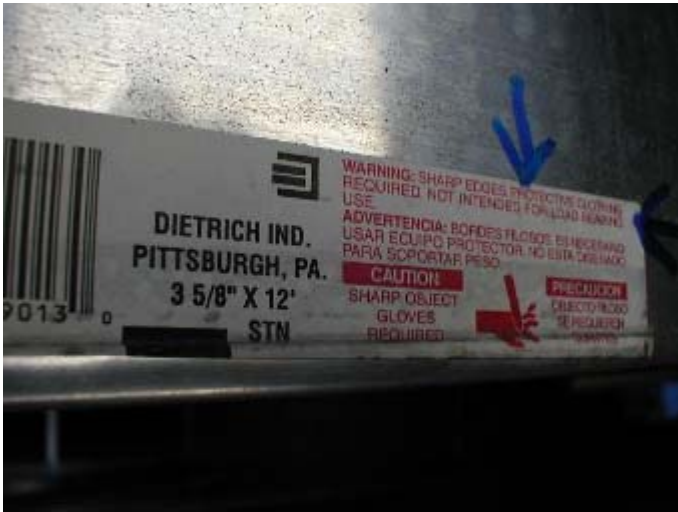
Light gauge metal & drywall screws at 2x4 blocking are not designed to support entrance into attic. –Hazard. §2504.5.2, §2504.5.1

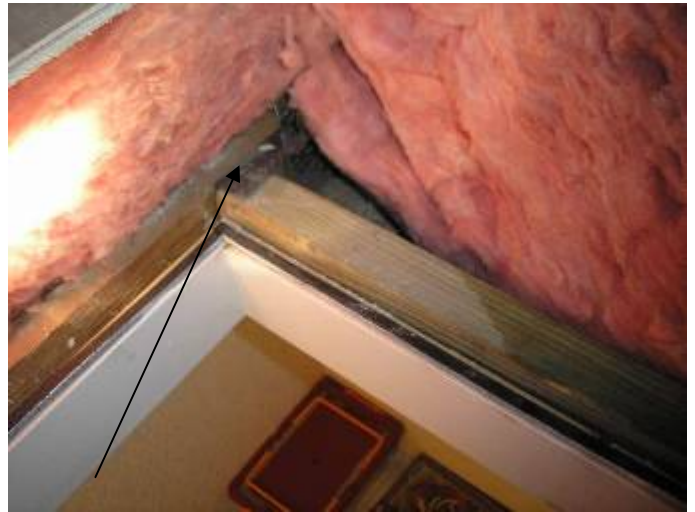
The 2x4 blocking should be secured through the trusses with 16d nails.

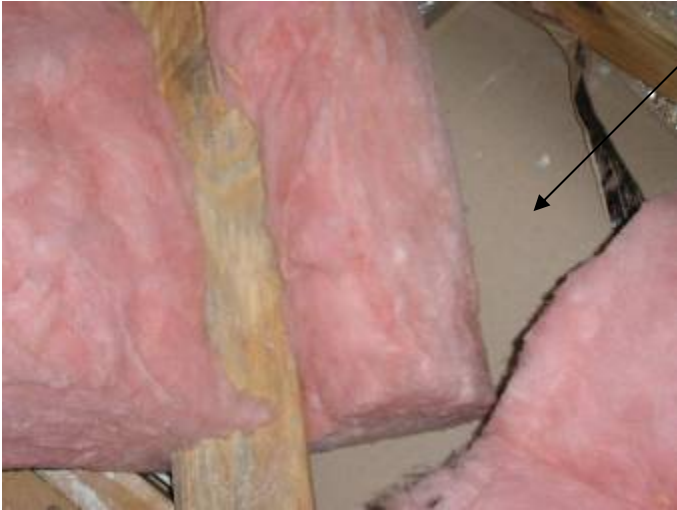
§13-604.1.ABC.1 Ceiling Insulation. Ceilings shall have an insulation level of at least R-19, space permitting. For the purposes of this code, types of ceiling construction that are considered to have inadequate space to install R-19 include single assembly ceilings of the exposed deck and beam type and concrete deck roofs. Such ceiling assemblies shall be insulated to at least a level of R-10.

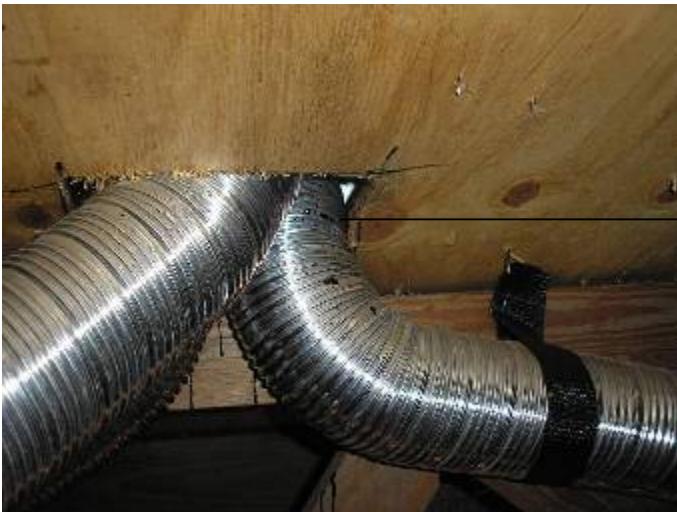
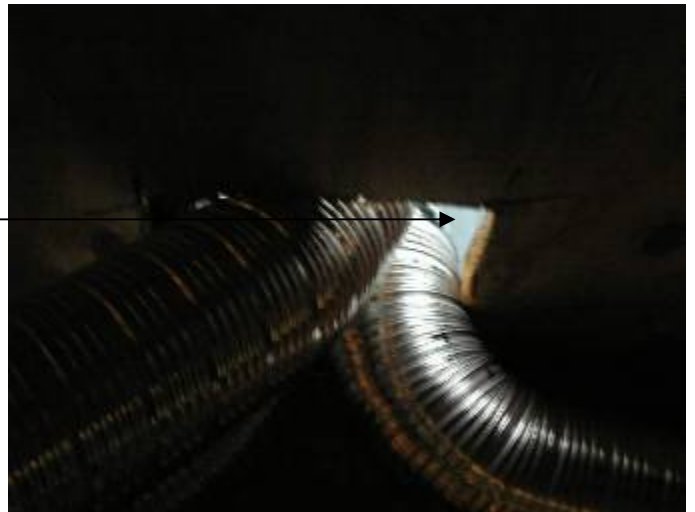
The area around the exhaust vent ducting is not sealed to prevent water & pest intrusion into the attic & house.

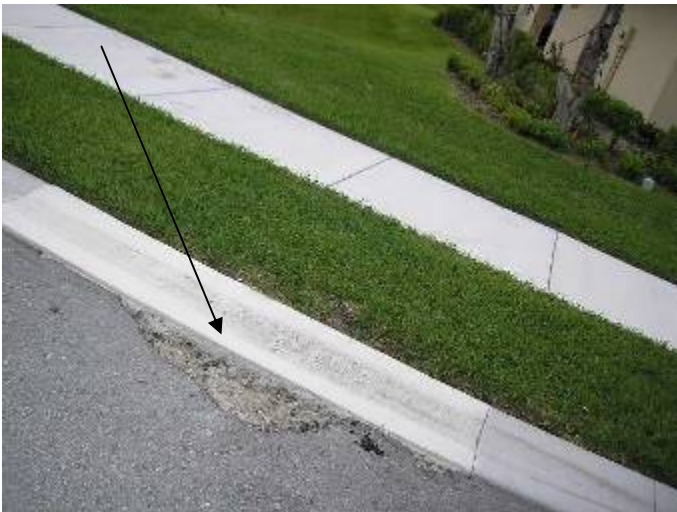
The damaged black top paving is a trip hazard at the street in the front of the house.

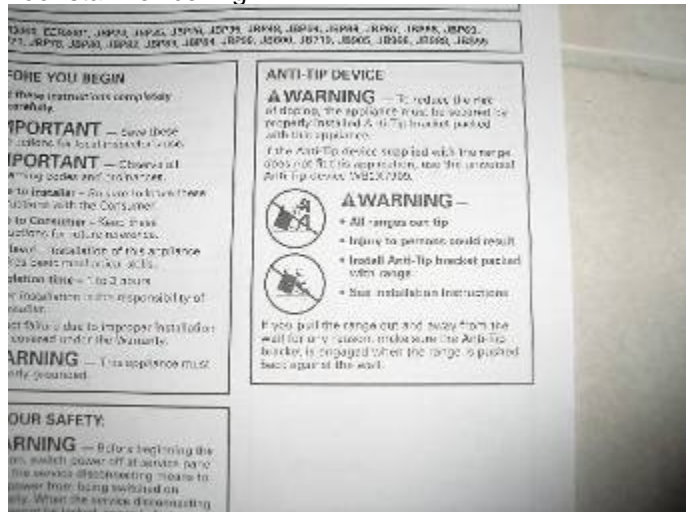
Note: the anti-tip device needs to be reinstalled when the range has been reinstalled after the mold repairs have been completed. §M304.1

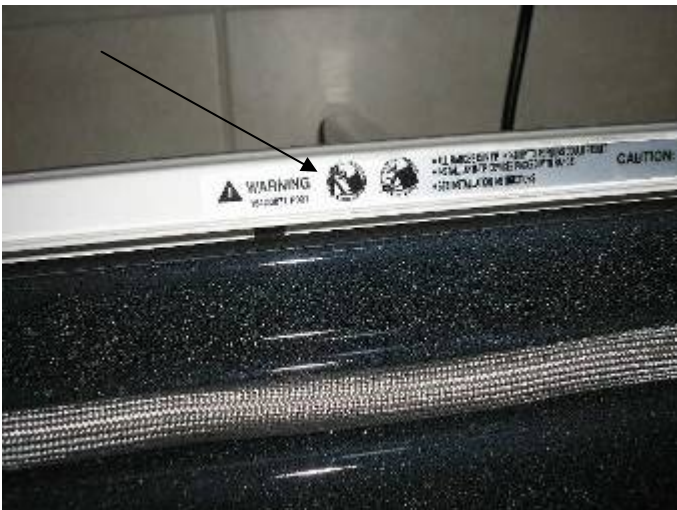
Note: the anti-tip device needs to be reinstalled when the range has been reinstalled after the mold repairs have been completed. §M304.1
