3rd Walkthrough & Inspection Report of 1895 Jamesport Dr PSL, FL 7.13.06

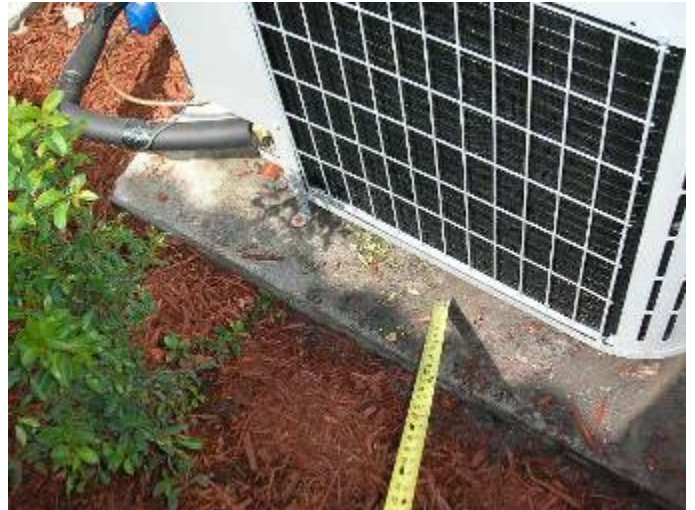
The A/C condensers are not secured properly. There are not enough straps at the base of the unit. M301.13.1

Repairs to the condensing units were completed during the 3rd inspection.

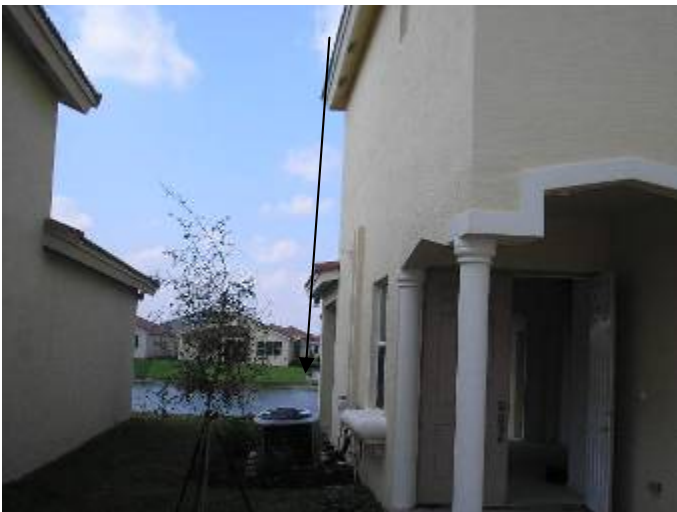
Gutters have been installed in accordance with the manufacturer's installation instructions. §M304.1

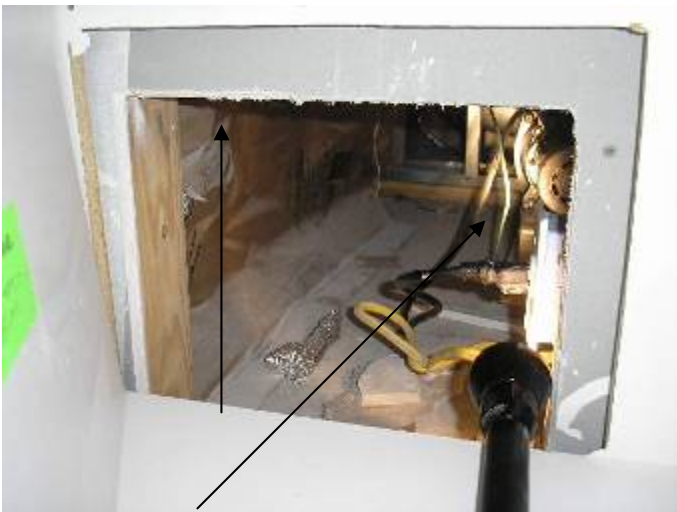
The opening in the cabinet is not big enough to allow the whirlpool tub pump motor to be accessed for service.

§M306.1 Clearances for maintenance and replacement. Clearances around appliances to elements of permanent construction, including other installed equipment and appliances, shall be sufficient to allow inspection, service, repair or replacement without removing such elements of permanent construction or disabling the function of a required fire-resistance-rated assembly.

§P421.2 Installation. Whirlpool bathtubs shall be installed and tested in accordance with the manufacturer's installation instructions. The pump shall be located above the weir of the fixture trap. Access shall be provided to the pump.

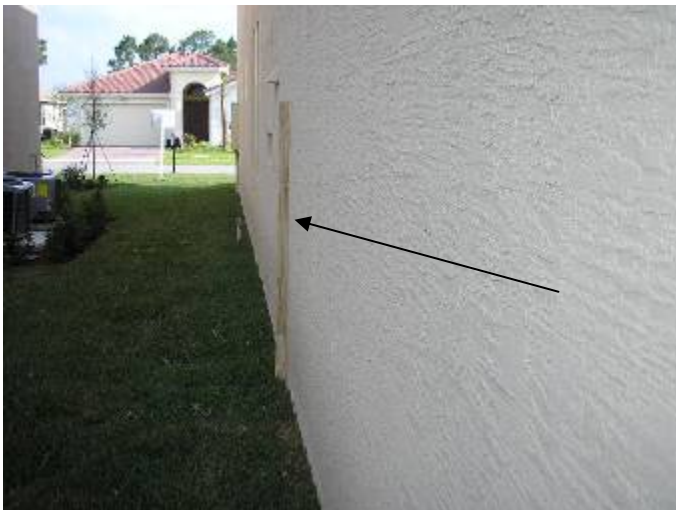
§1403.1.3 Veneered walls shall provide weather protection for the building at the walls.

§2504.2.1 Exterior use of portland cement plaster shall comply with the application requirements of ASTM C 926.

See the engineer's documentation concerning stucco & the certification that the stucco installation is correct.

We recommend core sampling to verify the thickness of the exterior stucco & compliance with ASTM C 926.

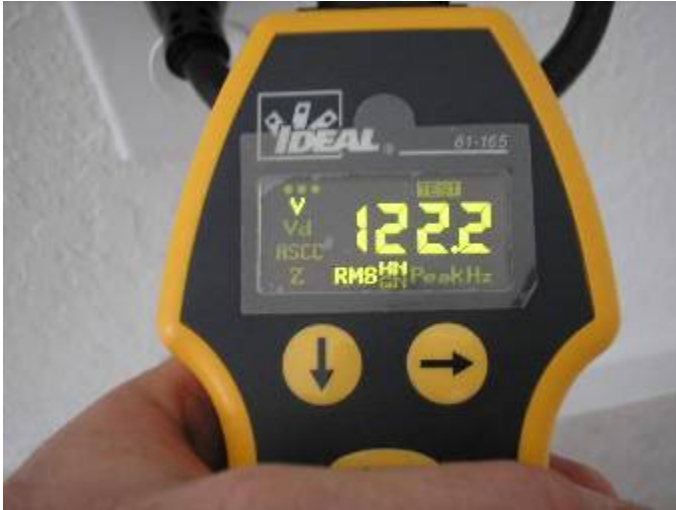
Note: Some of the receptacle outlets had voltage drops that exceed 5% 2002(NEC) 210.19 Conductors. - See Below.

See the builder's/electrical engineer's response to this item. **The voltage drops noted in the report are referenced as a suggested guideline & informational only. They are not considered a violation of the code & this condition is not enforceable.**

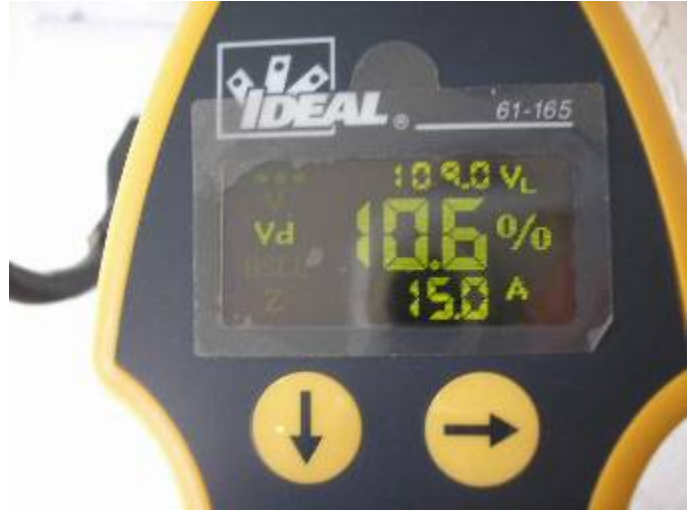
Note: Some of the receptacle outlets had voltage drops that exceed 5% 2002(NEC) 210.19 Conductors. - See Below.

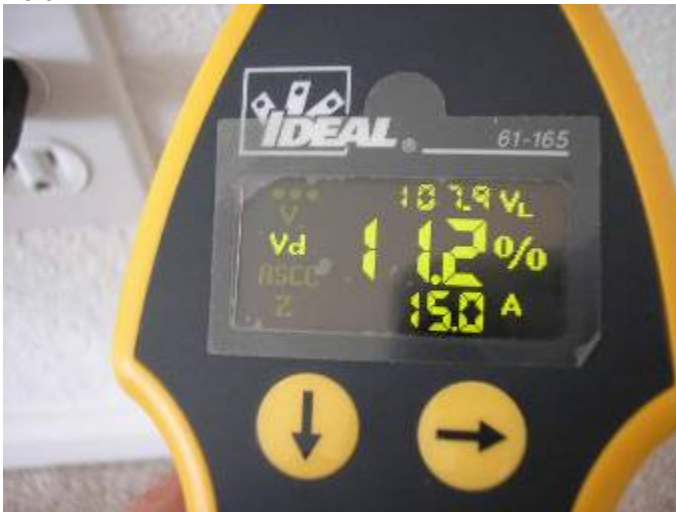
Note: Some of the receptacle outlets had voltage drops that exceed 5% 2002(NEC) 210.19 Conductors. - See Below.
