ONE YEAR PROPERTY INSPECTION REPORT

Prepared For: Janet Ng
(name of client)

Concerning: 17510 Olympic Park Lane, Humble, TX 77346
(address or other identification of inspected property)

Date: 01/14/06

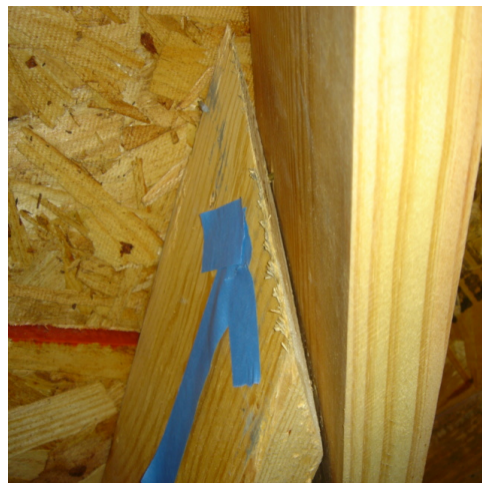
Conventional framed rafters and joists with purlin system. Attic was inspected from inside attic. <ul style="list-style-type: none">Jack rafter has only one fastener at top end. |

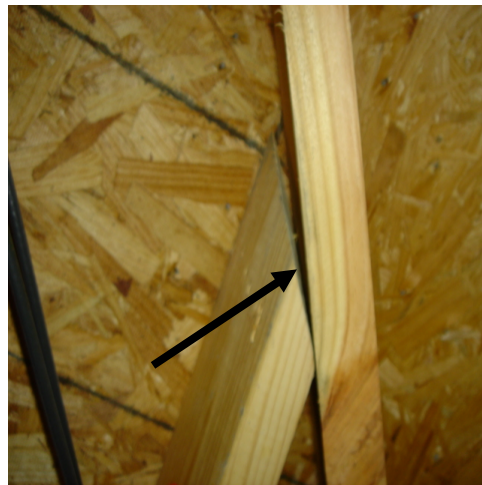
- **Several rafters do not have full bearing on ridge board due to incorrect miter cut.**
