3rd Walkthrough & Inspection Report of 1895 Jamesport Dr PSL, FL 7.13.06

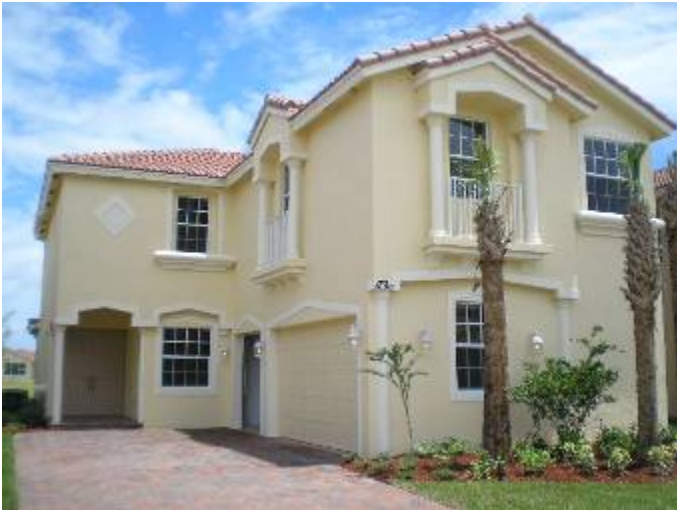
Site photo. The front of the house faces towards the east.

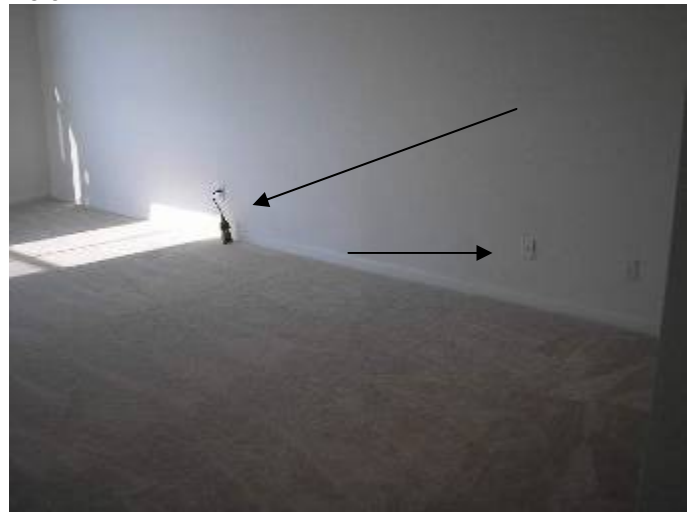
Location of the previous photos

Note: Some of the receptacle outlets had voltage drops that exceed 5% 2002(NEC) 210.19 Conductors. - See Below.

See the builder's/electrical engineer's response to this item. **The voltage drops noted in the report are referenced as a suggested guideline & informational only. They are not considered a violation of the code & this condition is not enforceable.**
