Five-O Building Inspections
2450 SE Springtree Pl
Stuart FL 34997
tomglyn@adelphia.net

02/06/07

Inspection Report of 1005 Ruby Ave Vero Beach FL 32968
Prepared for Bob & Tracey Schafer

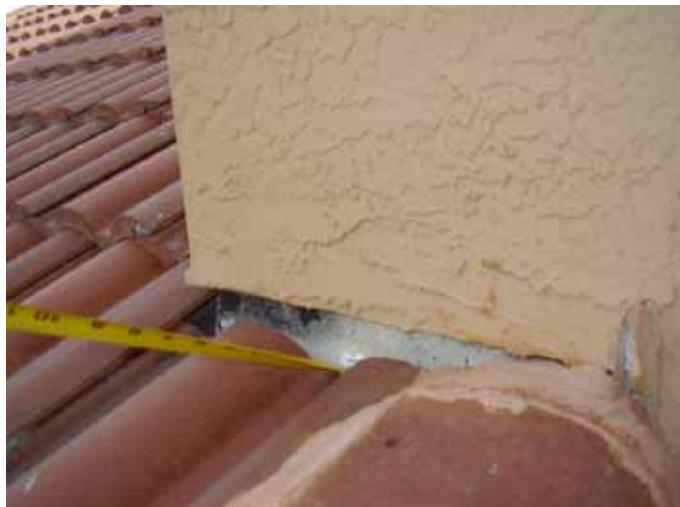
The roof wall abutment areas have not been correctly pointed up with mortar as required by the manufacturer's NOA. R118-3.13

R118-3.13A. Cut tile to fit approximately 1/2 in. to base of walls. Fill void with mortar and point to finish.

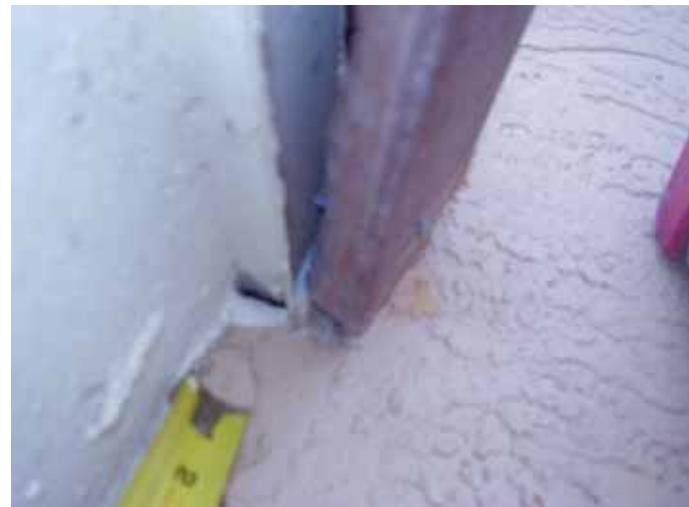
There were areas around the wall flashing & fascia boards that were not completely sealed with stucco.

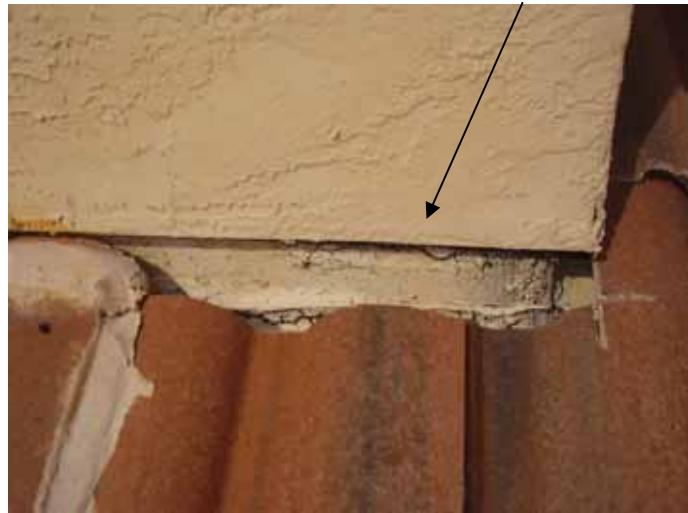
The roof wall abutments have not been correctly pointed up with mortar as required by the tile manufacturer's NOA. R118-3.13

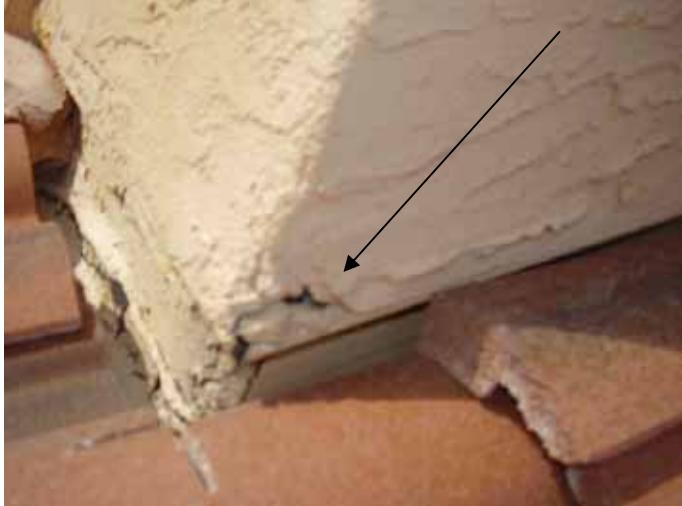
There were areas around the wall flashing that were not completely sealed with stucco.

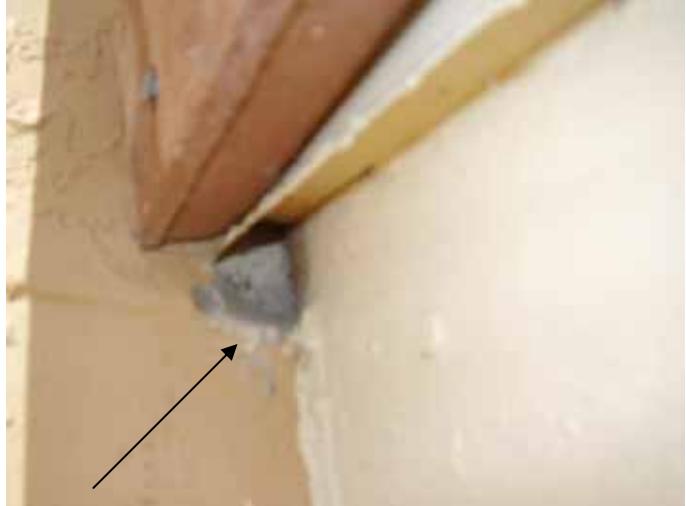
There were areas around the wall flashing & fascia boards that were not completely sealed with stucco.

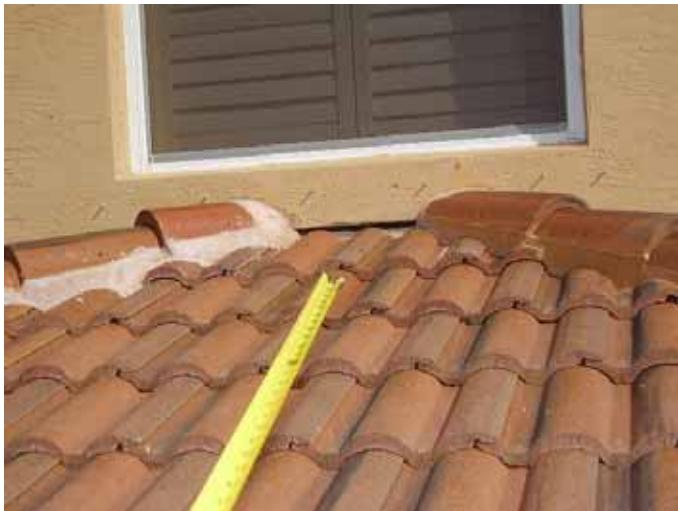
The roof wall abutments have not been correctly pointed up with mortar as required by the tile manufacturer's NOA. R118-3.13

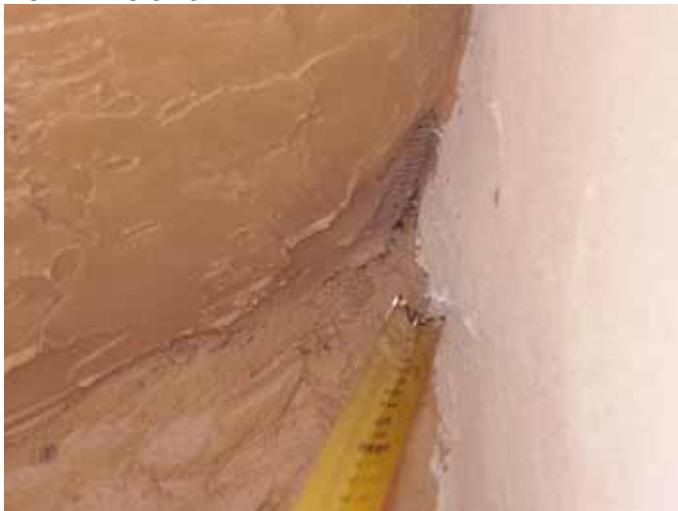
There was exposed lath at the soffit return above the front entry. There was not enough stucco applied to the soffit area.

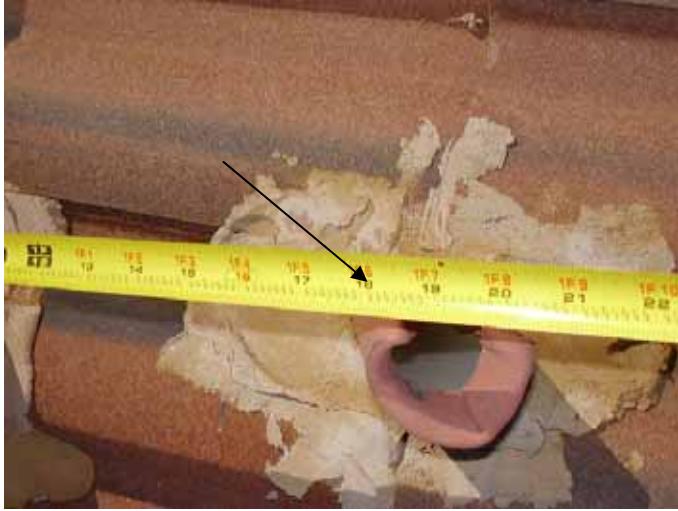
Some of the waste drain plumbing vent stacks are very close to the exhaust hood openings. Ref: §M401.5.1, §P904.5

The opening can act as a make up air intake when the AC or Heat is running. Sewer gasses can be drawn back into the attic & house. §M401.5.1, §P904.5. We recommend installing dampers at the exhaust hoods to prevent any possibility of waste gasses re-entering the building.

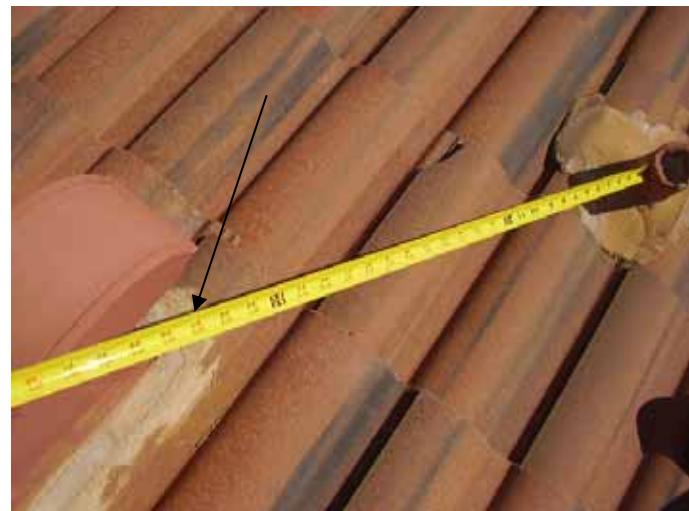
Some of the waste drain plumbing vent stacks are very close to the exhaust hood openings.

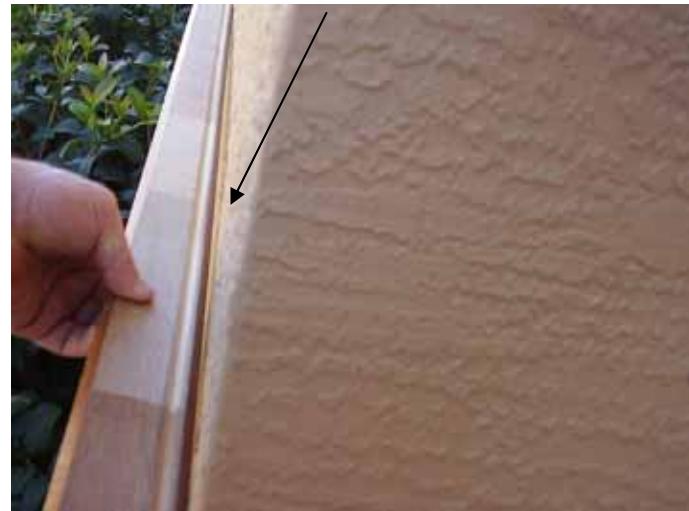
Some of the stucco work appears to be uneven & not the proper depth. ASTM C 926, §2504.2 §1403.1.3

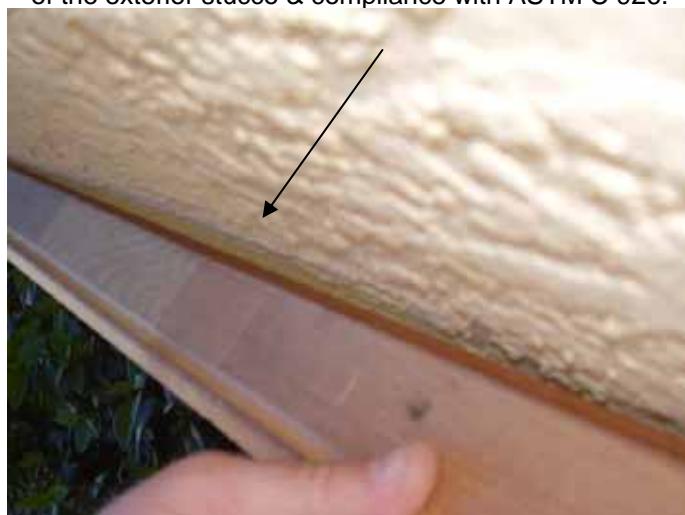
Some of the stucco work appears to be uneven & not the proper depth. ASTM C 926, §2504.2 §1403.1.3

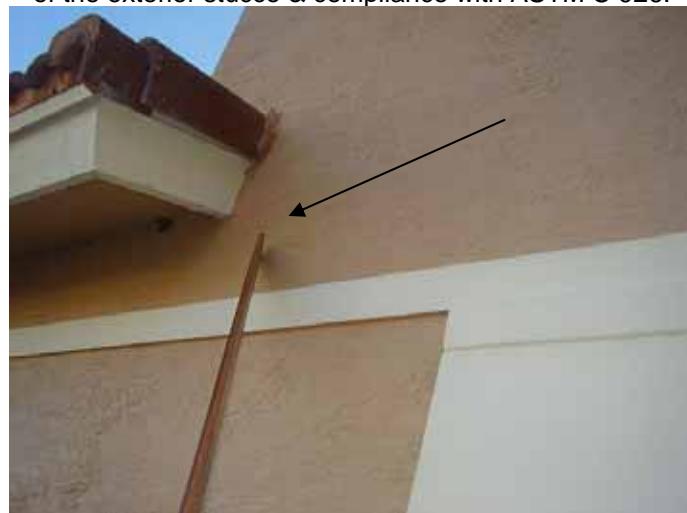
Some of the stucco work appears to be uneven & not the proper depth. ASTM C 926, §2504.2 §1403.1.3

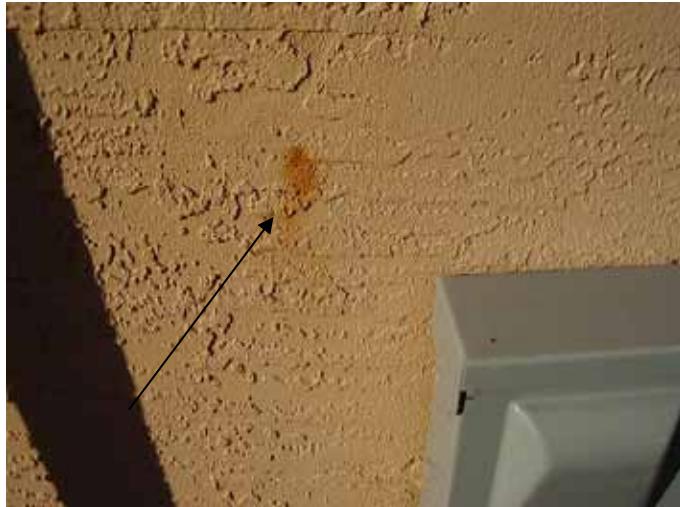
There was rust bleeding through the stucco at several locations. We recommend core sampling at the areas identified to verify the thickness of the exterior stucco.

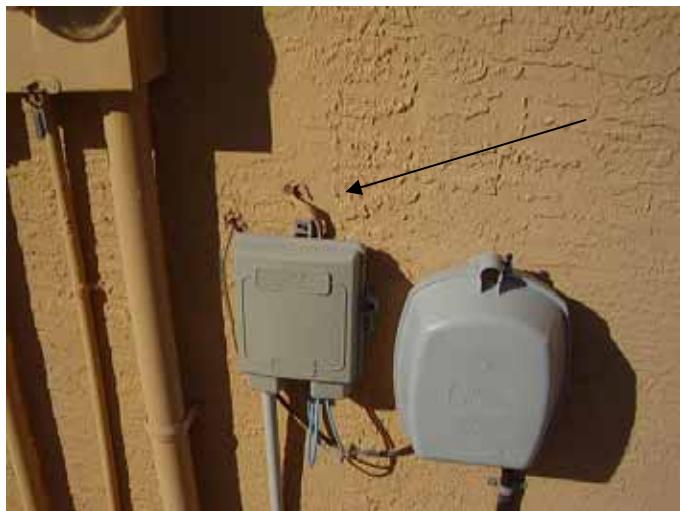
Location of the previous photo at the south side of the building.

All openings around penetrations into the building should be sealed to prevent water & pest intrusion.

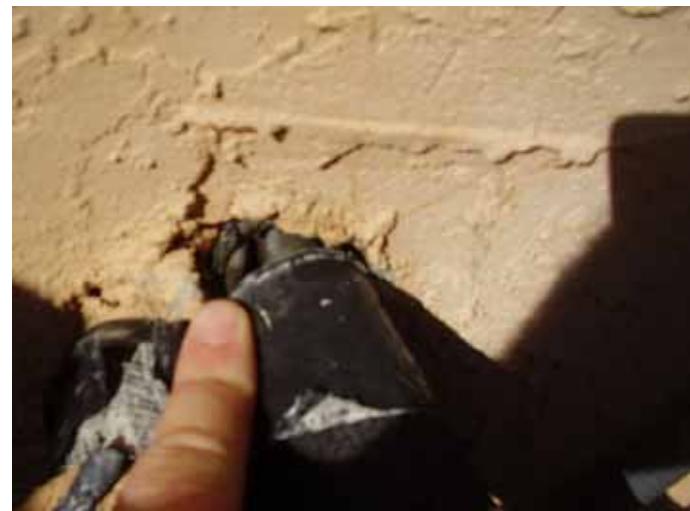
All openings around penetrations into the building should be sealed to prevent water & pest intrusion.

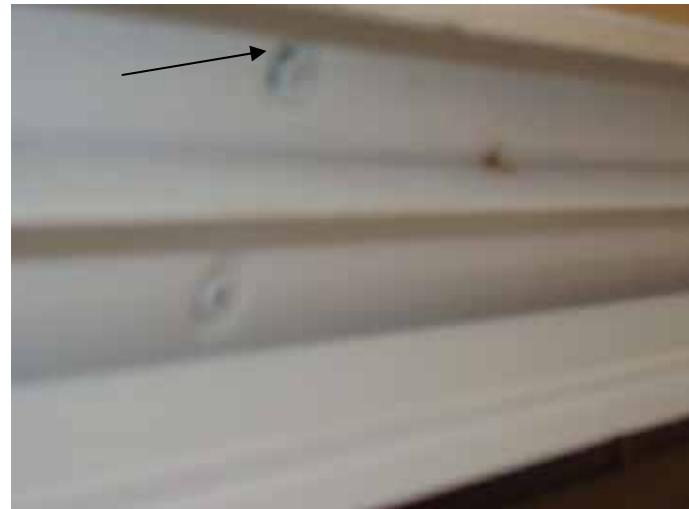
Some of the screw anchors are not completely set or sealed to prevent water & pest intrusion.

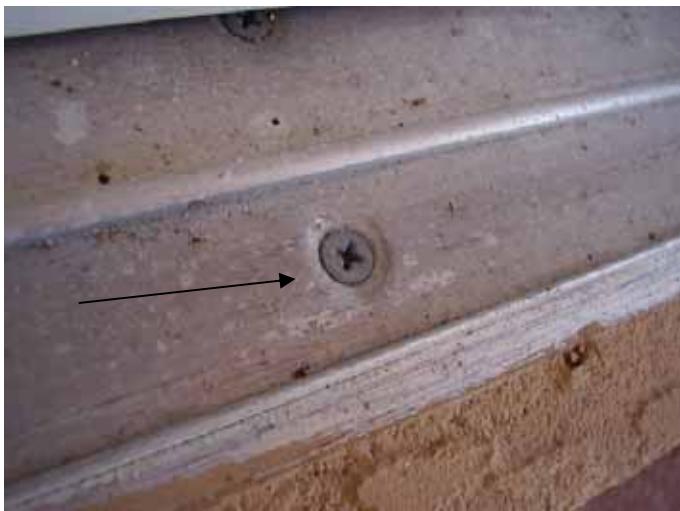
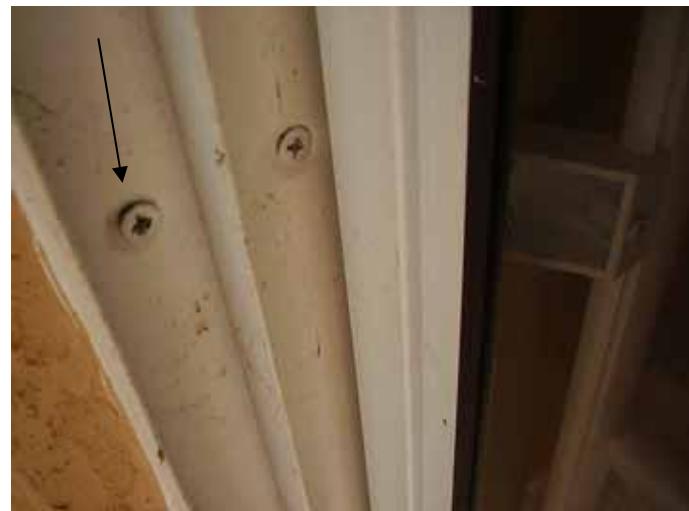
Some of the screw anchors are not completely set or sealed to prevent water & pest intrusion at the rear sliding glass doors.

All of the screws should be correctly installed, set & sealed to prevent water & pest intrusion.

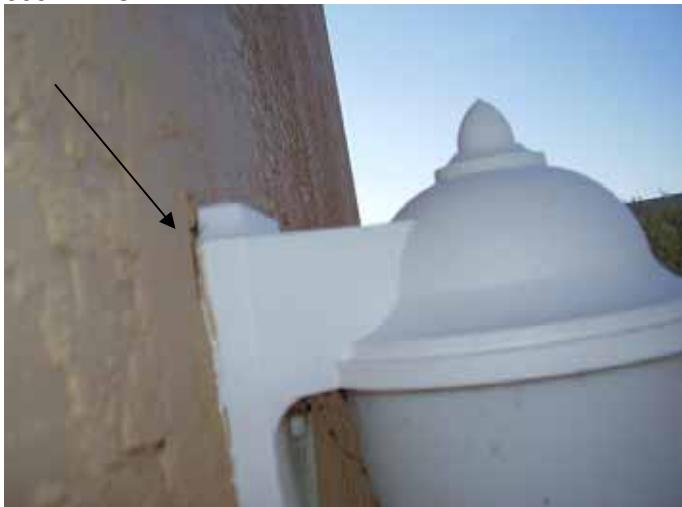
The exterior lighting fixtures were not completely sealed to prevent water & pest intrusion at the wall or base. 2002 NEC 410.4, §13-606.1.ABC.1.2

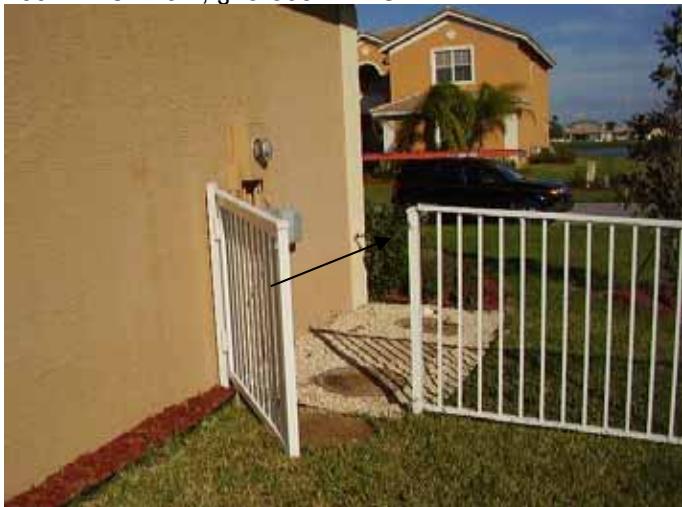
The self closing hinges were not working correctly at the south side gate.

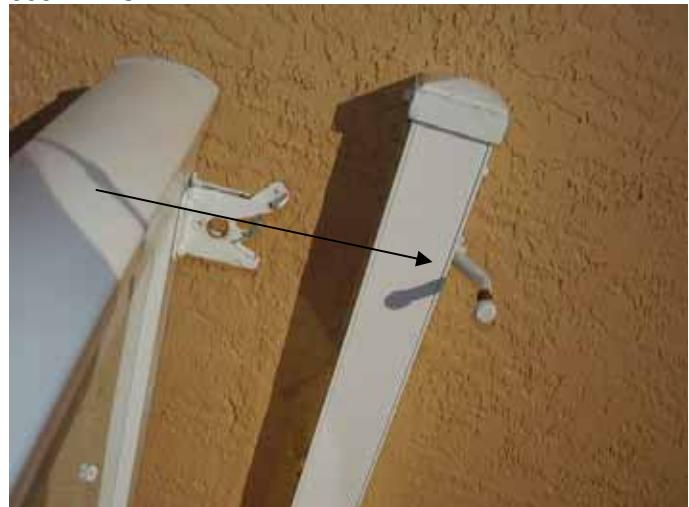
Some of the gates did not close or latch correctly.

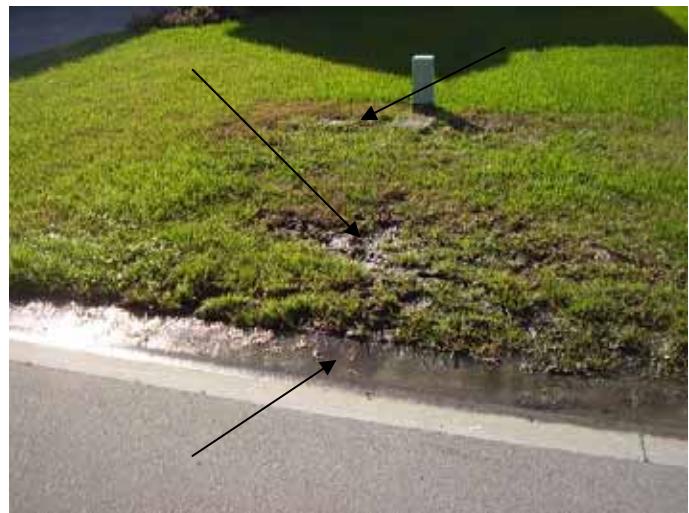
The front of the house & yard were very wet. The area was not draining correctly.

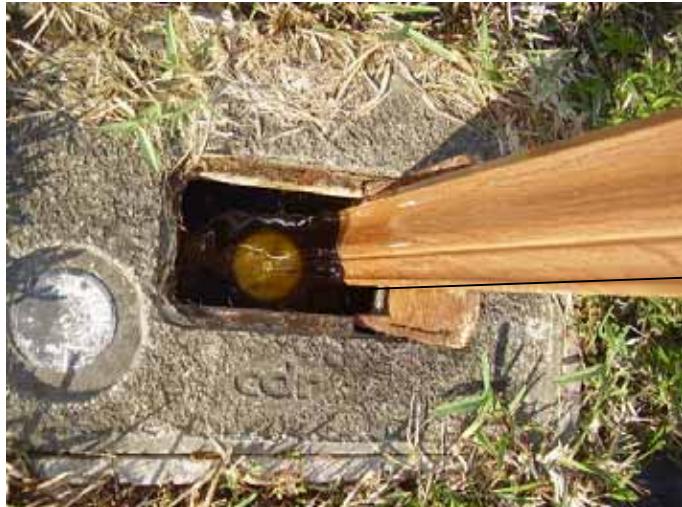
The meter box was filled with water.

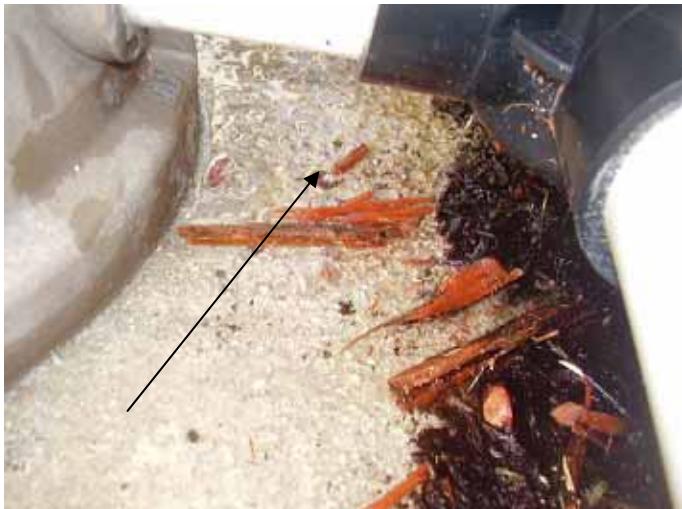
The concrete pad below the pool filter housing was also wet.

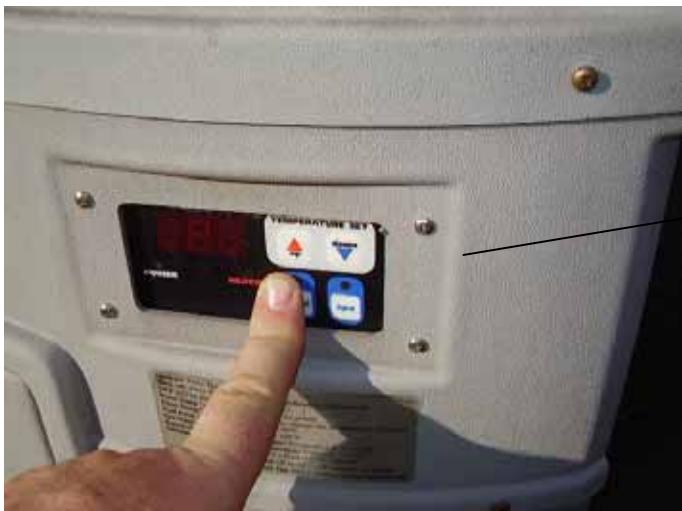
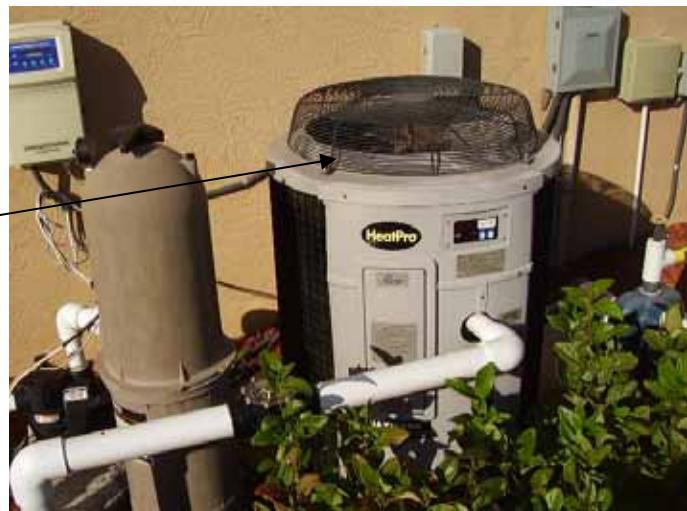
The pool heater was short cycling or turning on for only a short period of time before turning back off.

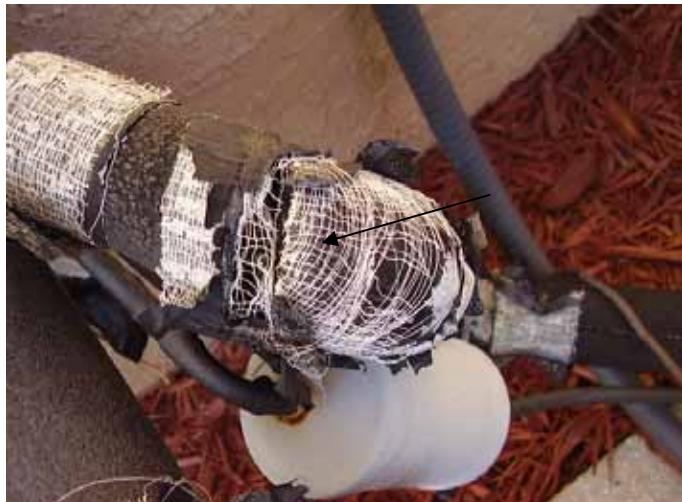
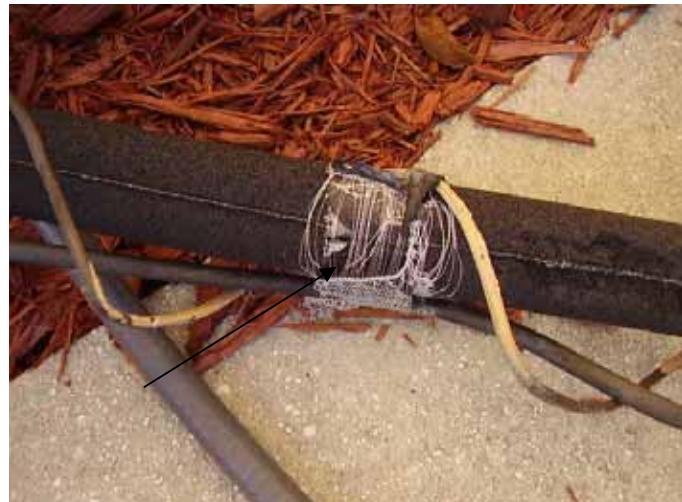
The tape used to secure the low voltage wiring & refrigerant line insulation was deteriorating & did not appear to be exposed to UV radiation or sunlight.

All of the wiring & insulation should be correctly secured.

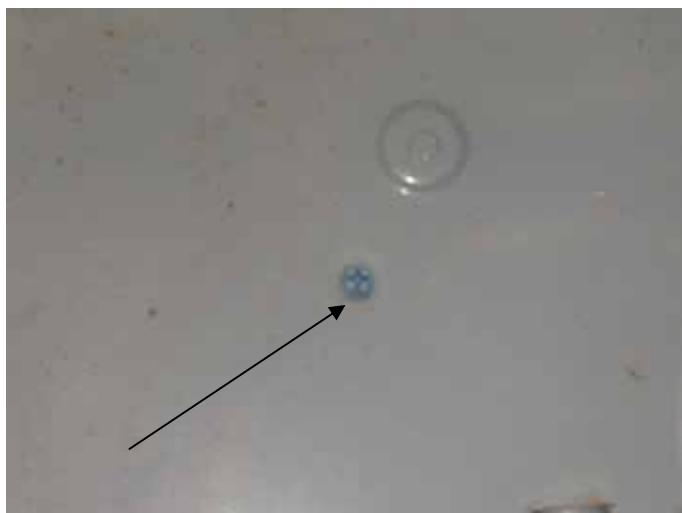
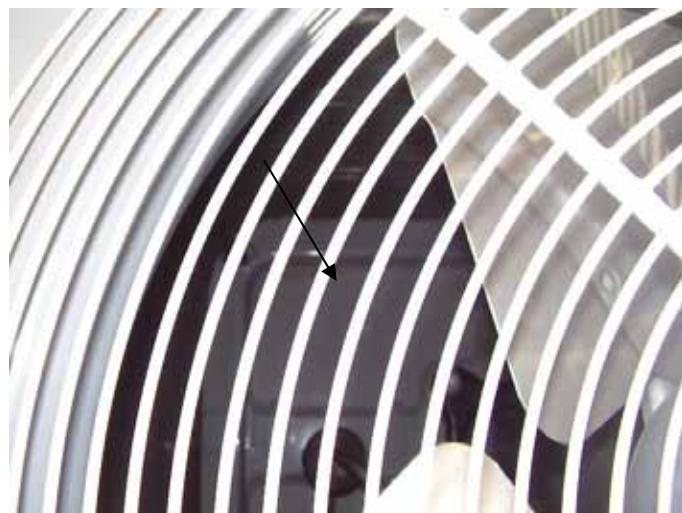
There were (4) Tap-Con type fasteners installed inside the housing base without washers to secure the AC condensing units to the concrete pad.

3 fasteners are required per side or as prescribed by the design professional or by the specifications in FBC M301.13.1

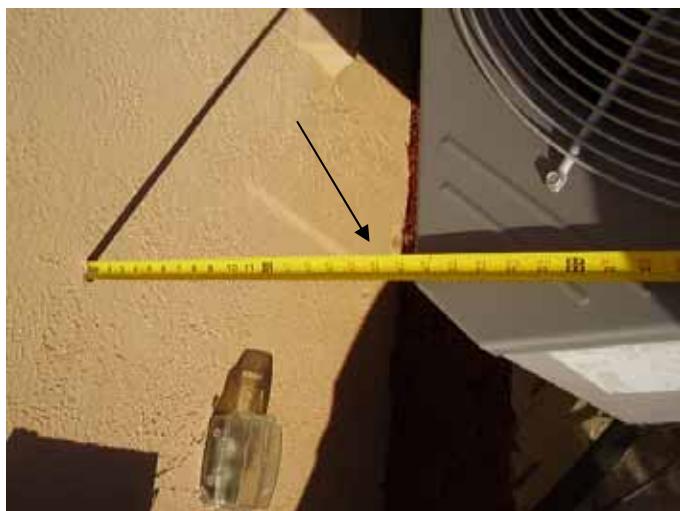
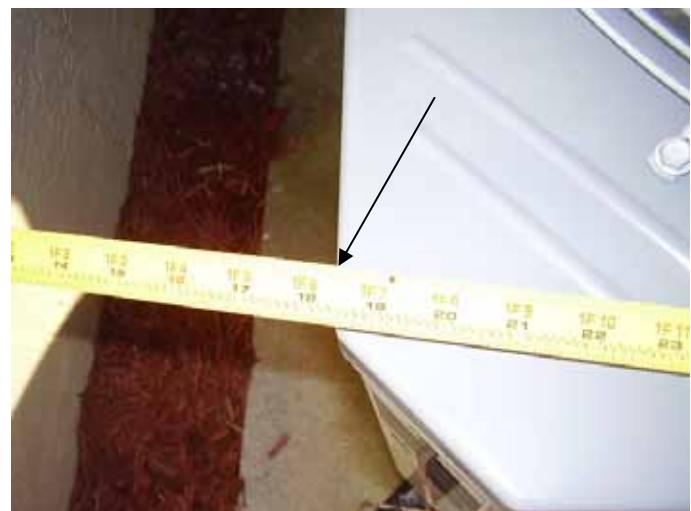
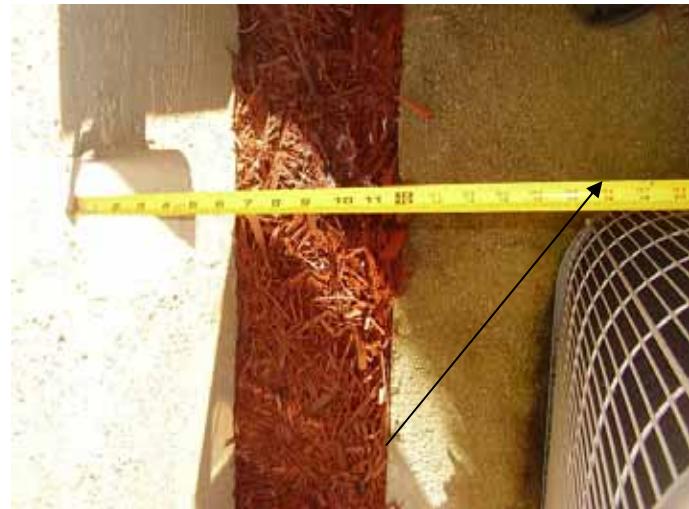
The AC condensing units were turned the wrong way. 36 inch working space clearance is required at the electrical component access panel.

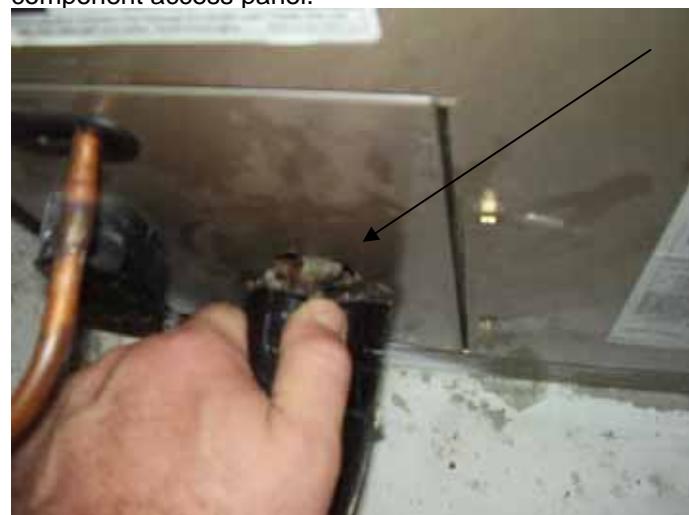
The grommet or seal is not installed around the refrigerant line.

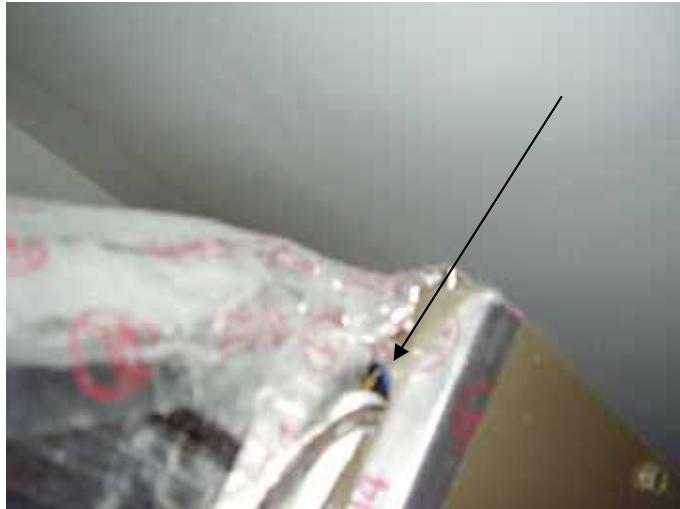
The grommet or seal is not installed around the low voltage line.

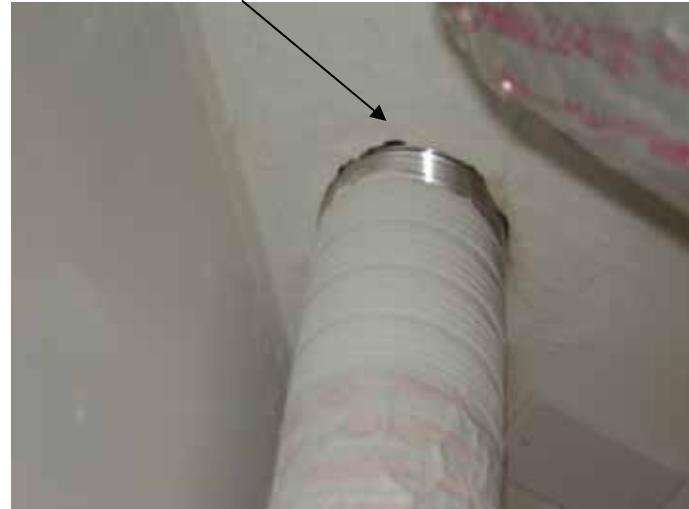
The AC mechanical closet was not completely sealed as required. §M603.1.3, §13-410.1.ABCD.3.7

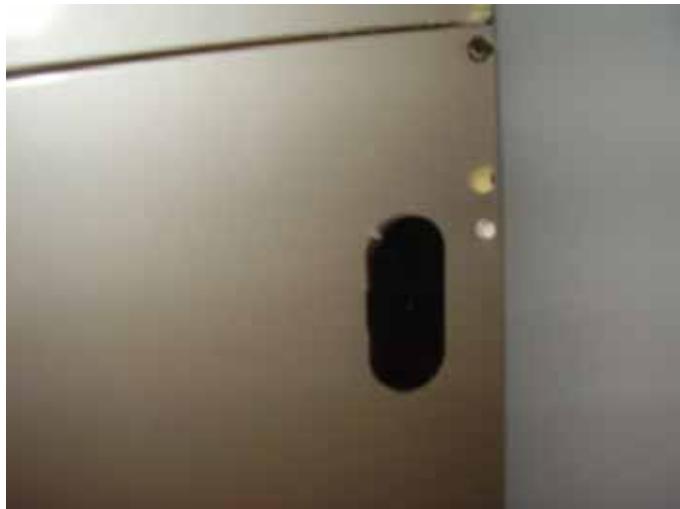
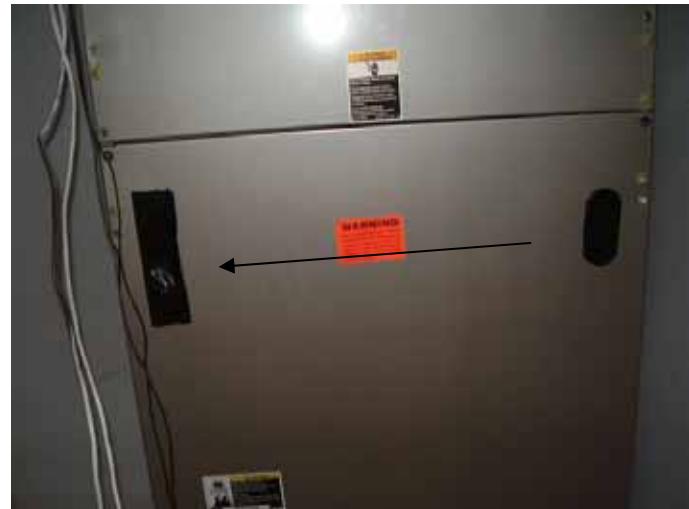
The tape patch was not correctly sealed at the opening in the front of AHU #1.

The tape patch was not correctly sealed at the opening in the front of AHU #1. The grommet provided by the AC manufacturer should be installed.

The grommet provided by the AC manufacturer should be installed.

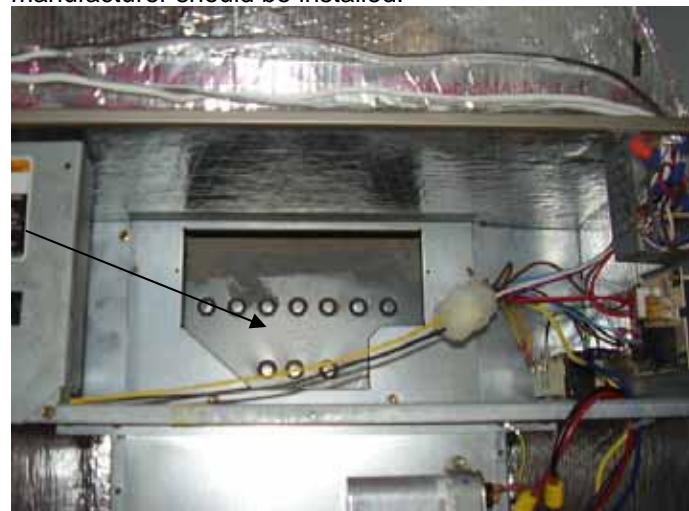
There were no electric heat strips located inside the furnace.

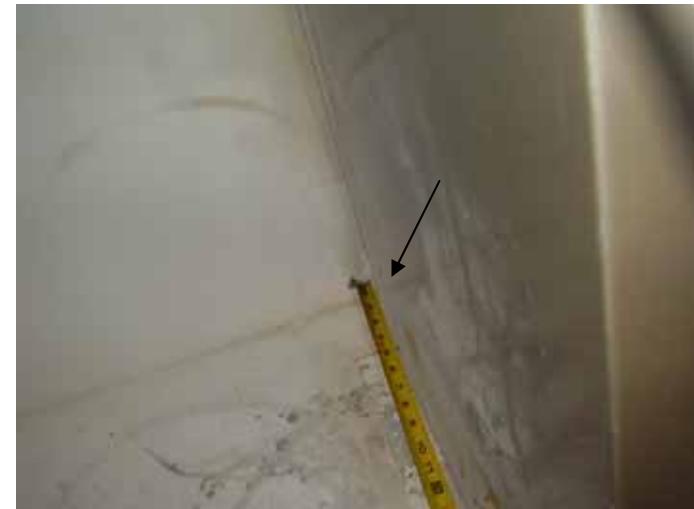
There was not sufficient clearance from the back of the wall to the AC air handler. §M603.1.3 4 inches of clearance is required.

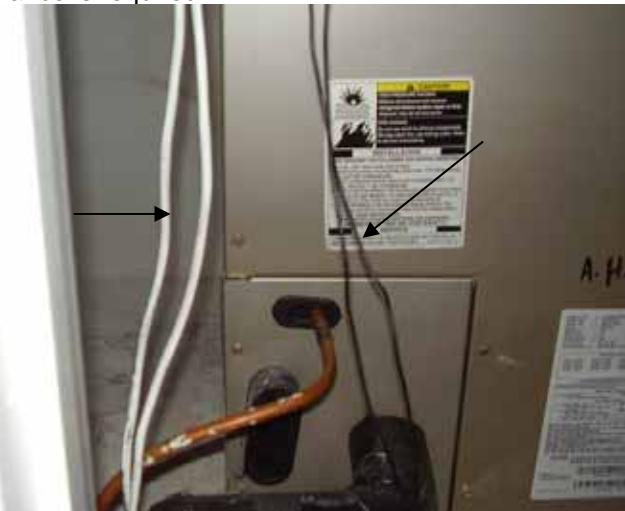
The low voltage wiring should be correctly secured & protected from damage.

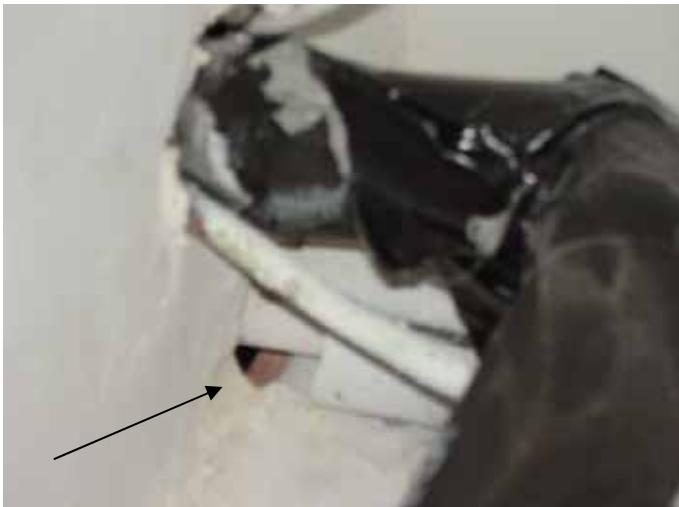
The AC mechanical closet is not completely sealed as required. §M603.1.3, §13-410.1.ABCD.3.7

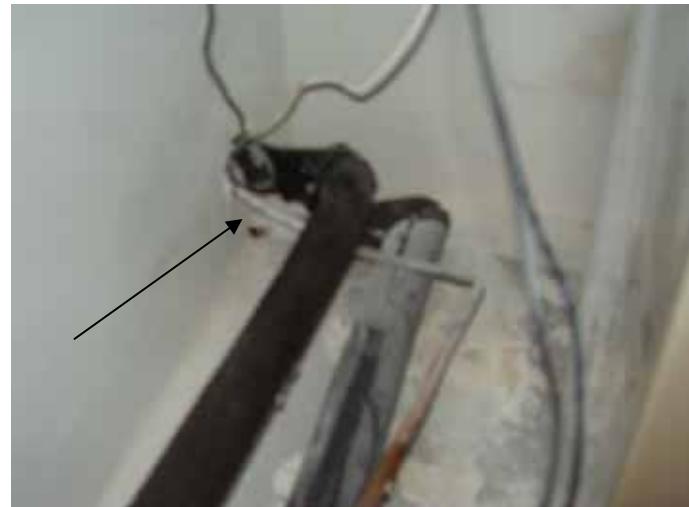
The AC mechanical closet is not completely sealed as required. §M603.1.3, §13-410.1.ABCD.3.7

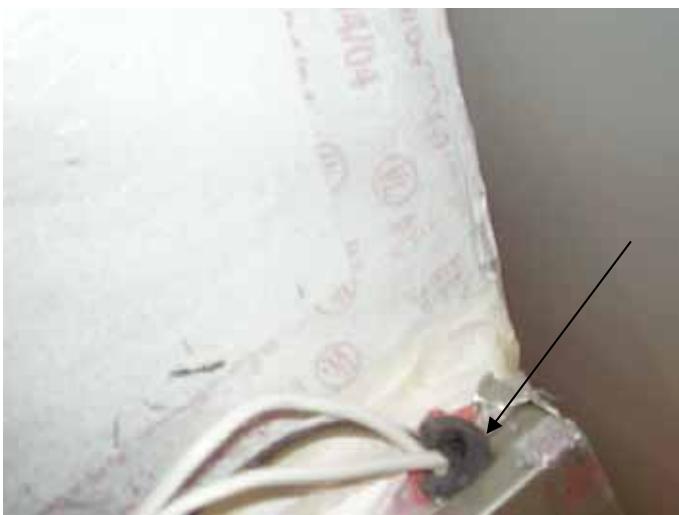
The grommet was not correctly installed at the top of AHU #1

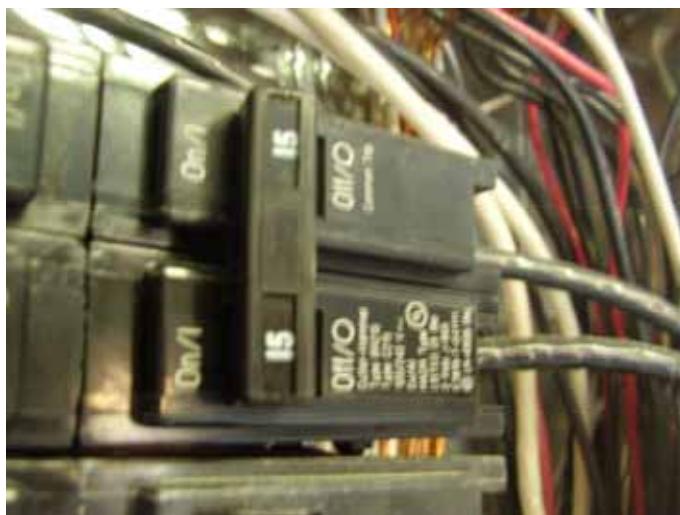
There were only 15 amp breakers at the furnace circuits in the main panel in the garage.

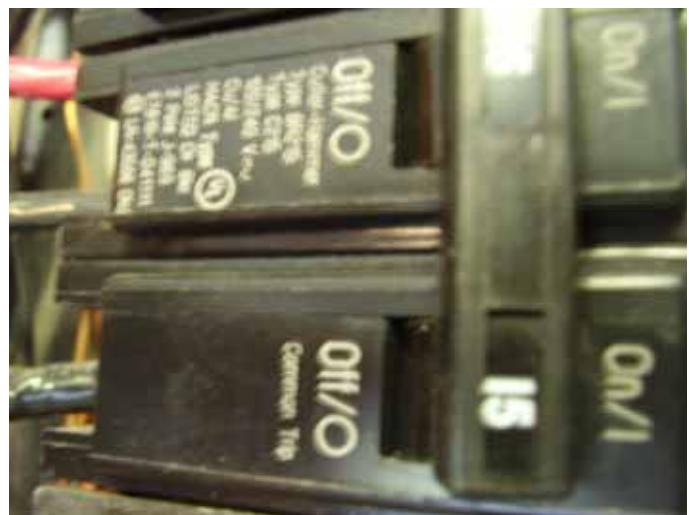
There were only 15 amp breakers at the furnace circuits in the main panel in the garage.

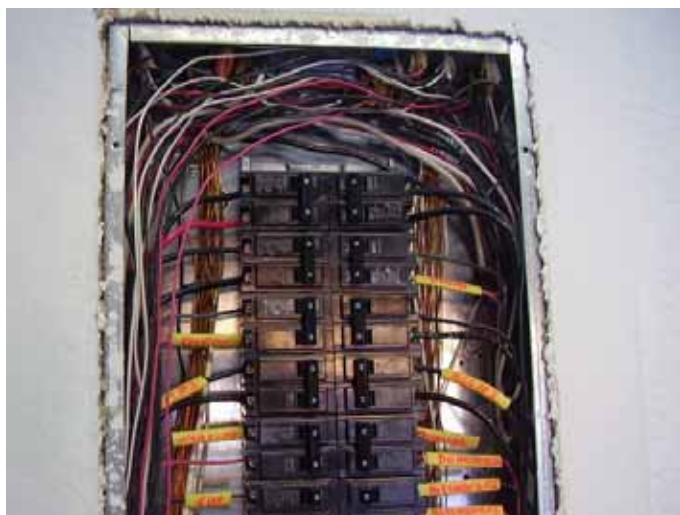
The approved plans called for 10kW w/ 60 amp or 7.5 kW with 40 amp overcurrent protection.

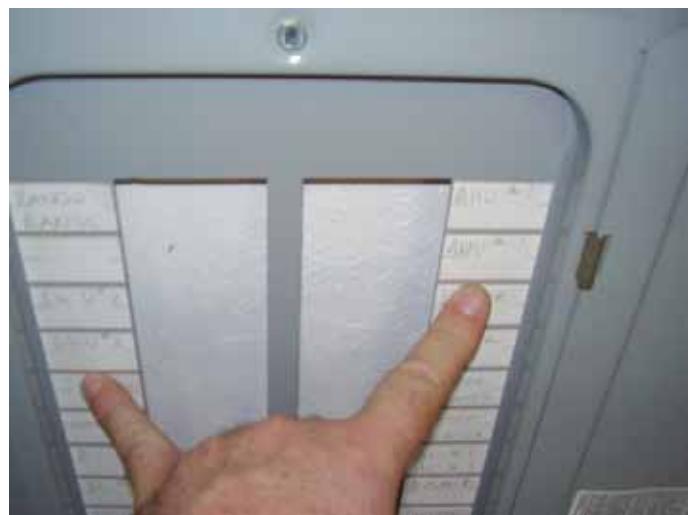
The approved plans called for 10kW w/ 60 amp or 7.5 kW with 40 amp overcurrent protection.

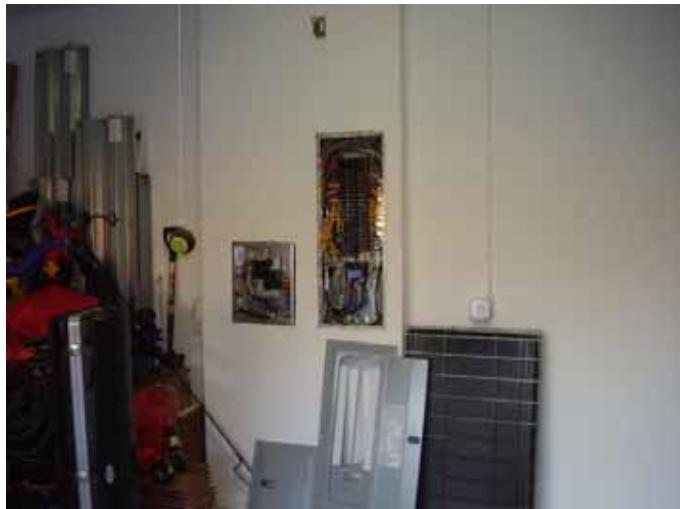
Location of the previous photos at the main electric distribution panel in the garage.

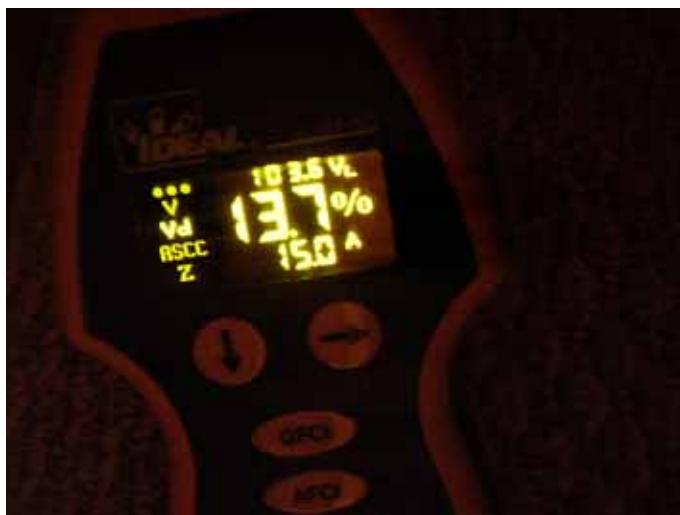
The voltage drop at many of the outlets exceeds 10%.
2002(NEC) 210.19 Conductors. We believe that any voltage drops over 10% require further investigation.

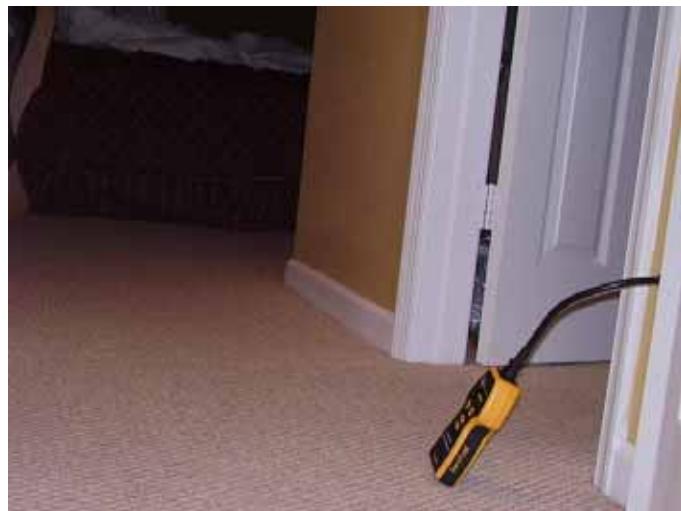
Location of the previous photo/s in & by the closets in the master bedroom.

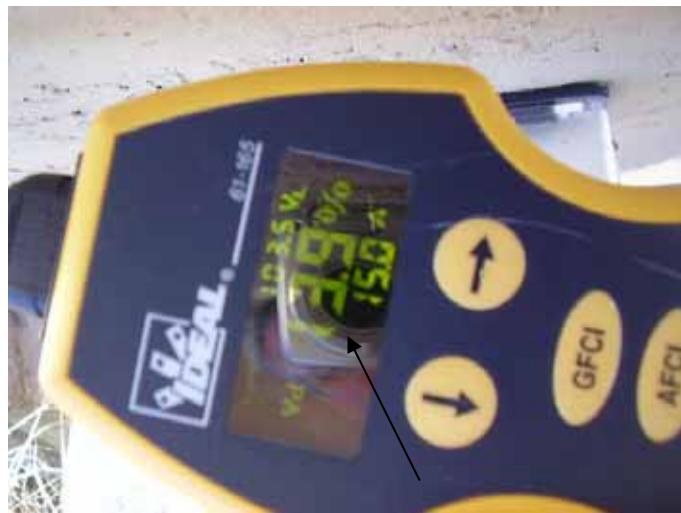
The voltage drop at many of the outlets exceeds 10%.
2002(NEC) 210.19 Conductors. We believe that any voltage drops over 10% require further investigation.

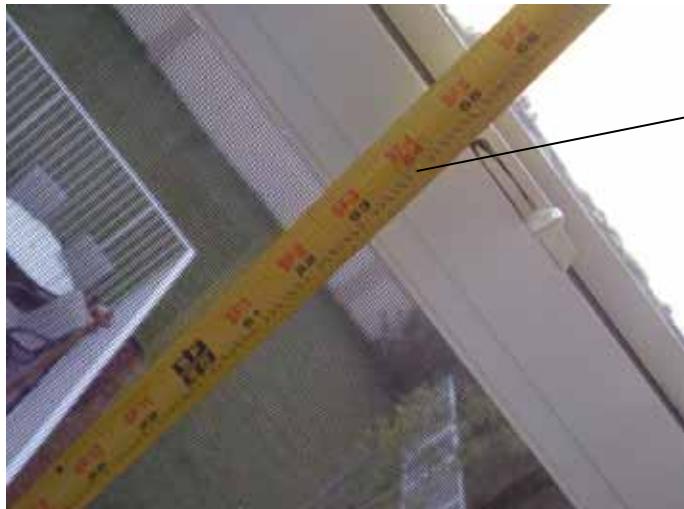
The window locks should not be higher than 54" above the floor in the bedrooms.

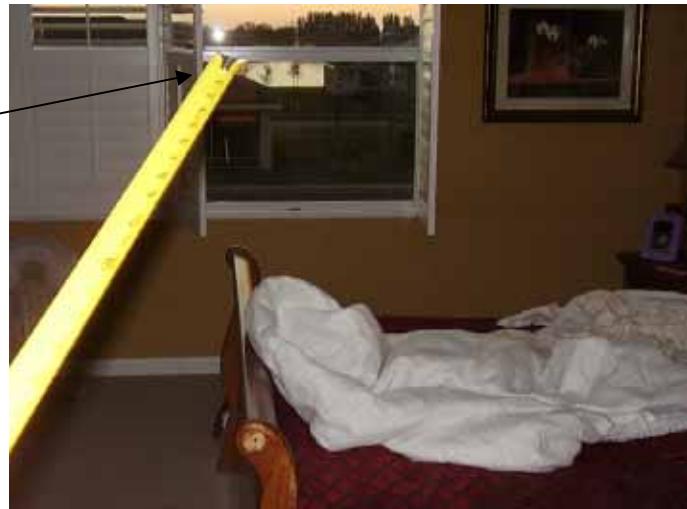
The window locks should not be higher than 54" above the floor in the bedrooms.

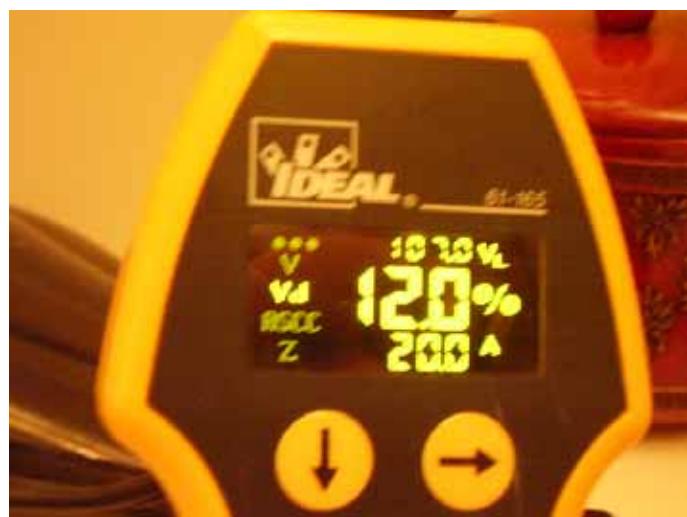
The voltage drop at many of the outlets exceeds 10%. 2002(NEC) 210.19 Conductors. We believe that any voltage drops over 10% require further investigation.

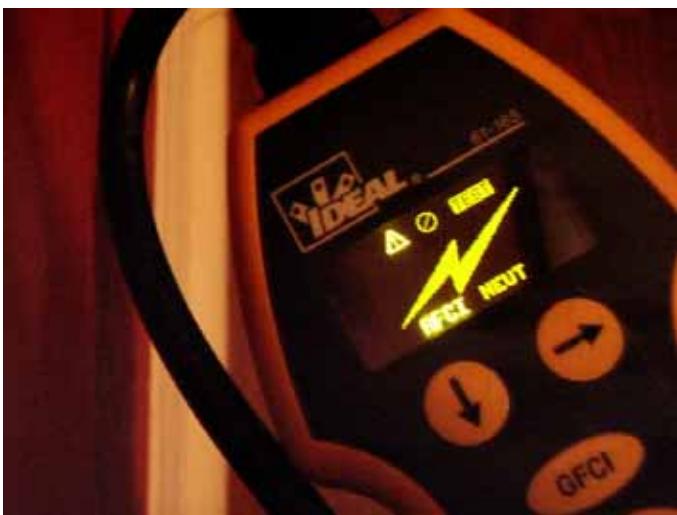
The receptacle & fixture outlets test non-AFCI protected behind by the closet in the 1st floor bedroom. 2002 NEC 210.12 Arc-Fault Circuit-Interrupter Protection.

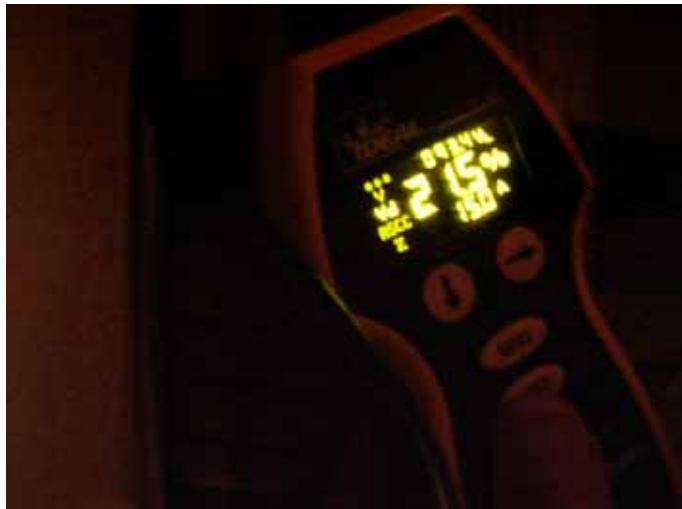
The voltage drop at several of the outlets exceeds 20%. 2002(NEC) 210.19 Conductors. We believe that any voltage drops over 10% require further investigation.

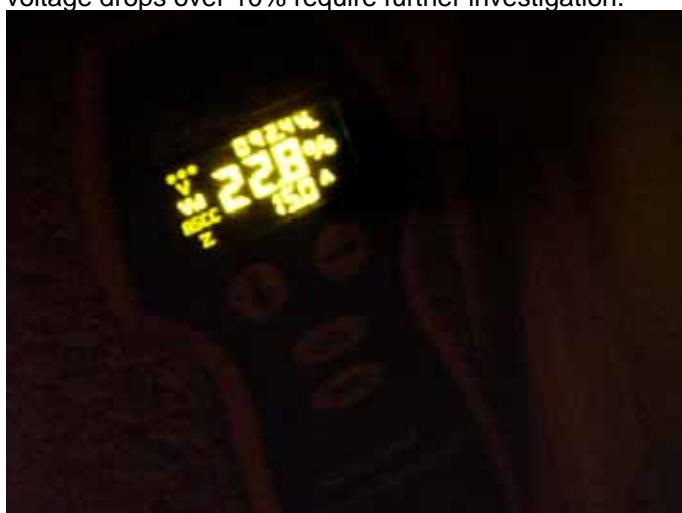
The voltage drop at several of the outlets exceeds 20%. 2002(NEC) 210.19 Conductors. We believe that any voltage drops over 10% require further investigation.

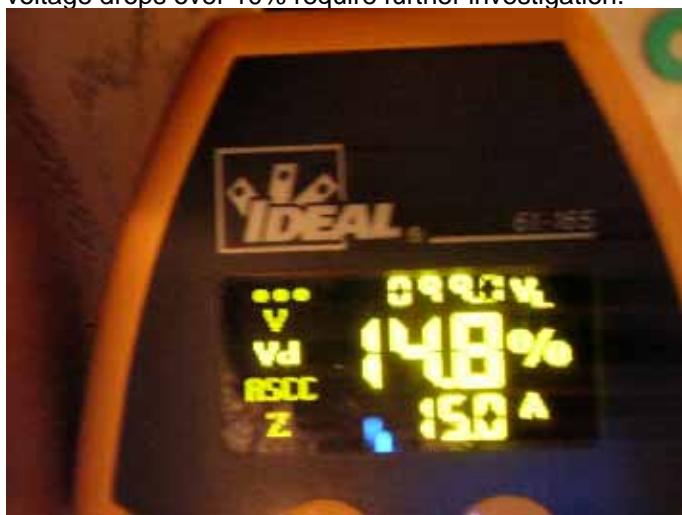
The voltage drop at several of the outlets exceeds 10%. 2002(NEC) 210.19 Conductors. We believe that any voltage drops over 10% require further investigation.

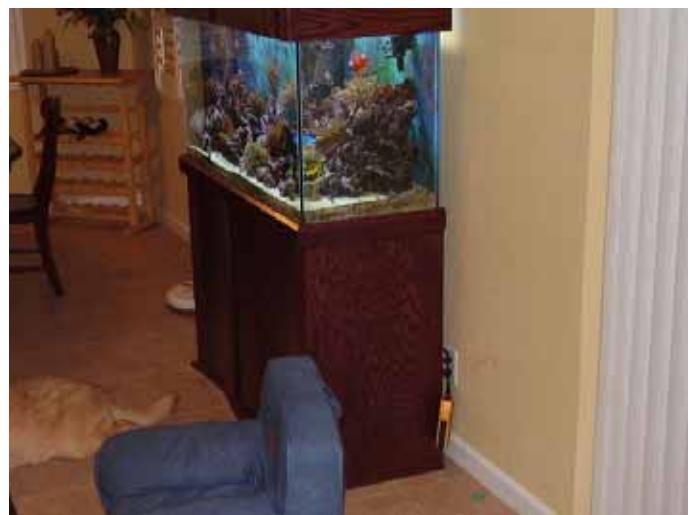
The client stated that there has been a problem with the fish tank when the TV is turned on.

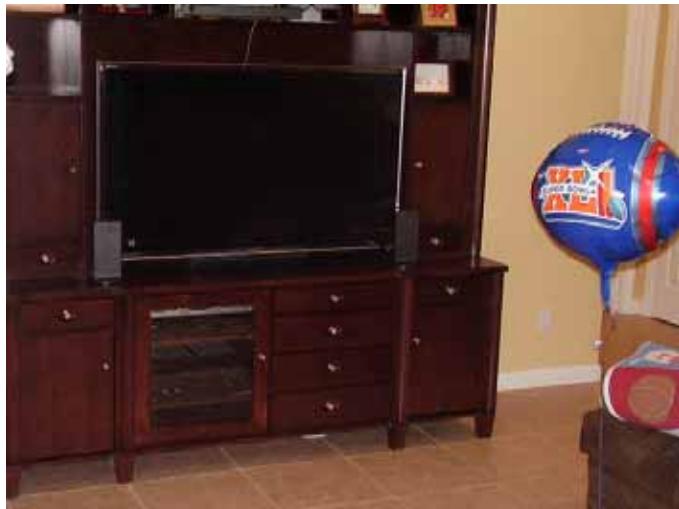
The client stated that there has been a problem with the fish tank when the TV is turned on.
