Five-O Building Inspections
2450 SE Springtree Pl
Stuart FL 34997
tomglyn@adelphia.net

02/06/07

Inspection Report of 1005 Ruby Ave Vero Beach FL 32968
Prepared for Bob & Tracey Schafer

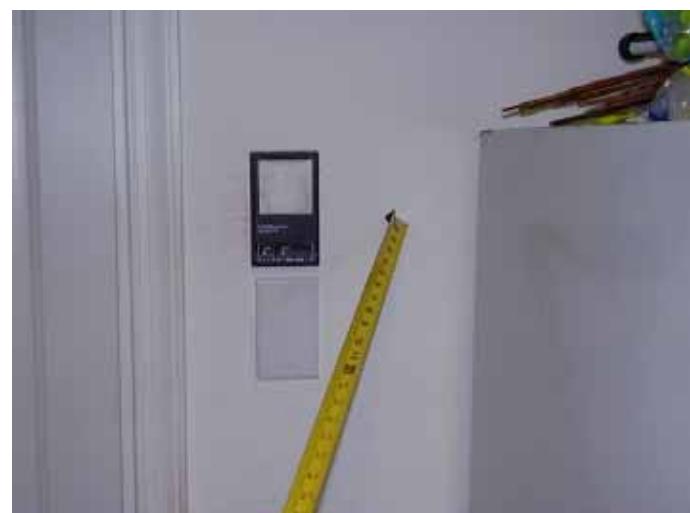
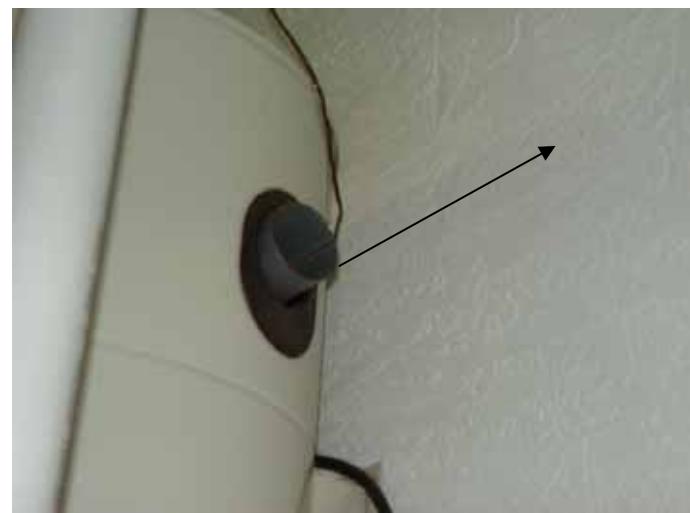
The central vacuum should be vented to the outdoors as per §M501.3 & by the manufacturer's installation instructions. See Below. §M304.1

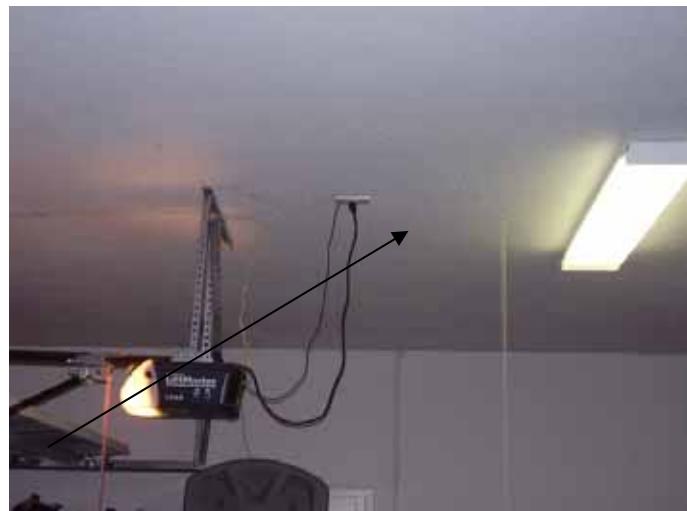
An access has not been installed for entry to the attic above the garage.

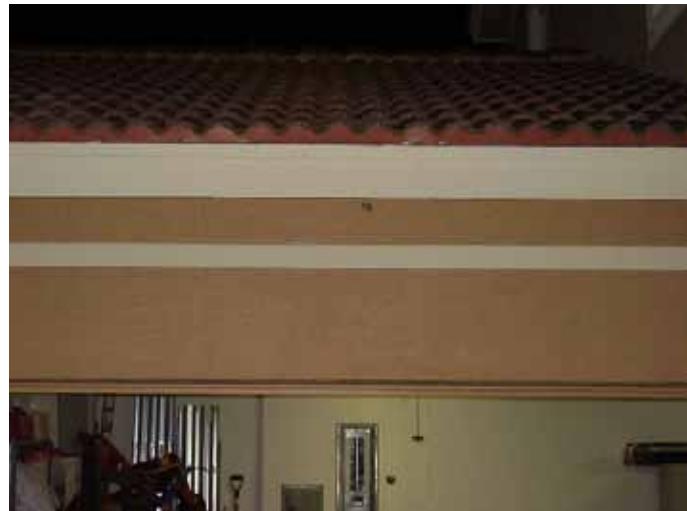
There was more than 24" clear height between the garage ceiling & the roof peak. §2309.6

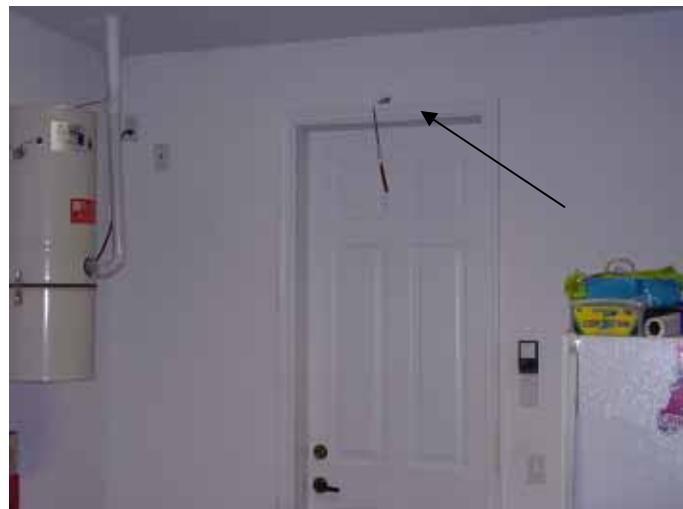
Both sides of the door frame should be sealed.

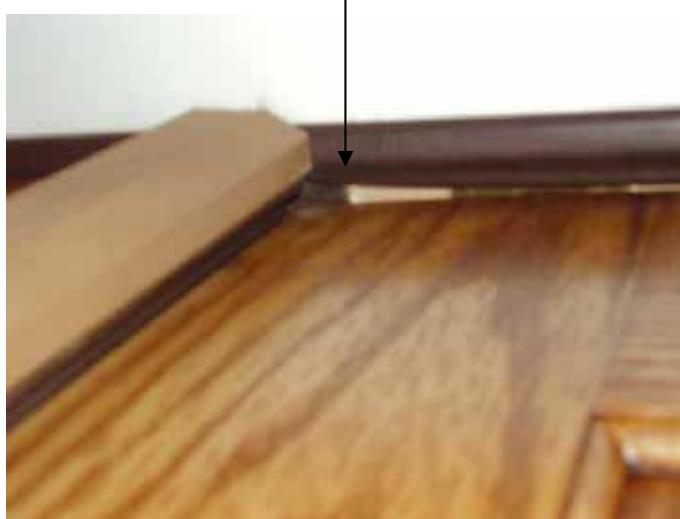
There were gaps with daylight at the front door & frame.

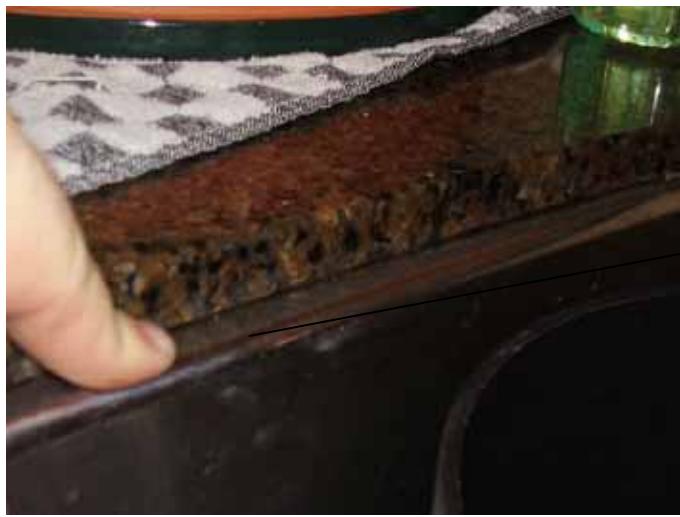
The sink was not completely sealed at the countertop to prevent water from seeping through to the cabinet below.

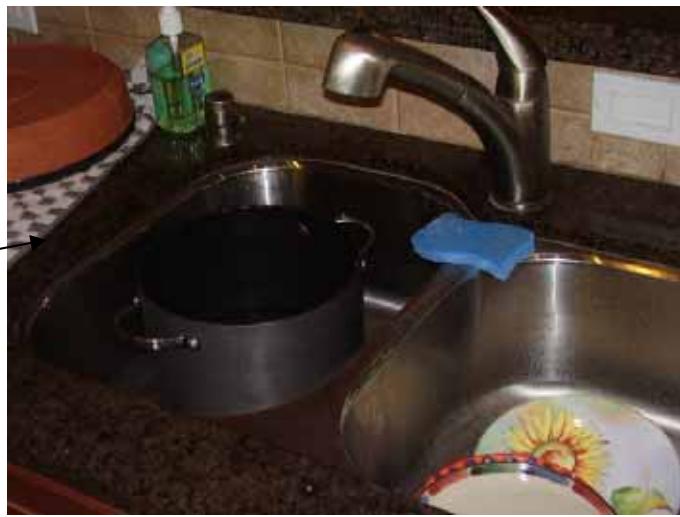
The sink was not completely sealed at the countertop to prevent water from seeping through to the cabinet below in the kitchen.

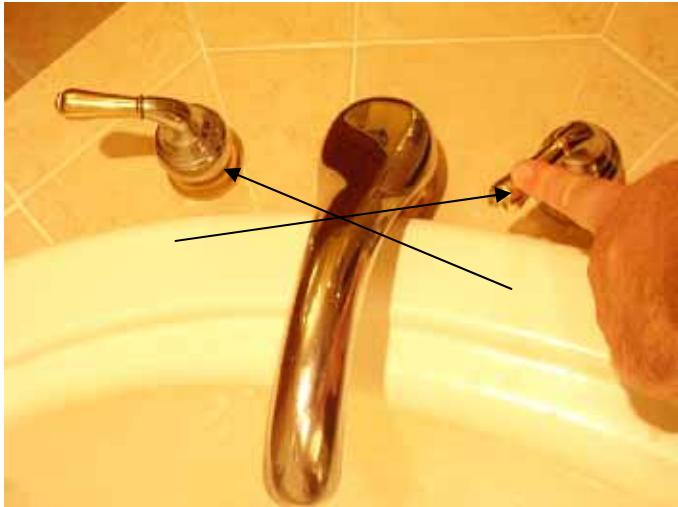
The hot & cold were reversed at the faucets at the master bath tub.

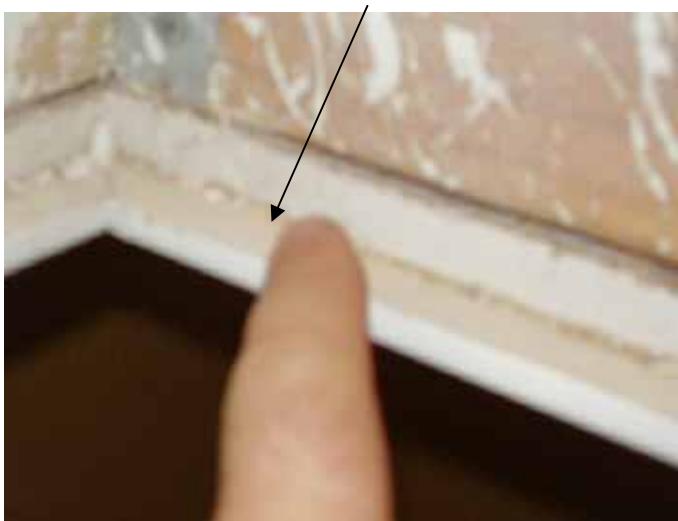
There was no air tight seal or gasket at the attic access openings as required. §13-606.1.ABC.1.2.3

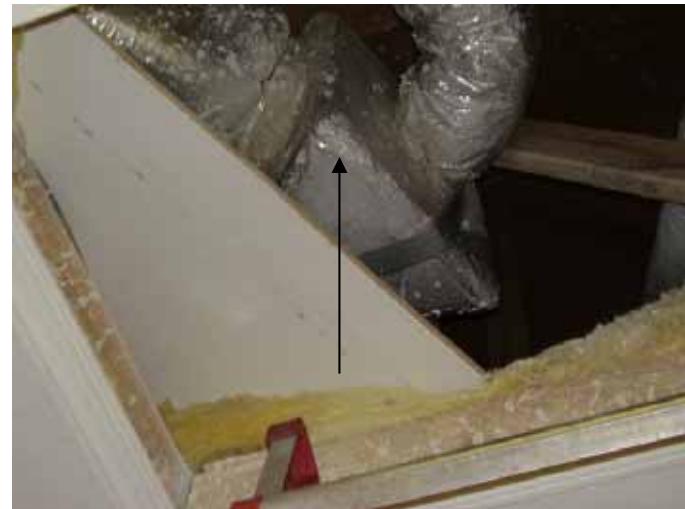
The AC refrigerant ductwork was installed over the attic opening & obstructs entrance to the attic.

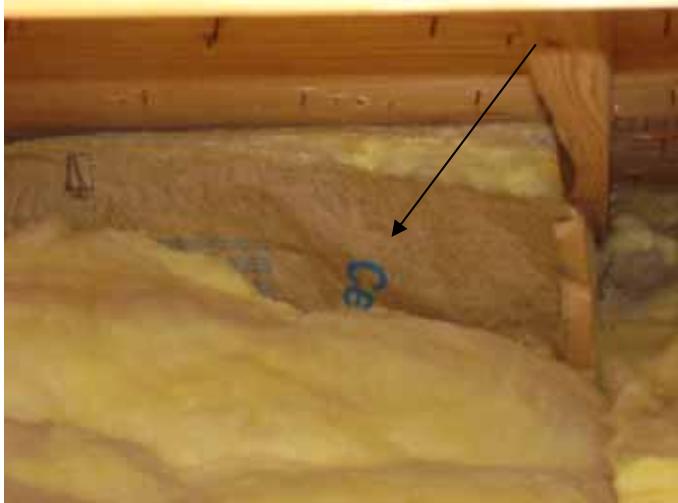
There is exposed kraft paper insulation backing in the attic. The manufacturer states the facing will burn & should not be exposed. §708.2

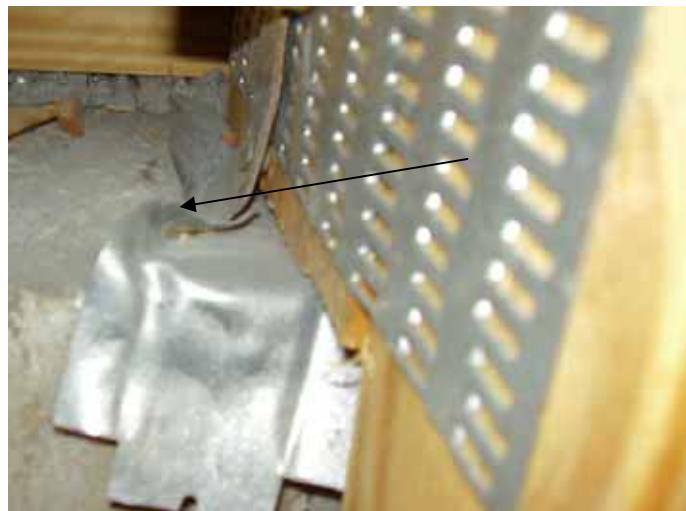
Some of the truss anchor straps are not correctly installed. There should be no slack in the straps. §1606.1.3, §2306.2

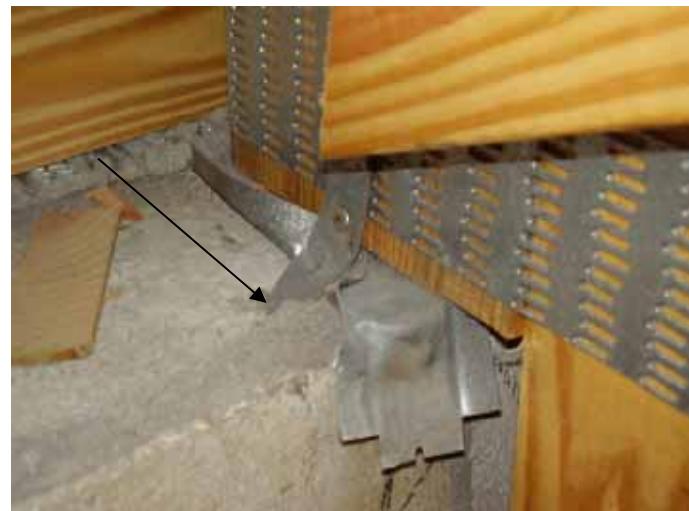
Some of the truss anchor straps are not correctly embedded in the concrete. They are offset 1& ½" or more from trusses over the garage. §2306.2, §1606.1.3

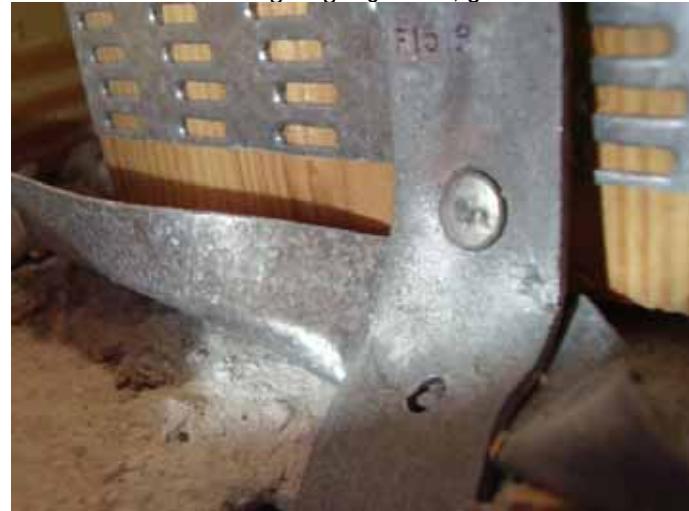
Some of the truss anchor straps are not correctly installed. There should be no slack in the straps. §1606.1.3, §2306.2

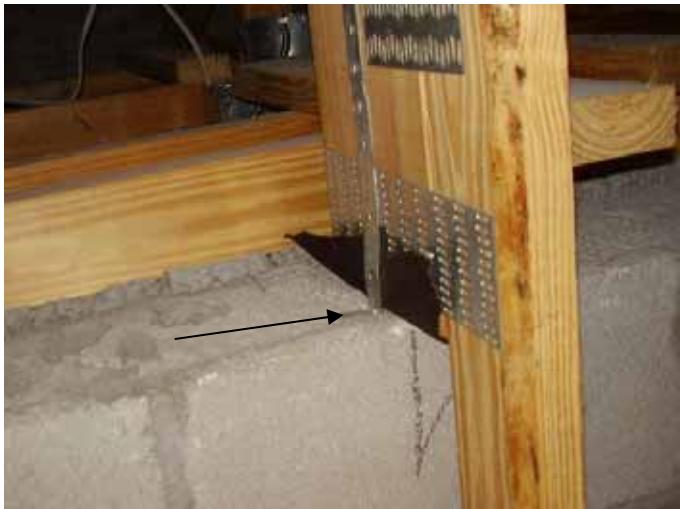
Some of the truss anchor straps were not correctly embedded into the concrete. §1606.1.3, §2306.2.

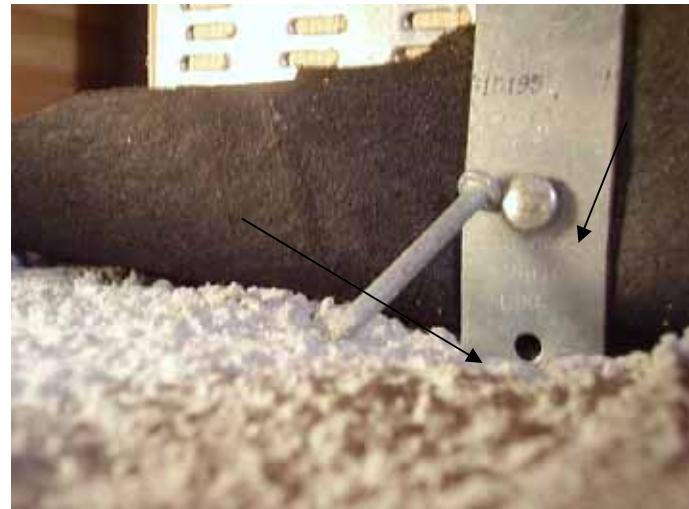
The straps should be embedded into the concrete up to the line on the strap. Some of the straps had more than an inch exposed below the embedment line.

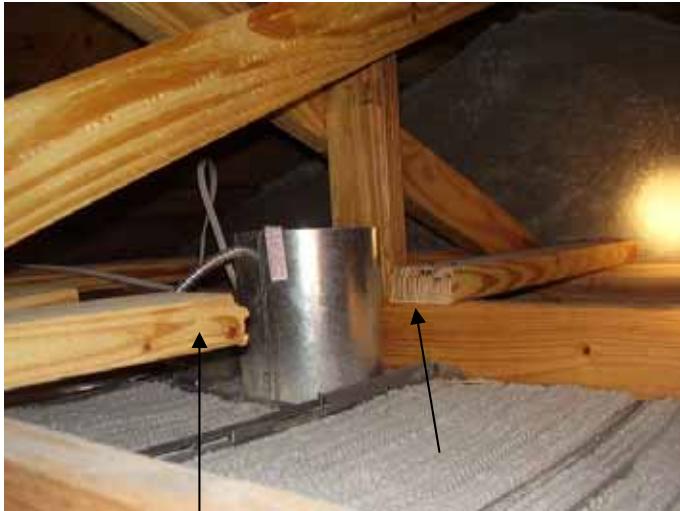
The 2x4 ceiling joist support was cut for the recessed lighting fixture & should be re-routed above the front entryway.

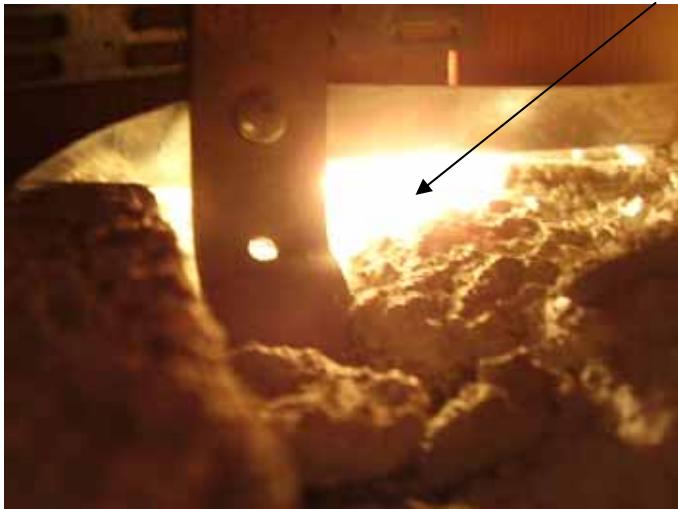
Some of the truss anchor straps were not correctly embedded into the concrete. The concrete should fill the block up to the top & embedment line. §1606.1.3, §2306.2.

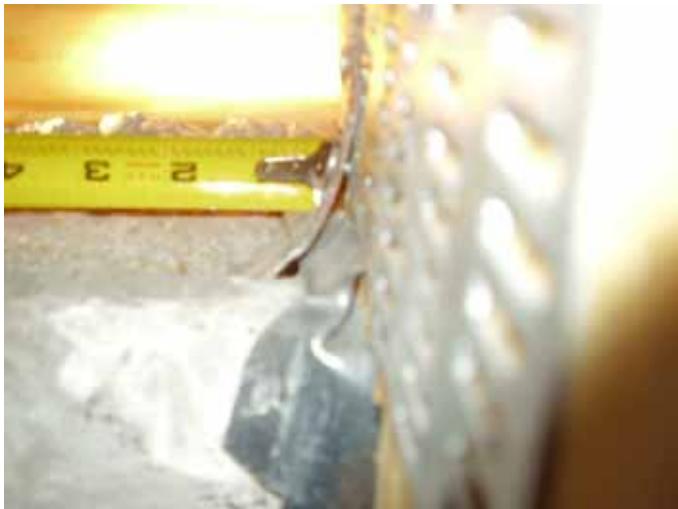
Some of the truss anchor straps are not correctly installed. There should be no slack in the straps. §1606.1.3, §2306.2

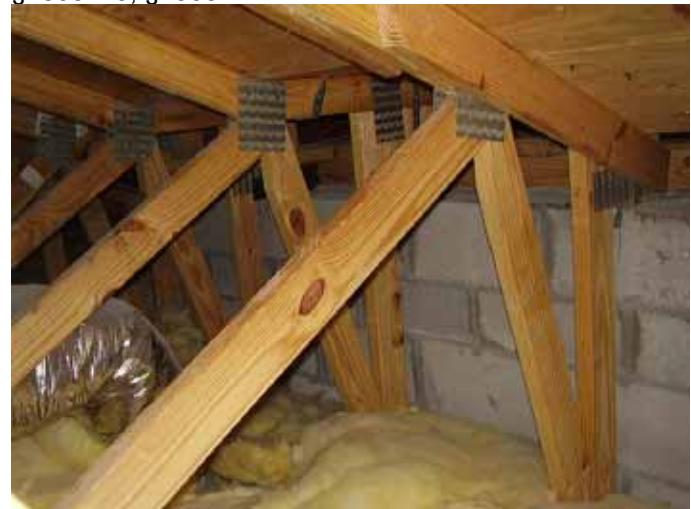
Some of the truss anchor straps are not correctly embedded in the concrete. They are offset 1& ½" or more from trusses over the garage. §2306.2, §1606.1.3

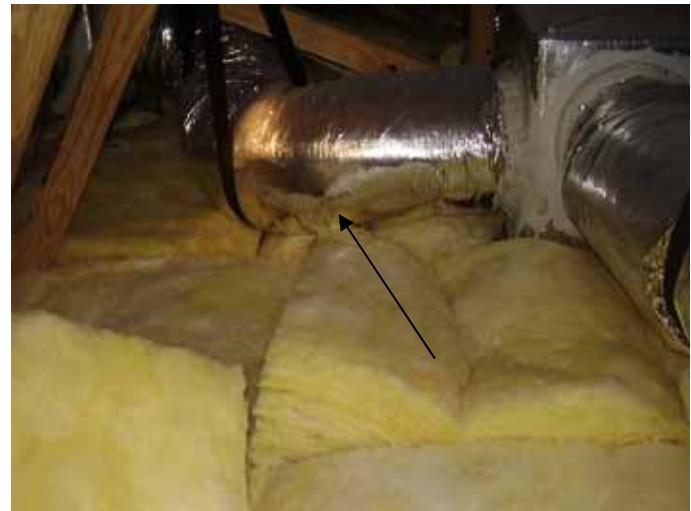
Some of the AC ducts were not correctly supported off the attic insulation or other ductwork as required.

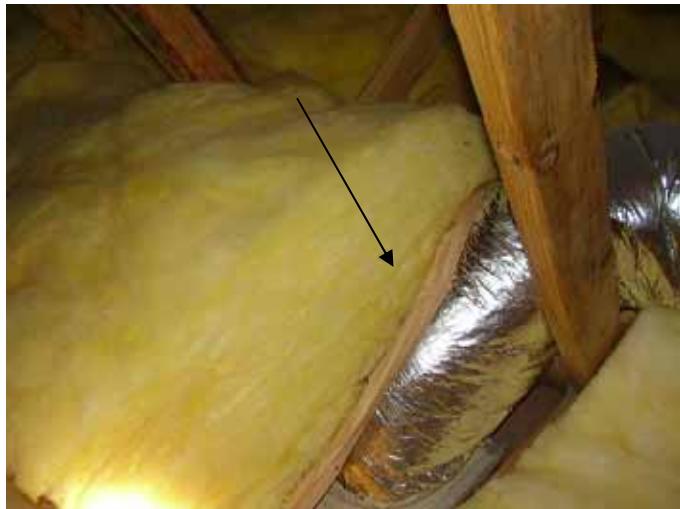
Some of the AC ducts were not correctly supported off the attic insulation or other ductwork as required.

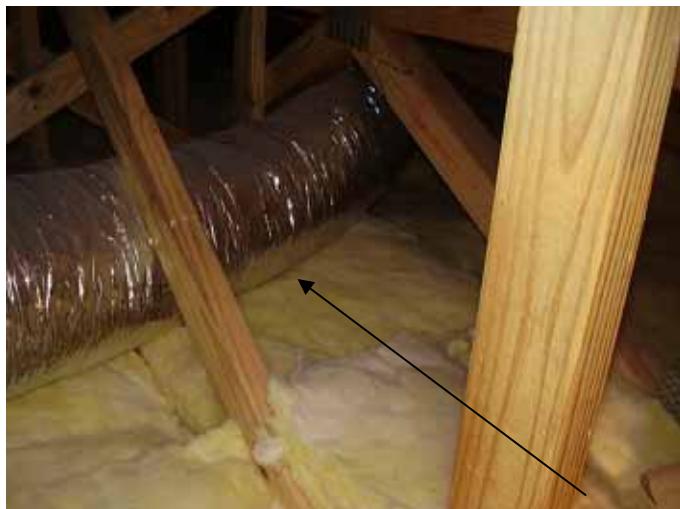
Some of the AC ducts were not correctly supported off the attic insulation or other ductwork as required.

6. Hangers, saddles and other supports shall meet the duct manufacturer's recommendations and shall be of sufficient width to prevent restriction of the internal duct diameter. In no case shall the material supporting flexible duct that is in direct contact with it be less than 1-1/2 inches wide.

See item (7) from the Indian River Inspection Department which states to Support all duct off the insulation in the attic.
